Profile/Photo Observation Report

Street:	FOXCROFT STREET	Flow Control:	Not Controlled
City:	Hobart, IN	Year Renewed:	
Location:	Light Highway	Tape/Media #:	
Purpose:	Routine Assessment	Dia/Height:	8"
Use:	Sanitary	Material:	VCP
Drain Area:	NA	Lining:	
Category:	NA		
Comment:	flow direction wrong . P_C at 7 ft mineral deposit		
Location Details:		Direction of Survey:	Upstream
US MH:	M-209-017	DS MH:	M-209-016
		Total Length Surveyed (ft):	8.0

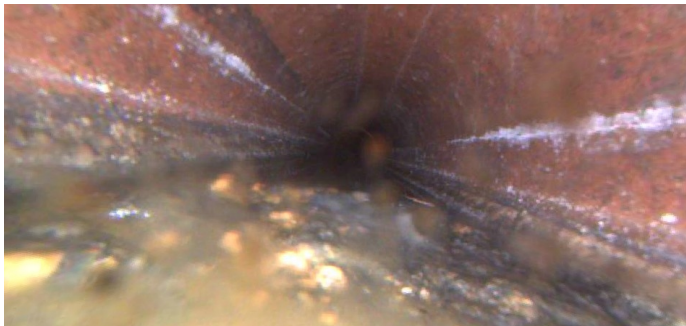
Code: **AMH**
Description: **Manhole**

Distance (ft): **.0**
Structural Grade: **0**
O&M Grade: **0**
Clock Start/From:
Clock To:
1st Value:
2nd Value:
Value Percent:
Continuous Index:
Within 8" of Joint: **NO**
Remarks: **M-209-016**

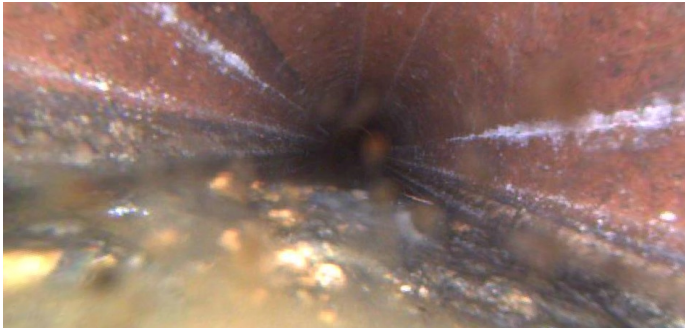
Code:	MWL
Description:	Water Level

Distance (ft):	.0
Structural Grade:	0
O&M Grade:	0
Clock Start/From:	
Clock To:	
1st Value:	
2nd Value:	
Value Percent:	25.000
Continuous Index:	
Within 8" of Joint:	NO
Remarks:

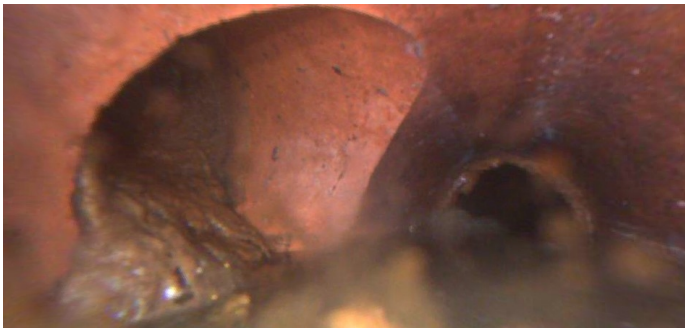
Code:	TFD
Description:	Tap Factory Defective

Distance (ft):	5.6
Structural Grade:	0
O&M Grade:	2
Clock Start/From:	10
Clock To:	
1st Value:	4.000
2nd Value:	
Value Percent:	
Continuous Index:	
Within 8" of Joint:	
Remarks:	DSF

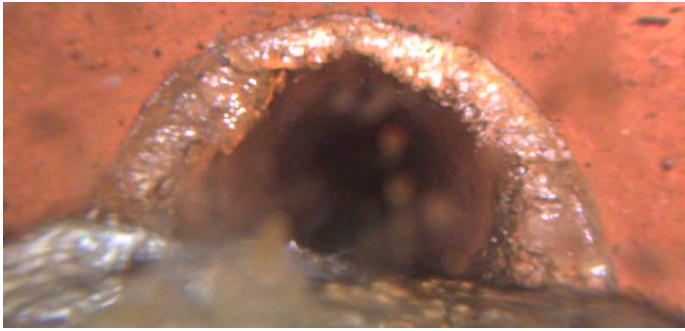
Code: **DAE**
Description: **Deposits Attached Encrustation**

Distance (ft): **6.8**
Structural Grade: **0**
O&M Grade: **3**
Clock Start/From: **9**
Clock To: **3**
1st Value:
2nd Value:
Value Percent: **15.000**
Continuous Index:
Within 8" of Joint: **YES**
Remarks:

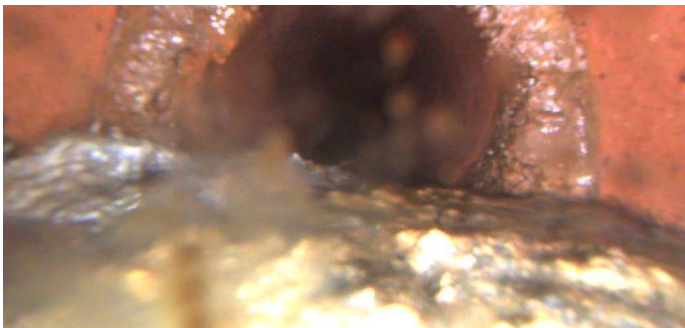
Code: **OBZ**
Description: **Obstacle Other**

Distance (ft): **6.8**
Structural Grade: **0**
O&M Grade: **4**
Clock Start/From: **4**
Clock To: **8**
1st Value:
2nd Value:
Value Percent: **25.000**
Continuous Index:
Within 8" of Joint: **NO**
Remarks: **Mixed materials**

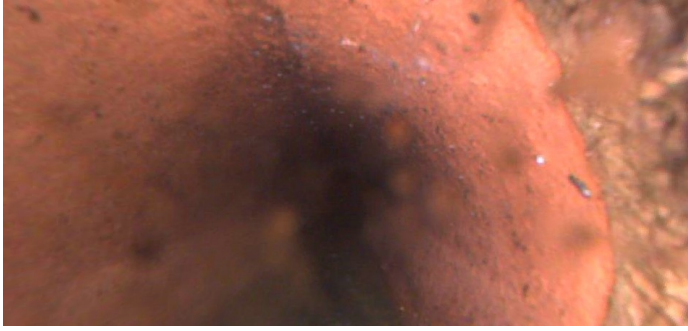
Code:	MSA
Description:	Abandoned Survey
Distance (ft):	8.0
Structural Grade:	0
O&M Grade:	0
Clock Start/From:	
Clock To:	
1st Value:	
2nd Value:	
Value Percent:	
Continuous Index:	
Within 8" of Joint:	NO
Remarks:	OBZ
