Profile/Photo Observation Report

Date:	03/19/2018	Weather:		Coding:	PACP 6.0
Pipe Length (ft):	117.8	Owner:	NA	Pre Clean:	No Pre-Cleaning
P.O.#:		Surveyor:	John Kuglmaier	PSR:	P-209-016-017
Customer:		Clean Date:	01/01/1900	Shape:	C

Street:	E 62ND PL	Flow Control:	Not Controlled
City:	Hobart, IN	Year Renewed:	
Location:	Light Highway	Tape/Media #:	
Purpose:	Routine Assessment	Dia/Height:	8"
Use:	Sanitary	Material:	VCP
Drain Area:	NA	Lining:	
Category:	NA		
Comment:	P_C at 63 ft debris . flow direction wrong		
Location Details:		Direction of Survey:	Downstream
US MH:	M-209-017	DS MH:	M-209-016
		Total Length Surveyed (ft):	64.2

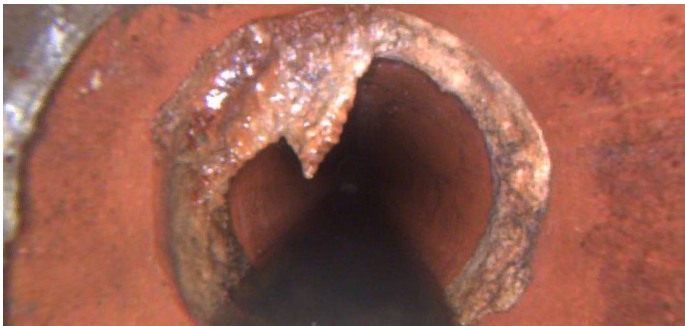
Code: **AMH**
Description: **Manhole**

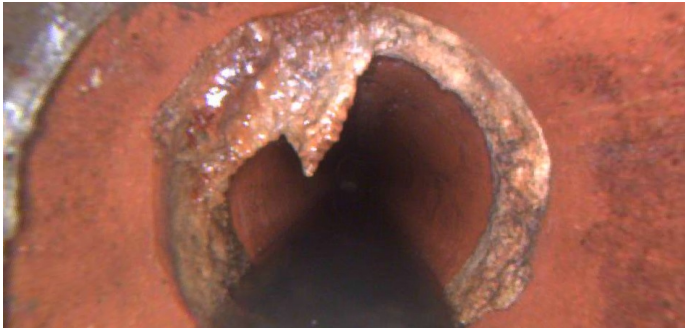
Code:	MWL
Description:	Water Level

Distance (ft):	.0
Structural Grade:	0
O&M Grade:	0
Clock Start/From:	
Clock To:	
1st Value:	
2nd Value:	
Value Percent:	15.000
Continuous Index:	
Within 8" of Joint:	NO
Remarks:

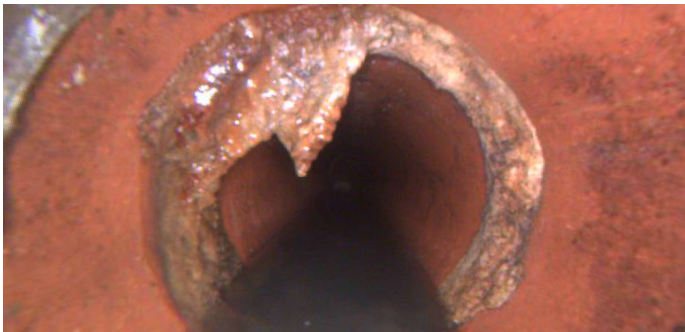
Code:	ID
Description:	Infil Dripper

Distance (ft):	.0
Structural Grade:	0
O&M Grade:	3
Clock Start/From:	12
Clock To:	
1st Value:	
2nd Value:	
Value Percent:	
Continuous Index:	
Within 8" of Joint:	YES
Remarks:

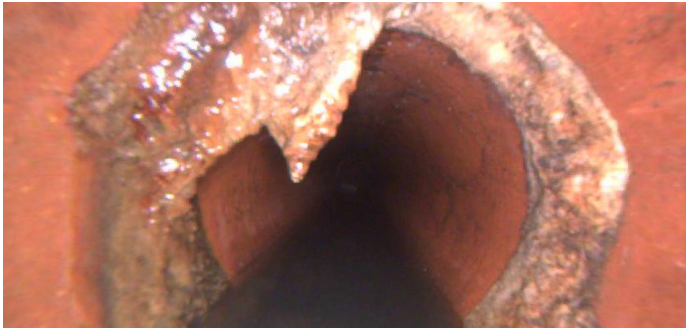
Code: **DAE**
Description: **Deposits Attached Encrustation**

Distance (ft): **.3**
Structural Grade: **0**
O&M Grade: **4**
Clock Start/From: **8**
Clock To: **4**
1st Value:
2nd Value:
Value Percent: **25.000**
Continuous Index: **S01**
Within 8" of Joint: **YES**
Remarks:

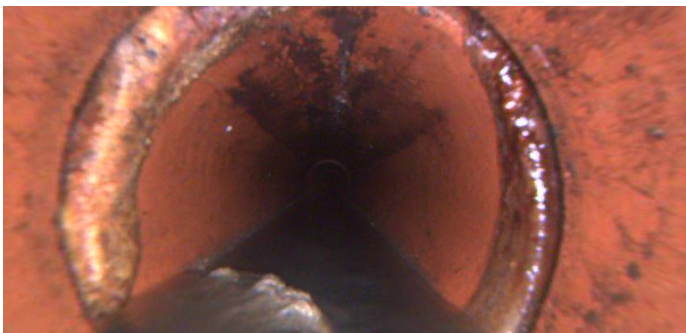
Code: **IW**
Description: **Infil Weeper**

Distance (ft): **5.3**
Structural Grade: **0**
O&M Grade: **2**
Clock Start/From: **12**
Clock To: **4**
1st Value:
2nd Value:
Value Percent:
Continuous Index:
Within 8" of Joint: **YES**
Remarks:

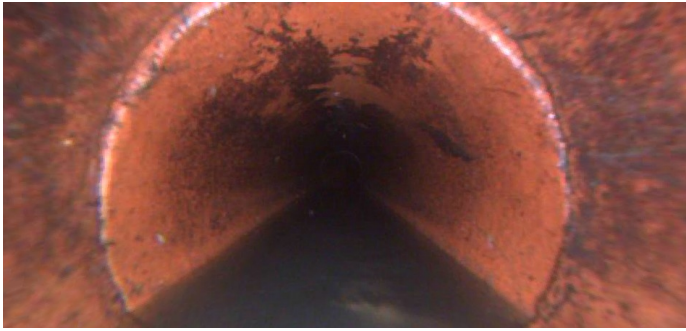
Code: **DAE**
Description: **Deposits Attached Encrustation**

Distance (ft): **13.4**
Structural Grade: **0**
O&M Grade: **4**
Clock Start/From: **8**
Clock To: **4**
1st Value:
2nd Value:
Value Percent: **25.000**
Continuous Index: **F01**
Within 8" of Joint: **YES**
Remarks: **Clock positions vary**

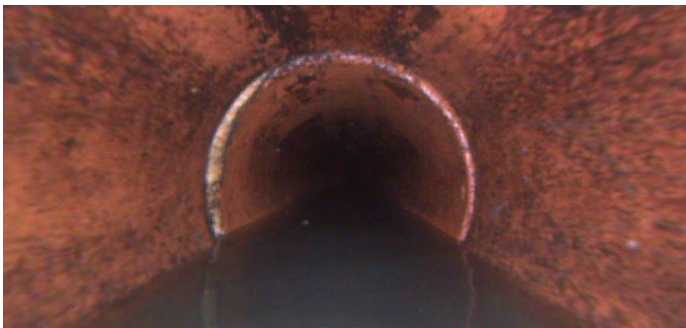
Code: **MWL**
Description: **Water Level**

Distance (ft): **17.2**
Structural Grade: **0**
O&M Grade: **0**
Clock Start/From:
Clock To:
1st Value:
2nd Value:
Value Percent: **30.000**
Continuous Index:
Within 8" of Joint: **NO**
Remarks:

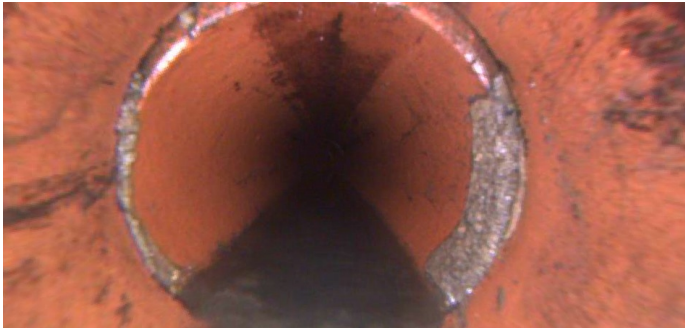
Code: **DAGS**
Description: **Deposits Attached Grease**

Distance (ft): **29.5**
Structural Grade: **0**
O&M Grade: **2**
Clock Start/From: **2**
Clock To: **4**
1st Value:
2nd Value:
Value Percent: **5.000**
Continuous Index:
Within 8" of Joint: **YES**
Remarks:

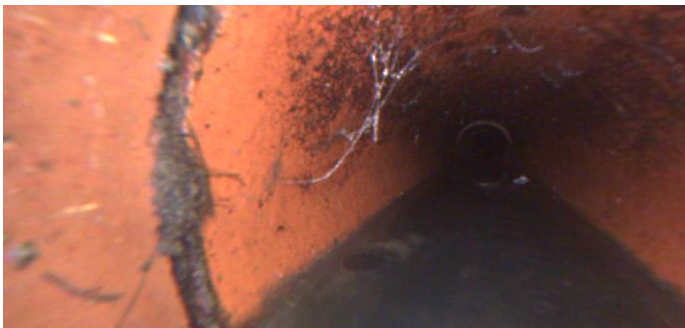
Code: **RFJ**
Description: **Roots Fine Joint**

Distance (ft): **58.1**
Structural Grade: **0**
O&M Grade: **1**
Clock Start/From: **9**
Clock To:
1st Value:
2nd Value:
Value Percent:
Continuous Index:
Within 8" of Joint: **YES**
Remarks:

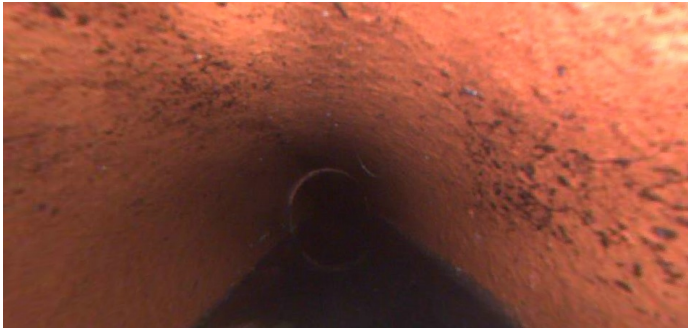
Code:	MSA
Description:	Abandoned Survey
Distance (ft):	64.2
Structural Grade:	0
O&M Grade:	0
Clock Start/From:	
Clock To:	
1st Value:	
2nd Value:	
Value Percent:	
Continuous Index:	
Within 8" of Joint:	NO
Remarks:	Unknown
