Profile/Photo Observation Report

Date:	03/19/2018	Weather:		Coding:	PACP 6.0
Pipe Length (ft):	299.4	Owner:	NA	Pre Clean:	No Pre-Cleaning
P.O.#:		Surveyor:	John Kuglmaier	PSR:	P-209-018-019
Customer:		Clean Date:	01/01/1900	Shape:	C

Street:	ALLEY BETWEEN WISCONSIN ST & C	Flow Control:	Not Controlled
City:	Hobart, IN	Year Renewed:	
Location:	Light Highway	Tape/Media #:	
Purpose:	Routine Assessment	Dia/Height:	8"
Use:	Sanitary	Material:	VCP
Drain Area:	NA	Lining:	
Category:	NA		
Comment:	P_C at 90 ft nothing visible . Flow direction wrong		
Location Details:		Direction of Survey:	Downstream
US MH:	M-209-019	DS MH:	M-209-018
		Total Length Surveyed (ft):	91.7

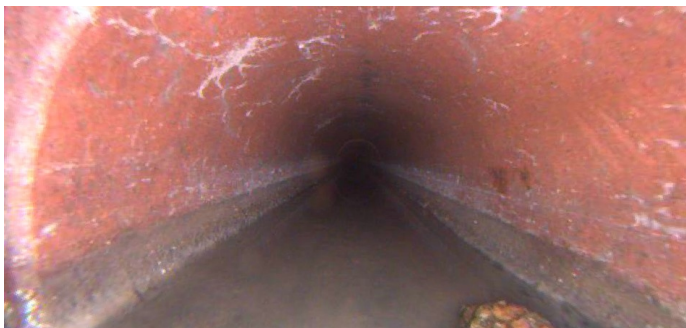
Code: **AMH**
Description: **Manhole**

Distance (ft): **.0**
Structural Grade: **0**
O&M Grade: **0**
Clock Start/From:
Clock To:
1st Value:
2nd Value:
Value Percent:
Continuous Index:
Within 8" of Joint: **NO**
Remarks: **M-209-019**

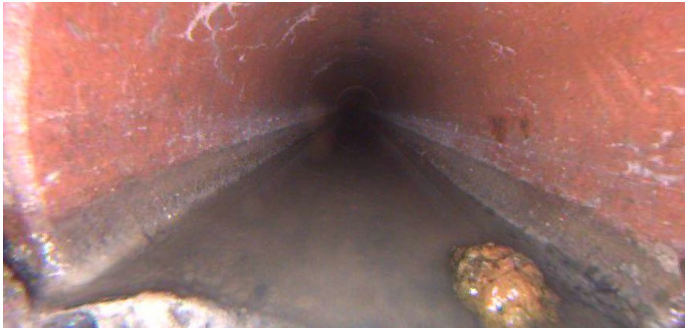
Code:	MWL
Description:	Water Level

Distance (ft):	.0
Structural Grade:	0
O&M Grade:	0
Clock Start/From:	
Clock To:	
1st Value:	
2nd Value:	
Value Percent:	20.000
Continuous Index:	
Within 8" of Joint:	NO
Remarks:

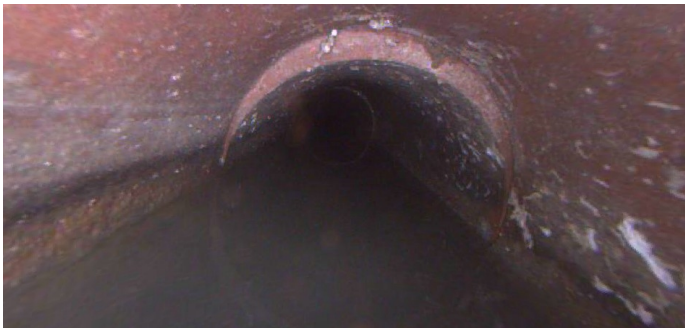
Code:	MWL
Description:	Water Level

Distance (ft):	13.1
Structural Grade:	0
O&M Grade:	0
Clock Start/From:	
Clock To:	
1st Value:	
2nd Value:	
Value Percent:	30.000
Continuous Index:	
Within 8" of Joint:	NO
Remarks:

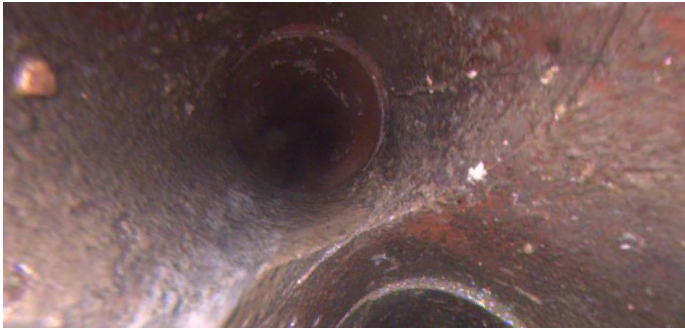
Code: **TF**
Description: **Tap Factory**

Distance (ft): **14.7**
Structural Grade: **0**
O&M Grade: **0**
Clock Start/From: **11**
Clock To:
1st Value: **4.000**
2nd Value:
Value Percent:
Continuous Index:
Within 8" of Joint:
Remarks:

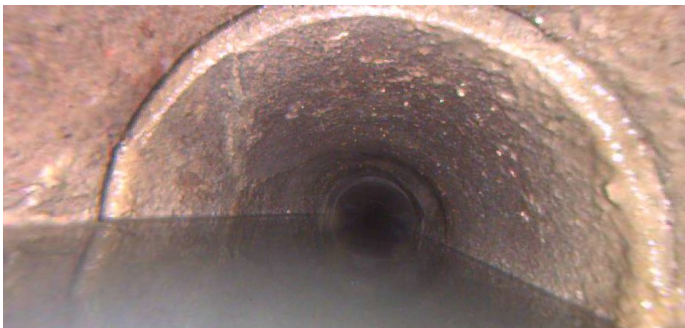
Code: **DAZ**
Description: **Deposits Attached Other**

Distance (ft): **15.3**
Structural Grade: **0**
O&M Grade: **2**
Clock Start/From: **9**
Clock To: **3**
1st Value:
2nd Value:
Value Percent: **5.000**
Continuous Index: **S01**
Within 8" of Joint: **NO**
Remarks: **Mixed materials**

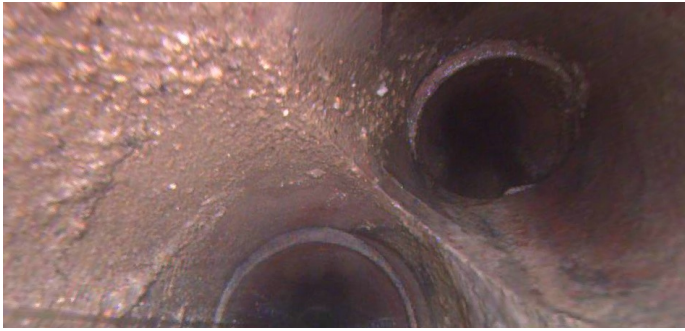
Code: **TF**
Description: **Tap Factory**

Distance (ft): **16.6**
Structural Grade: **0**
O&M Grade: **0**
Clock Start/From: **2**
Clock To:
1st Value: **4.000**
2nd Value:
Value Percent:
Continuous Index:
Within 8" of Joint:
Remarks:

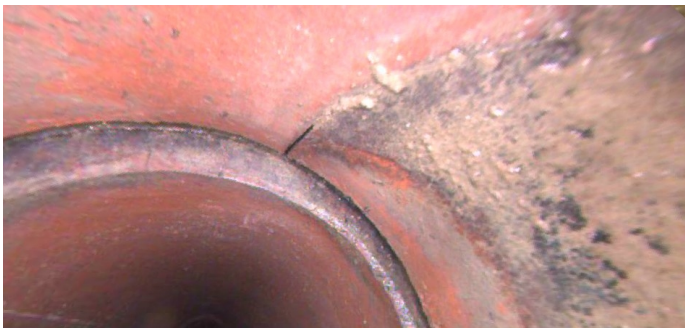
Code: **FL**
Description: **Fracture Longitudinal**

Distance (ft): **17.3**
Structural Grade: **3**
O&M Grade: **0**
Clock Start/From: **1**
Clock To:
1st Value:
2nd Value:
Value Percent:
Continuous Index:
Within 8" of Joint: **YES**
Remarks:

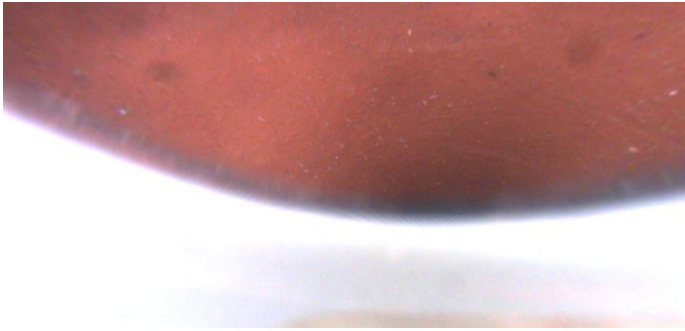
Code: **DAZ**
Description: **Deposits Attached Other**

Distance (ft): **18.7**
Structural Grade: **0**
O&M Grade: **2**
Clock Start/From: **9**
Clock To: **3**
1st Value:
2nd Value:
Value Percent: **5.000**
Continuous Index: **F01**
Within 8" of Joint: **NO**
Remarks: **Mixed materials / Clock positions vary**

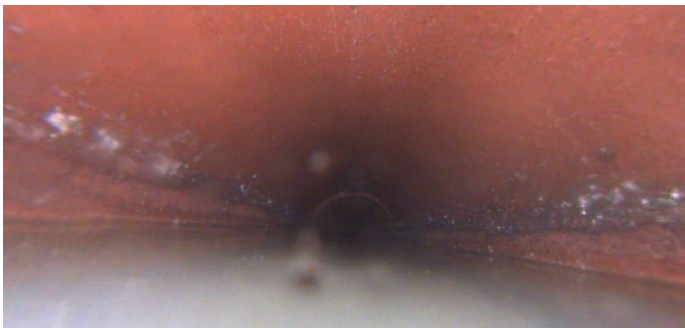
Code: **MWL**
Description: **Water Level**

Distance (ft): **19.5**
Structural Grade: **0**
O&M Grade: **0**
Clock Start/From:
Clock To:
1st Value:
2nd Value:
Value Percent: **50.000**
Continuous Index:
Within 8" of Joint: **NO**
Remarks:

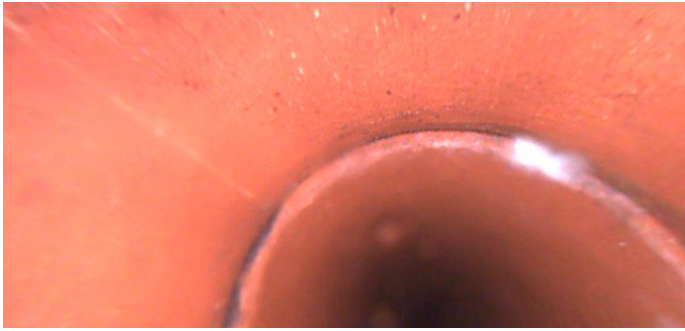
Code: **CL**
Description: **Crack Longitudinal**

Distance (ft): **37.8**
Structural Grade: **2**
O&M Grade: **0**
Clock Start/From: **10**
Clock To:
1st Value:
2nd Value:
Value Percent:
Continuous Index:
Within 8" of Joint: **YES**
Remarks:

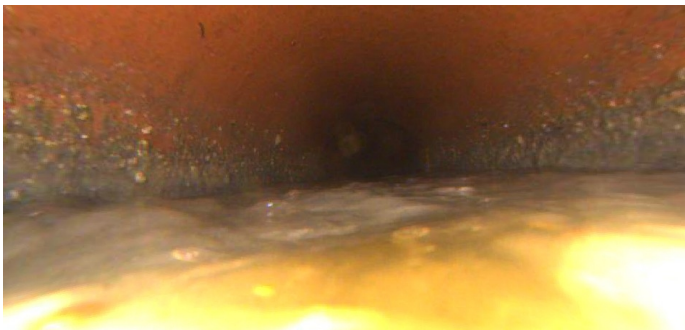
Code: **MGO**
Description: **General Observation**

Distance (ft): **52.3**
Structural Grade: **0**
O&M Grade: **0**
Clock Start/From:
Clock To:
1st Value:
2nd Value:
Value Percent:
Continuous Index:
Within 8" of Joint: **NO**
Remarks: **Switching to rear camera**

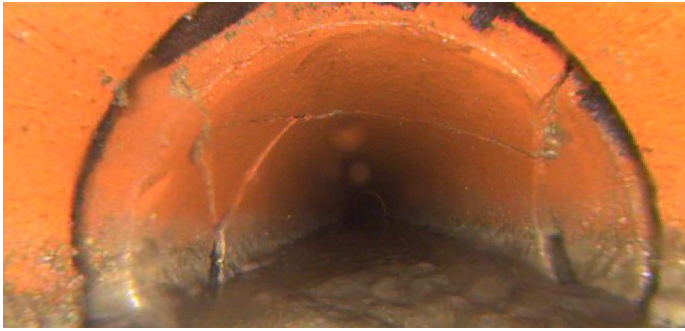
Code: **FM**
Description: **Fracture Multiple**

Distance (ft): **71.5**
Structural Grade: **4**
O&M Grade: **0**
Clock Start/From: **9**
Clock To: **3**
1st Value:
2nd Value:
Value Percent:
Continuous Index:
Within 8" of Joint: **YES**
Remarks:

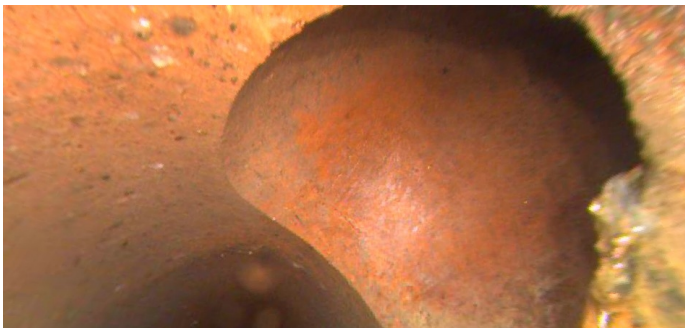
Code: **TF**
Description: **Tap Factory**

Distance (ft): **76.9**
Structural Grade: **0**
O&M Grade: **0**
Clock Start/From: **10**
Clock To:
1st Value: **4.000**
2nd Value:
Value Percent:
Continuous Index:
Within 8" of Joint:
Remarks:

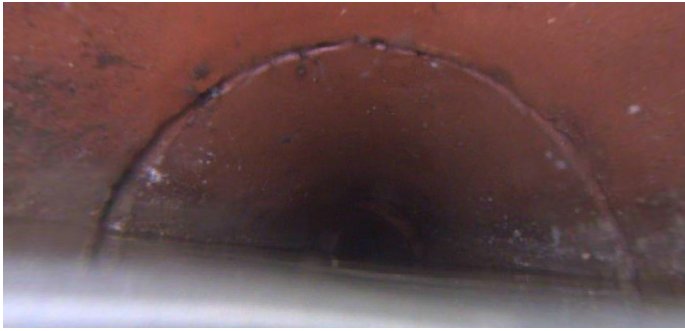
Code: **MGO**
Description: **General Observation**

Distance (ft): **76.9**
Structural Grade: **0**
O&M Grade: **0**
Clock Start/From:
Clock To:
1st Value:
2nd Value:
Value Percent:
Continuous Index:
Within 8" of Joint: **NO**
Remarks: **Switching to front camera**

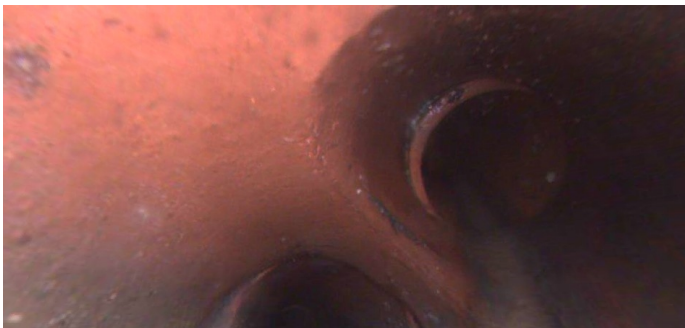
Code: **TF**
Description: **Tap Factory**

Distance (ft): **78.3**
Structural Grade: **0**
O&M Grade: **0**
Clock Start/From: **2**
Clock To:
1st Value: **4.000**
2nd Value:
Value Percent:
Continuous Index:
Within 8" of Joint:
Remarks:

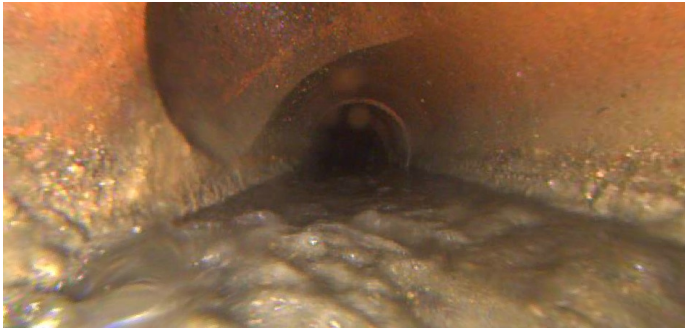
Code: **MGO**
Description: **General Observation**

Distance (ft): **79.3**
Structural Grade: **0**
O&M Grade: **0**
Clock Start/From:
Clock To:
1st Value:
2nd Value:
Value Percent:
Continuous Index:
Within 8" of Joint: **NO**
Remarks: **Switching to rear camera**

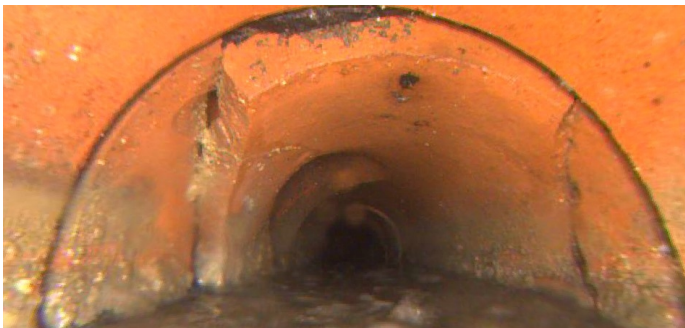
Code: **BVV**
Description: **Broken Void Visible**

Distance (ft): **79.7**
Structural Grade: **5**
O&M Grade: **0**
Clock Start/From: **9**
Clock To: **3**
1st Value:
2nd Value:
Value Percent:
Continuous Index:
Within 8" of Joint: **YES**
Remarks:

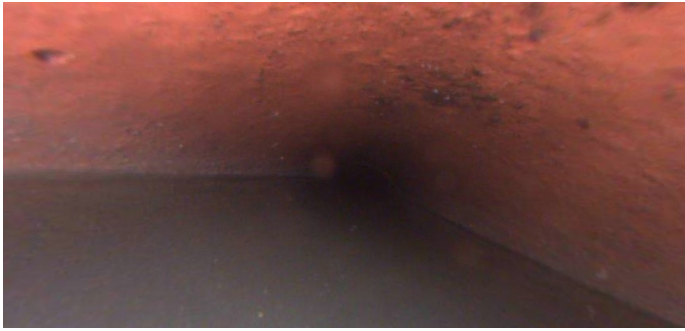
Code: **MGO**
Description: **General Observation**

Distance (ft): **89.4**
Structural Grade: **0**
O&M Grade: **0**
Clock Start/From:
Clock To:
1st Value:
2nd Value:
Value Percent:
Continuous Index:
Within 8" of Joint: **NO**
Remarks: **Switching to front camera**

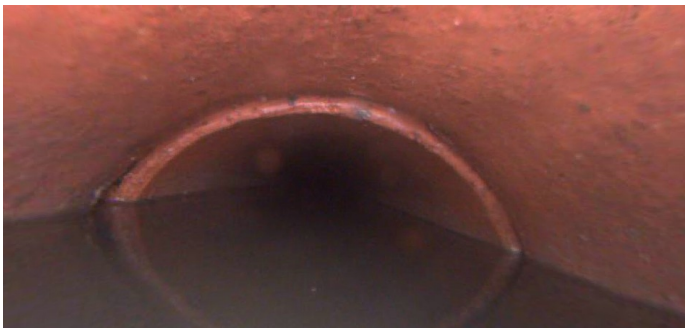
Code: **MWL**
Description: **Water Level**

Distance (ft): **91.5**
Structural Grade: **0**
O&M Grade: **0**
Clock Start/From:
Clock To:
1st Value:
2nd Value:
Value Percent: **70.000**
Continuous Index:
Within 8" of Joint: **NO**
Remarks:

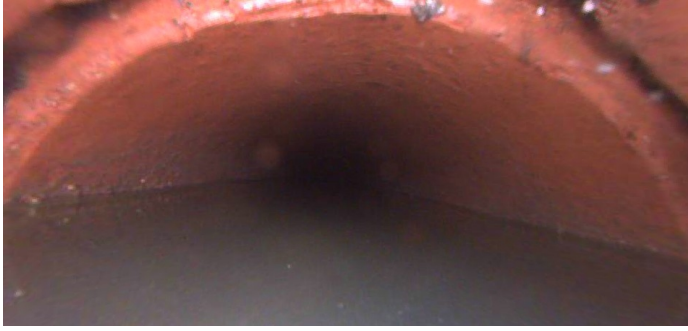
Code:	MSA
Description:	Abandoned Survey
Distance (ft):	91.7
Structural Grade:	0
O&M Grade:	0
Clock Start/From:	
Clock To:	
1st Value:	
2nd Value:	
Value Percent:	
Continuous Index:	
Within 8" of Joint:	NO
Remarks:	Unknown
