Profile/Photo Observation Report

Date:	03/19/2018	Weather:		Coding:	PACP 6.0
Pipe Length (ft):	299.4	Owner:	NA	Pre Clean:	No Pre-Cleaning
P.O.#:		Surveyor:	John Kuglmaier	PSR:	P-209-018-019
Customer:		Clean Date:	01/01/1900	Shape:	C

Street:	FOXCROFT STREET	Flow Control:	Not Controlled
City:	Hobart, IN	Year Renewed:	
Location:	Light Highway	Tape/Media #:	
Purpose:	Routine Assessment	Dia/Height:	8"
Use:	Sanitary	Material:	VCP
Drain Area:	NA	Lining:	
Category:	NA		
Comment:	P_C at 90 ft nothing visible . Flow direction wrong		
Location Details:		Direction of Survey:	Downstream
US MH:	M-209-019	DS MH:	M-209-018
		Total Length Surveyed (ft):	91.7

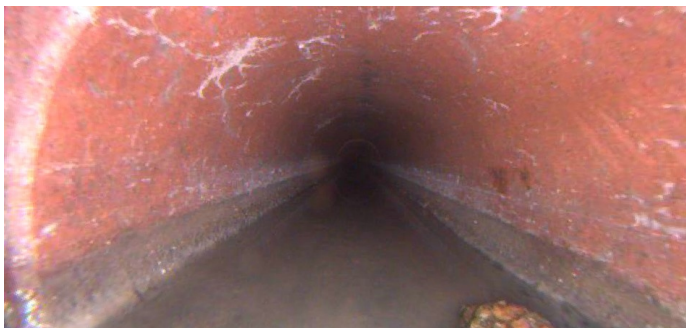
Code: **AMH**
Description: **Manhole**

Distance (ft): **.0**
Structural Grade: **0**
O&M Grade: **0**
Clock Start/From:
Clock To:
1st Value:
2nd Value:
Value Percent:
Continuous Index:
Within 8" of Joint: **NO**
Remarks: **M-209-019**

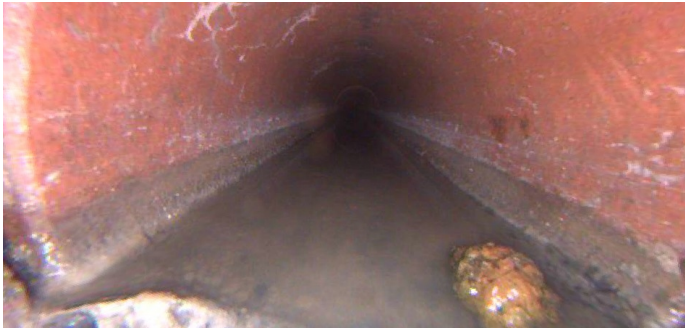
Code:	MWL
Description:	Water Level

Distance (ft):	.0
Structural Grade:	0
O&M Grade:	0
Clock Start/From:	
Clock To:	
1st Value:	
2nd Value:	
Value Percent:	20.000
Continuous Index:	
Within 8" of Joint:	NO
Remarks:

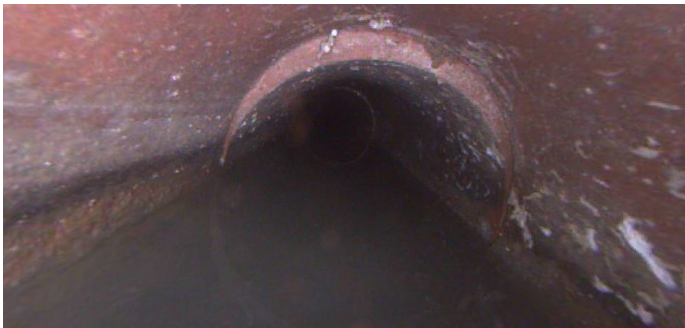
Code:	MWL
Description:	Water Level

Distance (ft):	13.1
Structural Grade:	0
O&M Grade:	0
Clock Start/From:	
Clock To:	
1st Value:	
2nd Value:	
Value Percent:	30.000
Continuous Index:	
Within 8" of Joint:	NO
Remarks:

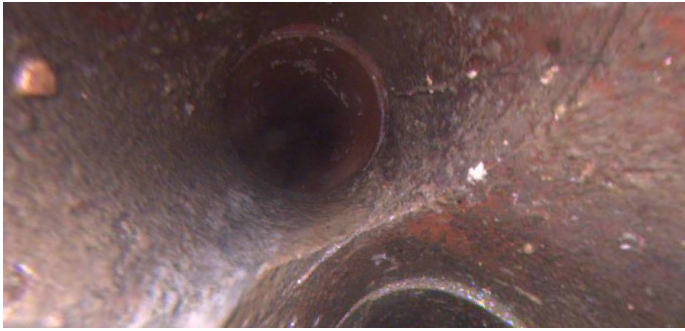
Code: **TF**
Description: **Tap Factory**

Distance (ft): **14.7**
Structural Grade: **0**
O&M Grade: **0**
Clock Start/From: **11**
Clock To:
1st Value: **4.000**
2nd Value:
Value Percent:
Continuous Index:
Within 8" of Joint:
Remarks:

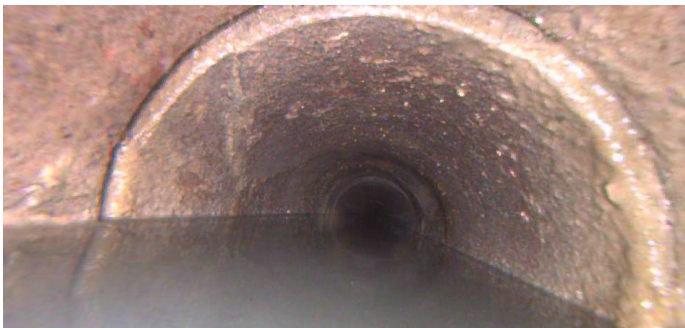
Code: **DAZ**
Description: **Deposits Attached Other**

Distance (ft): **15.3**
Structural Grade: **0**
O&M Grade: **2**
Clock Start/From: **9**
Clock To: **3**
1st Value:
2nd Value:
Value Percent: **5.000**
Continuous Index: **S01**
Within 8" of Joint: **NO**
Remarks: **Mixed materials**

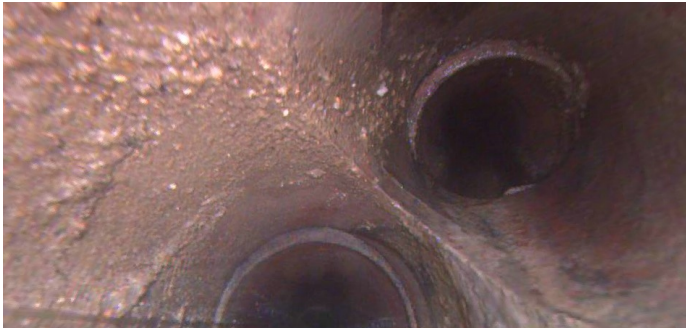
Code: **TF**
Description: **Tap Factory**

Distance (ft): **16.6**
Structural Grade: **0**
O&M Grade: **0**
Clock Start/From: **2**
Clock To:
1st Value: **4.000**
2nd Value:
Value Percent:
Continuous Index:
Within 8" of Joint:
Remarks:

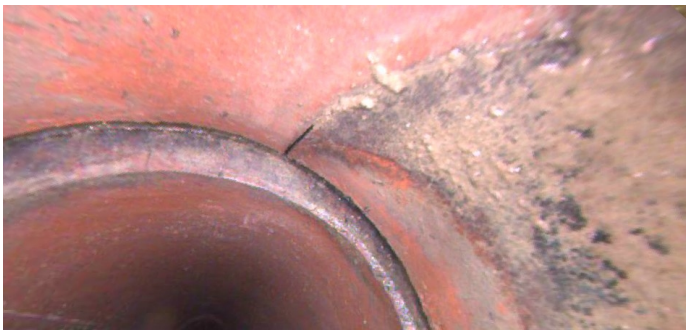
Code: **FL**
Description: **Fracture Longitudinal**

Distance (ft): **17.3**
Structural Grade: **3**
O&M Grade: **0**
Clock Start/From: **1**
Clock To:
1st Value:
2nd Value:
Value Percent:
Continuous Index:
Within 8" of Joint: **YES**
Remarks:

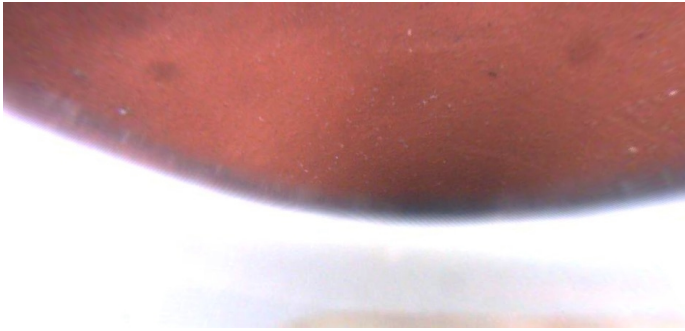
Code: **DAZ**
Description: **Deposits Attached Other**

Distance (ft): **18.7**
Structural Grade: **0**
O&M Grade: **2**
Clock Start/From: **9**
Clock To: **3**
1st Value:
2nd Value:
Value Percent: **5.000**
Continuous Index: **F01**
Within 8" of Joint: **NO**
Remarks: **Mixed materials / Clock positions vary**

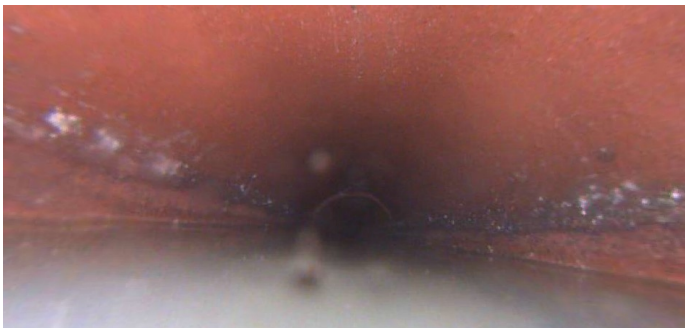
Code: **MWL**
Description: **Water Level**

Distance (ft): **19.5**
Structural Grade: **0**
O&M Grade: **0**
Clock Start/From:
Clock To:
1st Value:
2nd Value:
Value Percent: **50.000**
Continuous Index:
Within 8" of Joint: **NO**
Remarks:

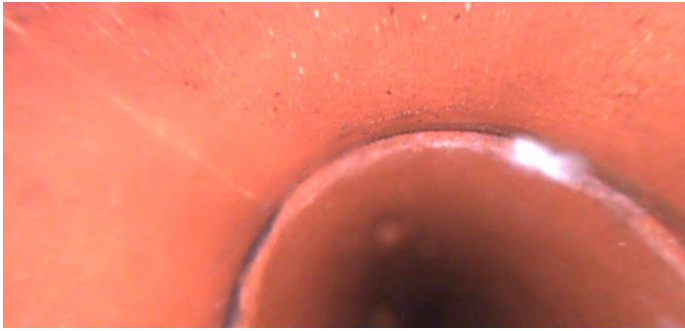
Code: **CL**
Description: **Crack Longitudinal**

Distance (ft): **37.8**
Structural Grade: **2**
O&M Grade: **0**
Clock Start/From: **10**
Clock To:
1st Value:
2nd Value:
Value Percent:
Continuous Index:
Within 8" of Joint: **YES**
Remarks:

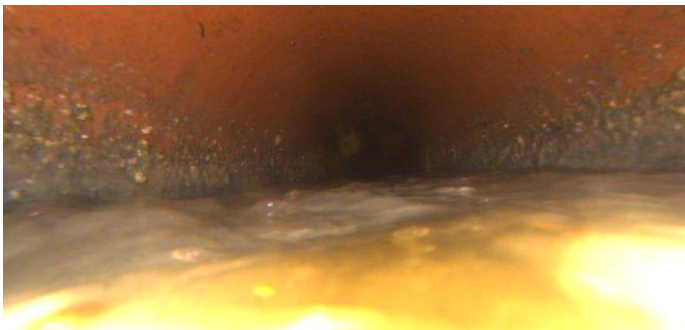
Code: **MGO**
Description: **General Observation**

Distance (ft): **52.3**
Structural Grade: **0**
O&M Grade: **0**
Clock Start/From:
Clock To:
1st Value:
2nd Value:
Value Percent:
Continuous Index:
Within 8" of Joint: **NO**
Remarks: **Switching to rear camera**

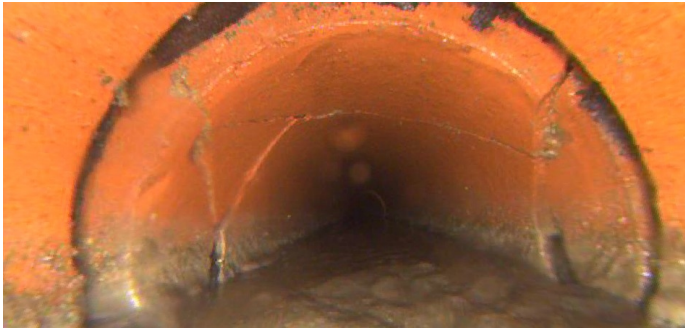
Code: **FM**
Description: **Fracture Multiple**

Distance (ft): **71.5**
Structural Grade: **4**
O&M Grade: **0**
Clock Start/From: **9**
Clock To: **3**
1st Value:
2nd Value:
Value Percent:
Continuous Index:
Within 8" of Joint: **YES**
Remarks:

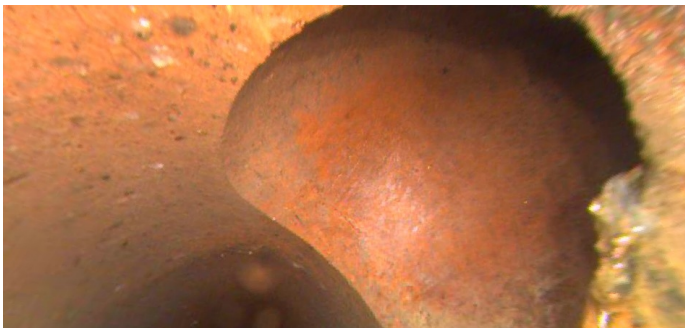
Code: **TF**
Description: **Tap Factory**

Distance (ft): **76.9**
Structural Grade: **0**
O&M Grade: **0**
Clock Start/From: **10**
Clock To:
1st Value: **4.000**
2nd Value:
Value Percent:
Continuous Index:
Within 8" of Joint:
Remarks:

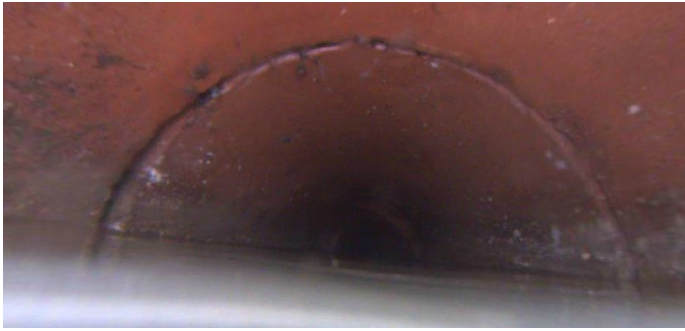
Code: **MGO**
Description: **General Observation**

Distance (ft): **76.9**
Structural Grade: **0**
O&M Grade: **0**
Clock Start/From:
Clock To:
1st Value:
2nd Value:
Value Percent:
Continuous Index:
Within 8" of Joint: **NO**
Remarks: **Switching to front camera**

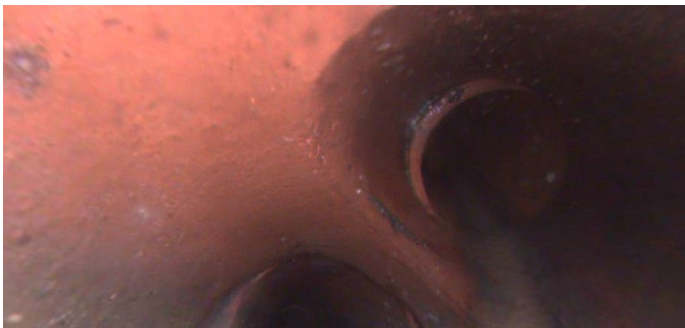
Code: **TF**
Description: **Tap Factory**

Distance (ft): **78.3**
Structural Grade: **0**
O&M Grade: **0**
Clock Start/From: **2**
Clock To:
1st Value: **4.000**
2nd Value:
Value Percent:
Continuous Index:
Within 8" of Joint:
Remarks:

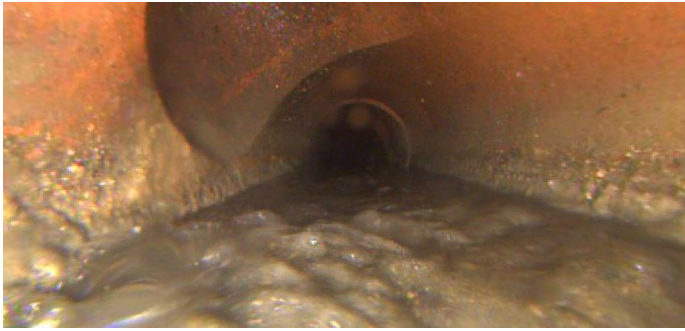
Code: **MGO**
Description: **General Observation**

Distance (ft): **79.3**
Structural Grade: **0**
O&M Grade: **0**
Clock Start/From:
Clock To:
1st Value:
2nd Value:
Value Percent:
Continuous Index:
Within 8" of Joint: **NO**
Remarks: **Switching to rear camera**

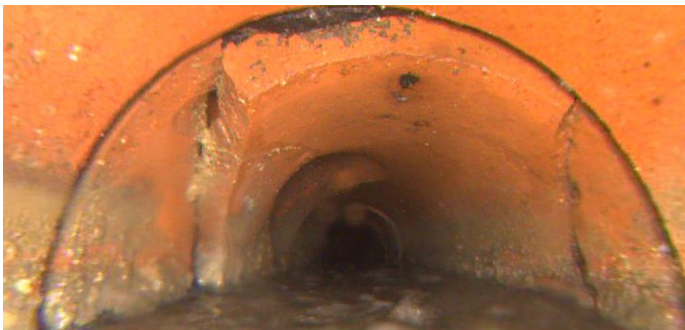
Code: **BVV**
Description: **Broken Void Visible**

Distance (ft): **79.7**
Structural Grade: **5**
O&M Grade: **0**
Clock Start/From: **9**
Clock To: **3**
1st Value:
2nd Value:
Value Percent:
Continuous Index:
Within 8" of Joint: **YES**
Remarks:

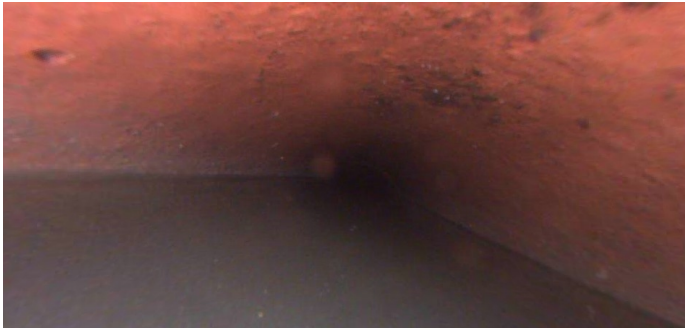
Code: **MGO**
Description: **General Observation**

Distance (ft): **89.4**
Structural Grade: **0**
O&M Grade: **0**
Clock Start/From:
Clock To:
1st Value:
2nd Value:
Value Percent:
Continuous Index:
Within 8" of Joint: **NO**
Remarks: **Switching to front camera**

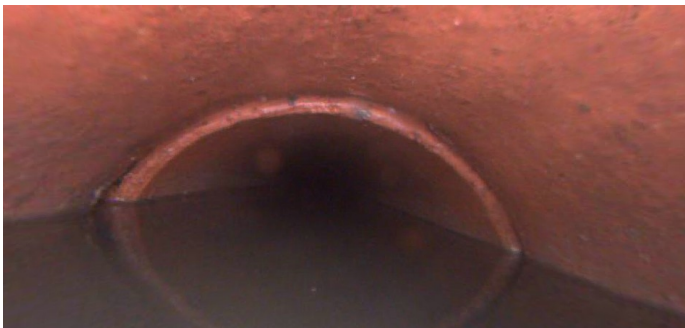
Code: **MWL**
Description: **Water Level**

Distance (ft): **91.5**
Structural Grade: **0**
O&M Grade: **0**
Clock Start/From:
Clock To:
1st Value:
2nd Value:
Value Percent: **70.000**
Continuous Index:
Within 8" of Joint: **NO**
Remarks:

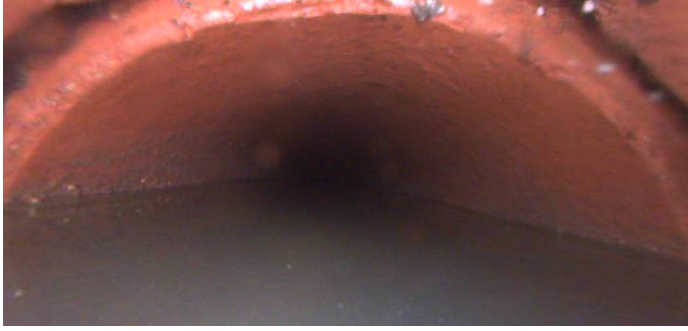
Code:	MSA
Description:	Abandoned Survey
Distance (ft):	91.7
Structural Grade:	0
O&M Grade:	0
Clock Start/From:	
Clock To:	
1st Value:	
2nd Value:	
Value Percent:	
Continuous Index:	
Within 8" of Joint:	NO
Remarks:	Unknown
