Profile/Photo Observation Report

| Street: | FOXCROFT STREET | Flow Control: | Not Controlled |
| City: | Hobart, IN | Year Renewed: | |
| US MH: | M-209-020 | DS MH: | M-209-014 |

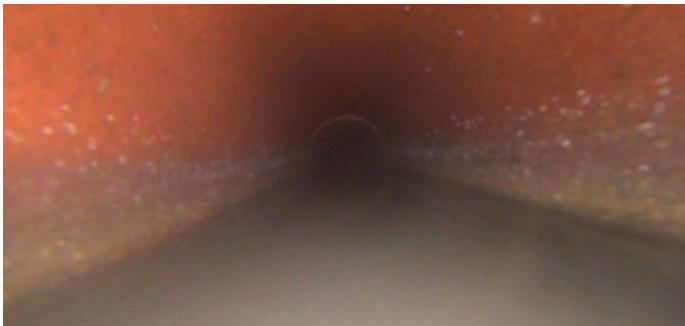
Code: **AMH**
Description: **Manhole**

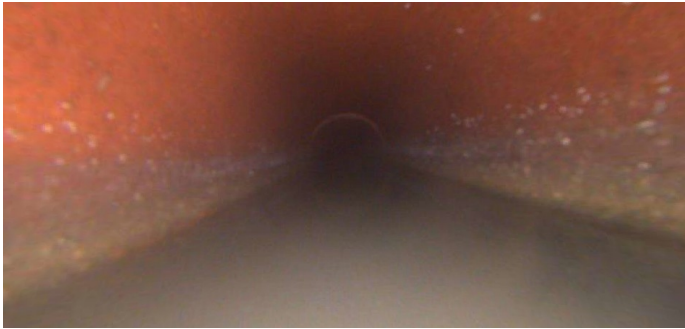
| Code: | MWL |
| Description: | Water Level |

| Distance (ft): | .0 |
| Value Percent: | 30.000 |

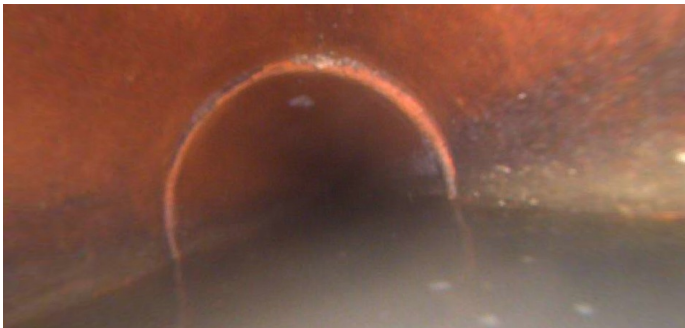
| Code: | MWL |
| Description: | Water Level |

| Distance (ft): | 8.5 |
| Value Percent: | 40.000 |

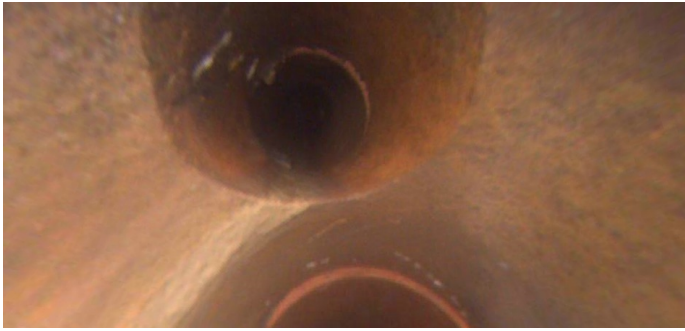
Code: **TF**
Description: **Tap Factory**

Distance (ft): **20.3**
Structural Grade: **0**
O&M Grade: **0**
Clock Start/From: **11**
Clock To:
1st Value: **4.000**
2nd Value:
Value Percent:
Continuous Index:
Within 8" of Joint:
Remarks:

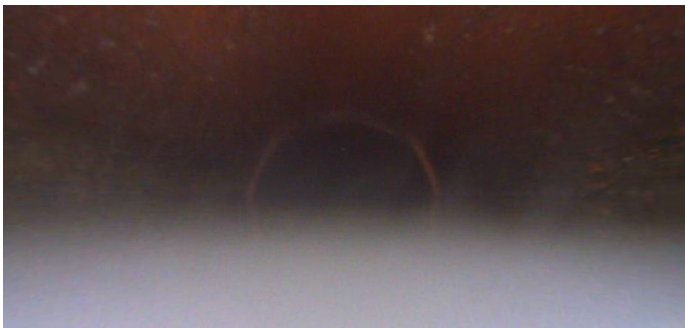
Code: **MWL**
Description: **Water Level**

Distance (ft): **40.7**
Structural Grade: **0**
O&M Grade: **0**
Clock Start/From:
Clock To:
1st Value:
2nd Value:
Value Percent: **50.000**
Continuous Index:
Within 8" of Joint: **NO**
Remarks:

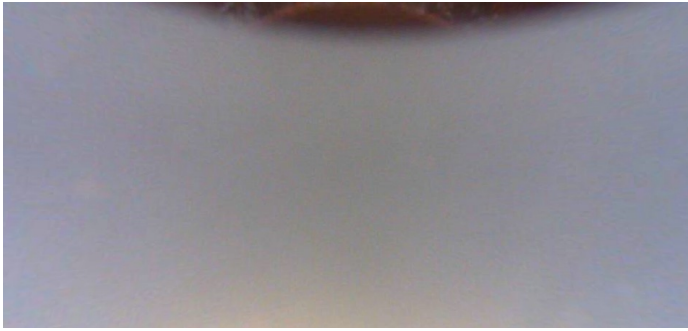
| Comment: | P_C at 40 ft CU .Flow direction wrong | | |

| Code: | MSA |
| Description: | Abandoned Survey |
| Distance (ft): | 41.5 |
| Remarks: | Unknown |
