## Profile/Photo Observation Report

Date:	<b>03/19/2018</b>	Weather:		Coding:	<b>PACP 6.0</b>
Pipe Length (ft):	<b>300.4</b>	Owner:	<b>NA</b>	Pre Clean:	<b>No Pre-Cleaning</b>
P.O.#:		Surveyor:	<b>John Kuglmaier</b>	PSR:	<b>P-209-019-020</b>
Customer:		Clean Date:	<b>01/01/1900</b>	Shape:	<b>C</b>

Street:	<b>OFF E 61ST PL</b>	Flow Control:	<b>Not Controlled</b>
City:	<b>Hobart, IN</b>	Year Renewed:	
Location:	<b>Light Highway</b>	Tape/Media #:	
Purpose:	<b>Routine Assessment</b>	Dia/Height:	<b>8"</b>
Use:	<b>Sanitary</b>	Material:	<b>VCP</b>
Drain Area:	<b>NA</b>	Lining:	
Category:	<b>NA</b>		
Comment:	<b>P_C at 36 ft nothing visible . flow direction wrong</b>		
Location Details:		Direction of Survey:	<b>Upstream</b>
US MH:	<b>M-209-020</b>	DS MH:	<b>M-209-019</b>
		Total Length Surveyed (ft):	<b>37.1</b>

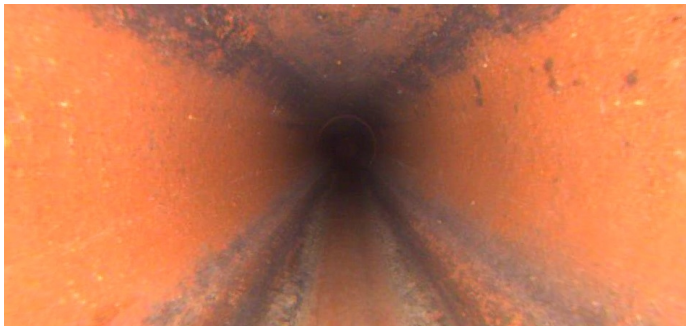
Code: **AMH**  
Description: **Manhole**

Distance (ft): **.0**  
Structural Grade: **0**  
O&M Grade: **0**  
Clock Start/From:  
Clock To:  
1st Value:  
2nd Value:  
Value Percent:  
Continuous Index:  
Within 8" of Joint: **NO**  
Remarks: **M-209-019**

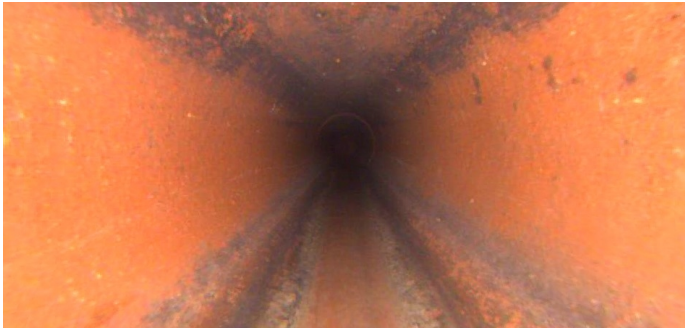
Code:	<b>MWL</b>
Description:	<b>Water Level</b>

Distance (ft):	<b>.0</b>
Structural Grade:	<b>0</b>
O&M Grade:	<b>0</b>
Clock Start/From:	
Clock To:	
1st Value:	
2nd Value:	
Value Percent:	<b>5.000</b>
Continuous Index:	
Within 8" of Joint:	<b>NO</b>
Remarks:

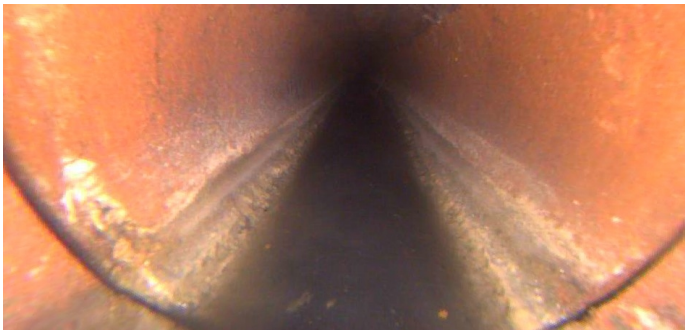
Code:	<b>DAGS</b>
Description:	<b>Deposits Attached Grease</b>

Distance (ft):	<b>12.7</b>
Structural Grade:	<b>0</b>
O&M Grade:	<b>2</b>
Clock Start/From:	<b>4</b>
Clock To:	<b>8</b>
1st Value:	
2nd Value:	
Value Percent:	<b>5.000</b>
Continuous Index:	<b>S01</b>
Within 8" of Joint:	<b>NO</b>
Remarks:

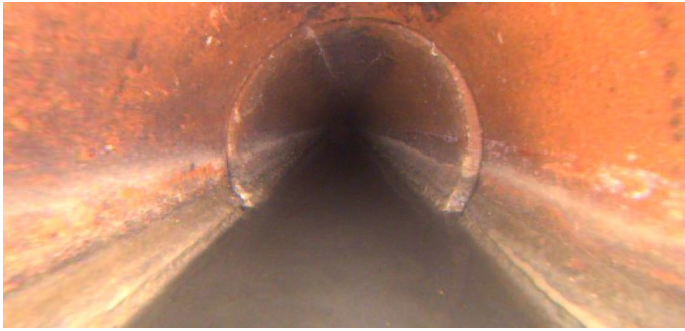
Code: **MWL**  
Description: **Water Level**

Distance (ft): **25.1**  
Structural Grade: **0**  
O&M Grade: **0**  
Clock Start/From:  
Clock To:  
1st Value:  
2nd Value:  
Value Percent: **20.000**  
Continuous Index:  
Within 8" of Joint: **NO**  
Remarks:

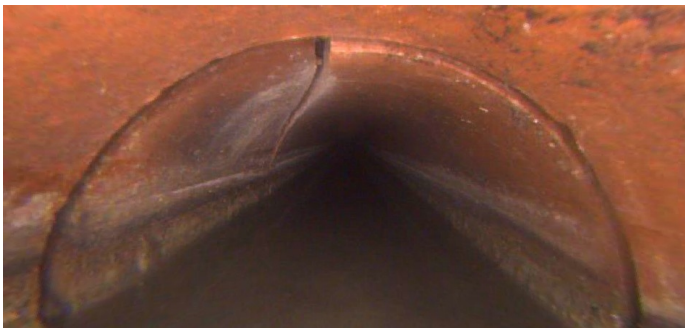
Code: **FS**  
Description: **Fracture Spiral**

Distance (ft): **34.2**  
Structural Grade: **3**  
O&M Grade: **0**  
Clock Start/From: **10**  
Clock To: **12**  
1st Value:  
2nd Value:  
Value Percent:  
Continuous Index:  
Within 8" of Joint: **YES**  
Remarks:

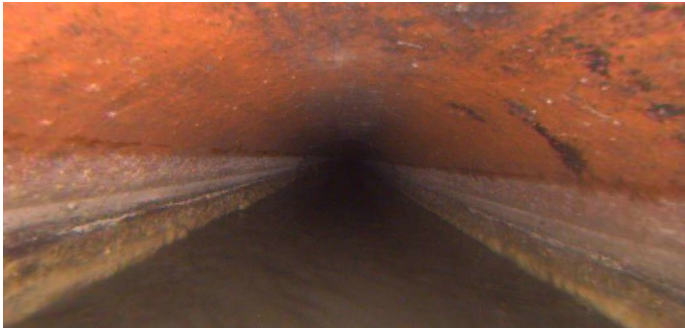
Code: **MSA**  
Description: **Abandoned Survey**

Distance (ft): **37.1**  
Structural Grade: **0**  
O&M Grade: **0**  
Clock Start/From:  
Clock To:  
1st Value:  
2nd Value:  
Value Percent:  
Continuous Index:  
Within 8" of Joint: **NO**  
Remarks: **Unknown**

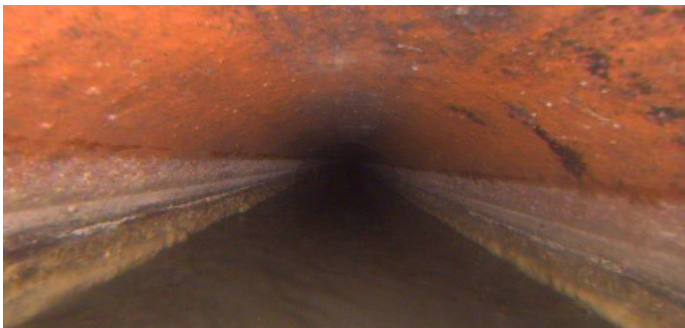
Code: **DAGS**  
Description: **Deposits Attached Grease**

Distance (ft): **37.1**  
Structural Grade: **0**  
O&M Grade: **2**  
Clock Start/From: **4**  
Clock To: **8**  
1st Value:  
2nd Value:  
Value Percent: **5.000**  
Continuous Index: **F01**  
Within 8" of Joint: **NO**  
Remarks: **Clock positions vary**
