Profile/Photo Observation Report

Street:	FOXCROFT STREET	Flow Control:	Not Controlled
City:	Hobart, IN	Year Renewed:	
Location:	Light Highway	Tape/Media #:	
Purpose:	Routine Assessment	Dia/Height:	8"
Use:	Sanitary	Material:	VCP
Drain Area:	NA	Lining:	
Category:	NA		
Comment:	P_C at 36 ft nothing visible . flow direction wrong		
Location Details:		Direction of Survey:	Upstream
US MH:	M-209-020	DS MH:	M-209-019
		Total Length Surveyed (ft):	37.1

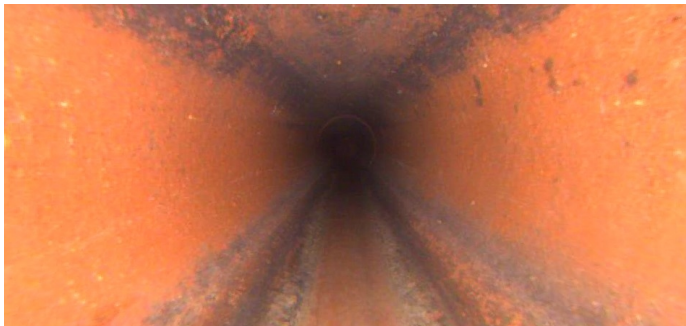
Code: **AMH**
Description: **Manhole**

Distance (ft): **.0**
Structural Grade: **0**
O&M Grade: **0**
Clock Start/From:
Clock To:
1st Value:
2nd Value:
Value Percent:
Continuous Index:
Within 8" of Joint: **NO**
Remarks: **M-209-019**

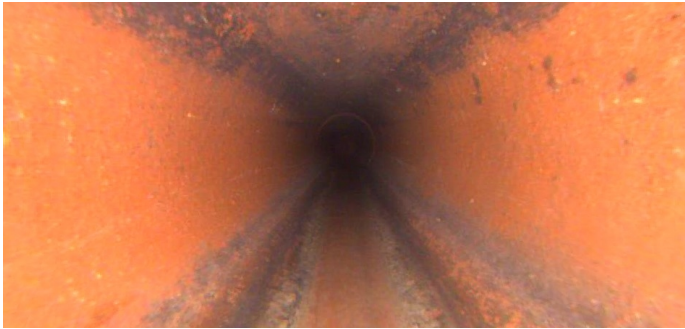
Code:	MWL
Description:	Water Level

Distance (ft):	.0
Structural Grade:	0
O&M Grade:	0
Clock Start/From:	
Clock To:	
1st Value:	
2nd Value:	
Value Percent:	5.000
Continuous Index:	
Within 8" of Joint:	NO
Remarks:

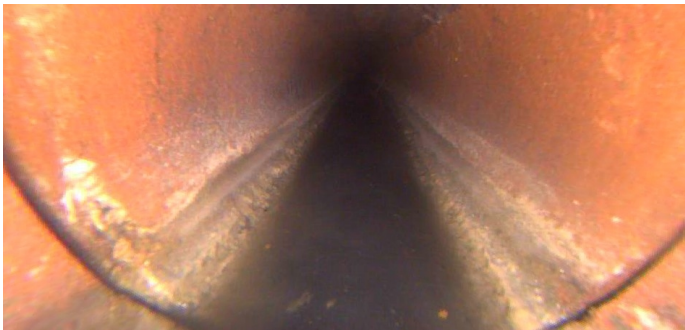
Code:	DAGS
Description:	Deposits Attached Grease

Distance (ft):	12.7
Structural Grade:	0
O&M Grade:	2
Clock Start/From:	4
Clock To:	8
1st Value:	
2nd Value:	
Value Percent:	5.000
Continuous Index:	S01
Within 8" of Joint:	NO
Remarks:

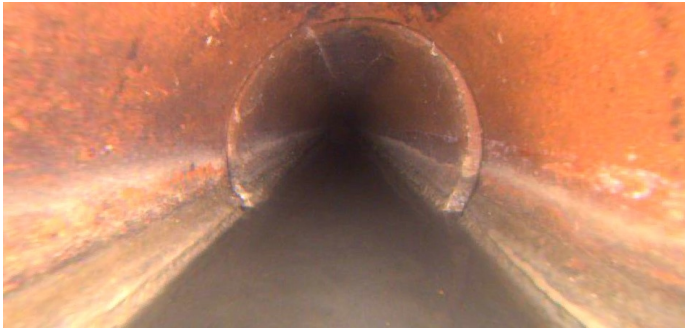
Code: **MWL**
Description: **Water Level**

Distance (ft): **25.1**
Structural Grade: **0**
O&M Grade: **0**
Clock Start/From:
Clock To:
1st Value:
2nd Value:
Value Percent: **20.000**
Continuous Index:
Within 8" of Joint: **NO**
Remarks:

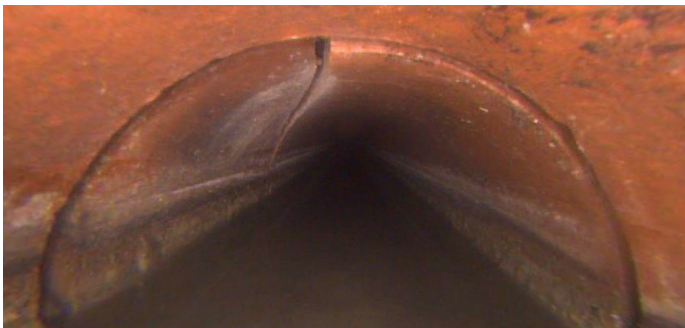
Code: **FS**
Description: **Fracture Spiral**

Distance (ft): **34.2**
Structural Grade: **3**
O&M Grade: **0**
Clock Start/From: **10**
Clock To: **12**
1st Value:
2nd Value:
Value Percent:
Continuous Index:
Within 8" of Joint: **YES**
Remarks:

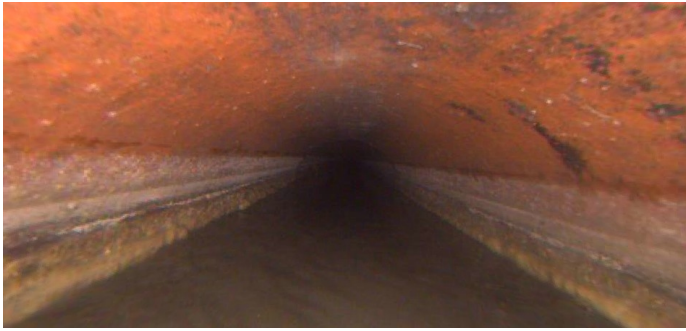
Code: **MSA**
Description: **Abandoned Survey**

Distance (ft): **37.1**
Structural Grade: **0**
O&M Grade: **0**
Clock Start/From:
Clock To:
1st Value:
2nd Value:
Value Percent:
Continuous Index:
Within 8" of Joint: **NO**
Remarks: **Unknown**

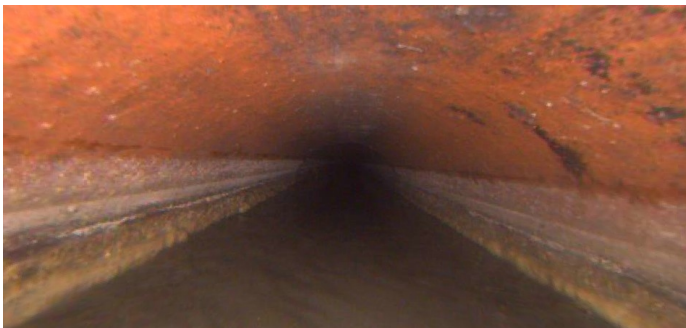
Code: **DAGS**
Description: **Deposits Attached Grease**

Distance (ft): **37.1**
Structural Grade: **0**
O&M Grade: **2**
Clock Start/From: **4**
Clock To: **8**
1st Value:
2nd Value:
Value Percent: **5.000**
Continuous Index: **F01**
Within 8" of Joint: **NO**
Remarks: **Clock positions vary**
