Profile/Photo Observation Report

Date:	03/19/2018	Weather:		Coding:	PACP 6.0
Pipe Length (ft):	300.4	Owner:	NA	Pre Clean:	No Pre-Cleaning
P.O.#:		Surveyor:	Byrd Fitzgerald	PSR:	P-209-019-020
Customer:		Clean Date:	01/01/1900	Shape:	C

Street:	OFF E 61ST PL	Flow Control:	Not Controlled
City:	Hobart, IN	Year Renewed:	
Location:	Light Highway	Tape/Media #:	
Purpose:	Routine Assessment	Dia/Height:	8"
Use:	Sanitary	Material:	VCP
Drain Area:	NA	Lining:	
Category:	NA		
Comment:	P_C at 265 ft nothing visible . Flow direction wrong		
Location Details:		Direction of Survey:	Downstream
US MH:	M-209-020	DS MH:	M-209-019
		Total Length Surveyed (ft):	266.5

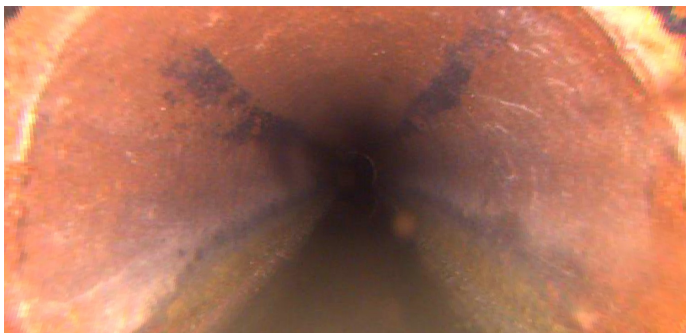
Code: **AMH**
Description: **Manhole**

Distance (ft): **.0**
Structural Grade: **0**
O&M Grade: **0**
Clock Start/From:
Clock To:
1st Value:
2nd Value:
Value Percent:
Continuous Index:
Within 8" of Joint: **NO**
Remarks: **M-209-020**

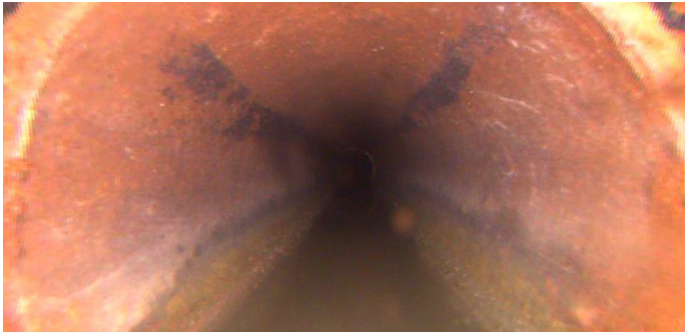
Code:	MWL
Description:	Water Level

Distance (ft):	.0
Structural Grade:	0
O&M Grade:	0
Clock Start/From:	
Clock To:	
1st Value:	
2nd Value:	
Value Percent:	5.000
Continuous Index:	
Within 8" of Joint:	NO
Remarks:

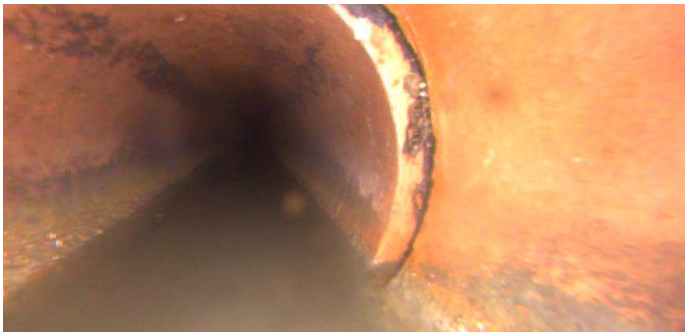
Code:	RFJ
Description:	Roots Fine Joint

Distance (ft):	5.2
Structural Grade:	0
O&M Grade:	1
Clock Start/From:	3
Clock To:	
1st Value:	
2nd Value:	
Value Percent:	
Continuous Index:	
Within 8" of Joint:	YES
Remarks:

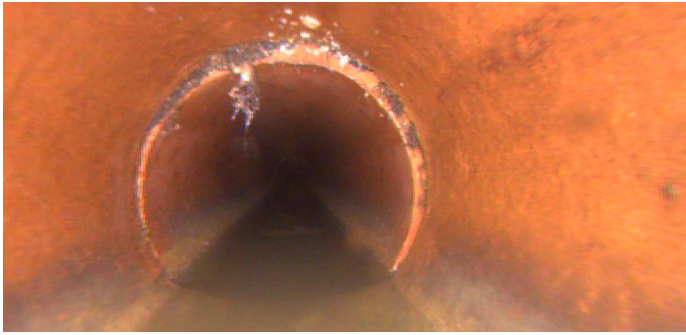
Code: **RFJ**
Description: **Roots Fine Joint**

Distance (ft): **17.7**
Structural Grade: **0**
O&M Grade: **1**
Clock Start/From: **11**
Clock To:
1st Value:
2nd Value:
Value Percent:
Continuous Index: **S01**
Within 8" of Joint: **YES**
Remarks: **wandering**

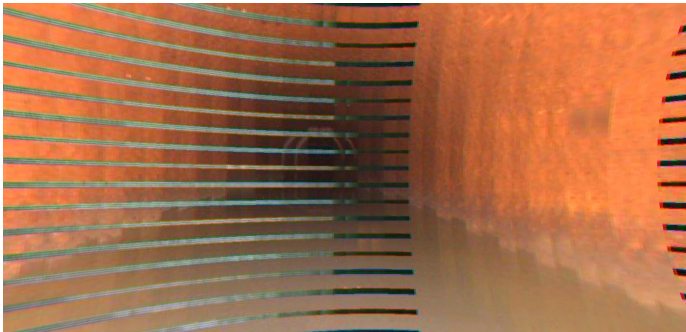
Code: **MGO**
Description: **General Observation**

Distance (ft): **62.3**
Structural Grade: **0**
O&M Grade: **0**
Clock Start/From:
Clock To:
1st Value:
2nd Value:
Value Percent:
Continuous Index:
Within 8" of Joint: **NO**
Remarks: **distortion in video**

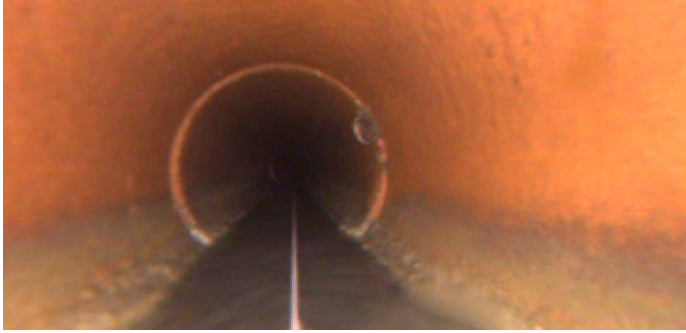
Code: **MGO**
Description: **General Observation**

Distance (ft): **62.3**
Structural Grade: **0**
O&M Grade: **0**
Clock Start/From:
Clock To:
1st Value:
2nd Value:
Value Percent:
Continuous Index:
Within 8" of Joint: **NO**
Remarks: **rear camera/distortion in video**

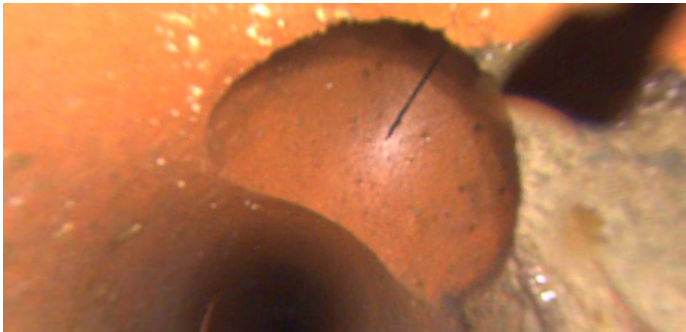
Code: **TF**
Description: **Tap Factory**

Distance (ft): **80.3**
Structural Grade: **0**
O&M Grade: **0**
Clock Start/From: **11**
Clock To:
1st Value: **4.000**
2nd Value:
Value Percent:
Continuous Index:
Within 8" of Joint:
Remarks:

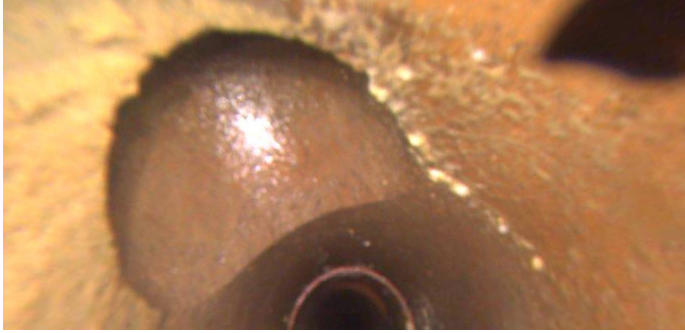
Code: **TF**
Description: **Tap Factory**

Distance (ft): **82.6**
Structural Grade: **0**
O&M Grade: **0**
Clock Start/From: **1**
Clock To:
1st Value: **4.000**
2nd Value:
Value Percent:
Continuous Index:
Within 8" of Joint:
Remarks:

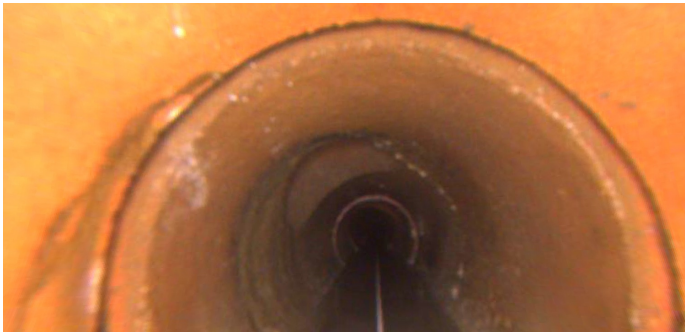
Code: **IW**
Description: **Infil Weeper**

Distance (ft): **83.2**
Structural Grade: **0**
O&M Grade: **2**
Clock Start/From: **1**
Clock To: **4**
1st Value:
2nd Value:
Value Percent:
Continuous Index:
Within 8" of Joint: **YES**
Remarks:

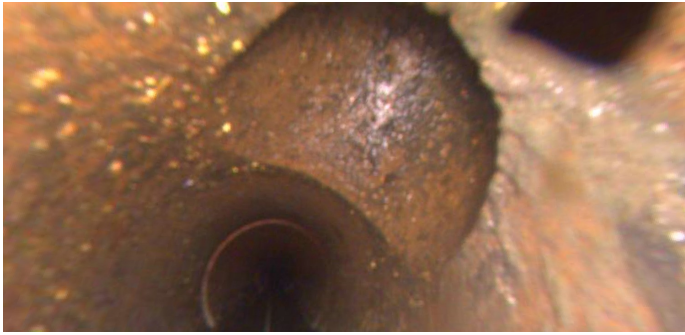
Code: **TF**
Description: **Tap Factory**

Distance (ft): **144.5**
Structural Grade: **0**
O&M Grade: **0**
Clock Start/From: **11**
Clock To:
1st Value: **4.000**
2nd Value:
Value Percent:
Continuous Index:
Within 8" of Joint:
Remarks:

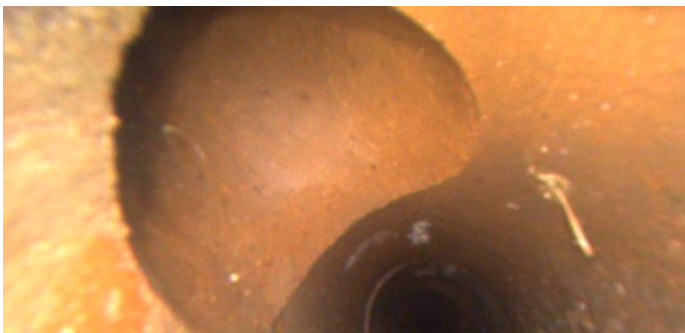
Code: **TF**
Description: **Tap Factory**

Distance (ft): **146.7**
Structural Grade: **0**
O&M Grade: **0**
Clock Start/From: **1**
Clock To:
1st Value: **4.000**
2nd Value:
Value Percent:
Continuous Index:
Within 8" of Joint:
Remarks:

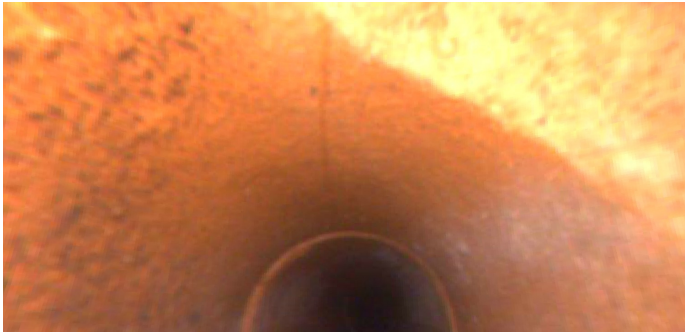
Code: **CL**
Description: **Crack Longitudinal**

Distance (ft): **204.0**
Structural Grade: **2**
O&M Grade: **0**
Clock Start/From: **12**
Clock To:
1st Value:
2nd Value:
Value Percent:
Continuous Index:
Within 8" of Joint: **YES**
Remarks:

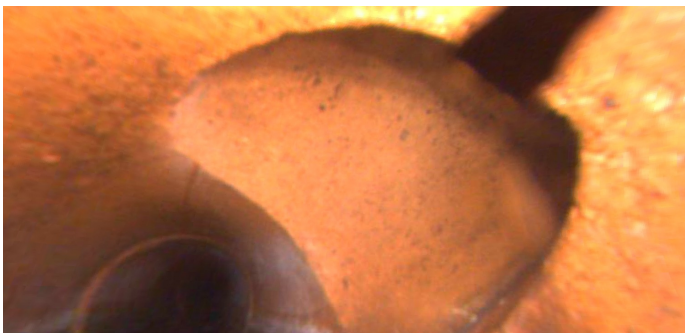
Code: **TF**
Description: **Tap Factory**

Distance (ft): **204.5**
Structural Grade: **0**
O&M Grade: **0**
Clock Start/From: **10**
Clock To:
1st Value: **4.000**
2nd Value:
Value Percent:
Continuous Index:
Within 8" of Joint:
Remarks:

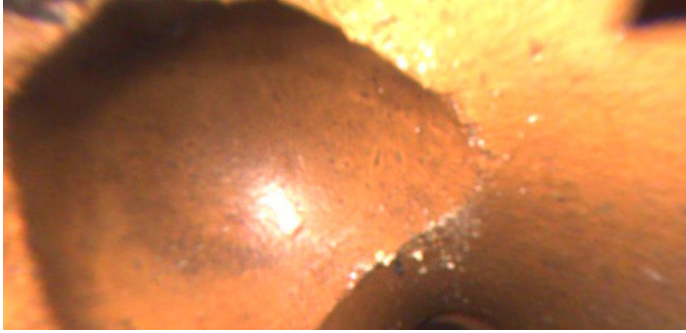
Code: **TF**
Description: **Tap Factory**

Distance (ft): **206.6**
Structural Grade: **0**
O&M Grade: **0**
Clock Start/From: **1**
Clock To:
1st Value: **4.000**
2nd Value:
Value Percent:
Continuous Index:
Within 8" of Joint:
Remarks:

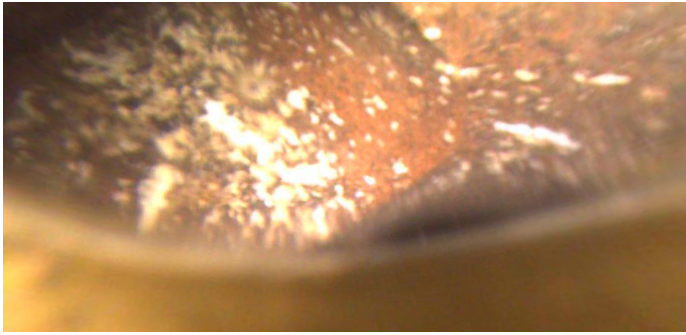
Code: **TF**
Description: **Tap Factory**

Distance (ft): **262.6**
Structural Grade: **0**
O&M Grade: **0**
Clock Start/From: **2**
Clock To:
1st Value: **4.000**
2nd Value:
Value Percent:
Continuous Index:
Within 8" of Joint:
Remarks:

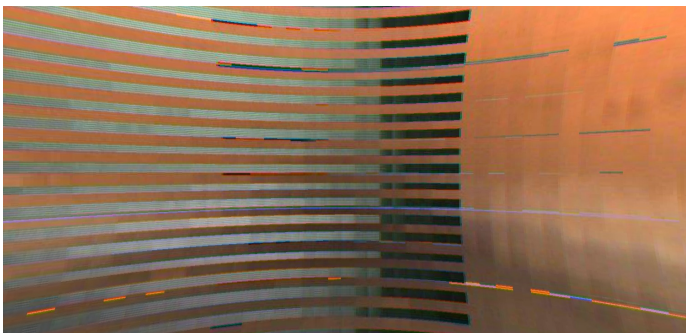
Code: **MSA**
Description: **Abandoned Survey**

Distance (ft): **266.5**
Structural Grade: **0**
O&M Grade: **0**
Clock Start/From:
Clock To:
1st Value:
2nd Value:
Value Percent:
Continuous Index:
Within 8" of Joint: **NO**
Remarks: **camera stopped/video distorted**
