Profile/Photo Observation Report

Date:	03/19/2018	Weather:		Coding:	PACP 6.0
Pipe Length (ft):	300.4	Owner:	NA	Pre Clean:	No Pre-Cleaning
P.O.#:		Surveyor:	Byrd Fitzgerald	PSR:	P-209-019-020
Customer:		Clean Date:	01/01/1900	Shape:	C

Street:	FOXCROFT STREET	Flow Control:	Not Controlled
City:	Hobart, IN	Year Renewed:	
Location:	Light Highway	Tape/Media #:	
Purpose:	Routine Assessment	Dia/Height:	8"
Use:	Sanitary	Material:	VCP
Drain Area:	NA	Lining:	
Category:	NA		
Comment:	P_C at 265 ft nothing visible . Flow direction wrong		
Location Details:		Direction of Survey:	Downstream
US MH:	M-209-020	DS MH:	M-209-019
		Total Length Surveyed (ft):	266.5

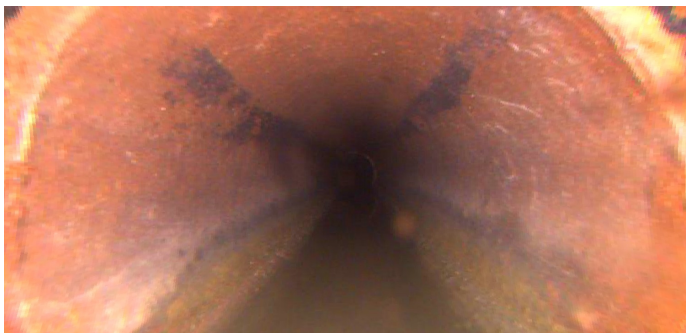
Code: **AMH**
Description: **Manhole**

Distance (ft): **.0**
Structural Grade: **0**
O&M Grade: **0**
Clock Start/From:
Clock To:
1st Value:
2nd Value:
Value Percent:
Continuous Index:
Within 8" of Joint: **NO**
Remarks: **M-209-020**

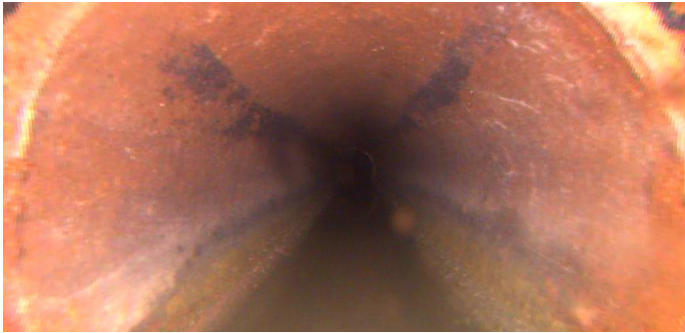
Code:	MWL
Description:	Water Level

Distance (ft):	.0
Structural Grade:	0
O&M Grade:	0
Clock Start/From:	
Clock To:	
1st Value:	
2nd Value:	
Value Percent:	5.000
Continuous Index:	
Within 8" of Joint:	NO
Remarks:

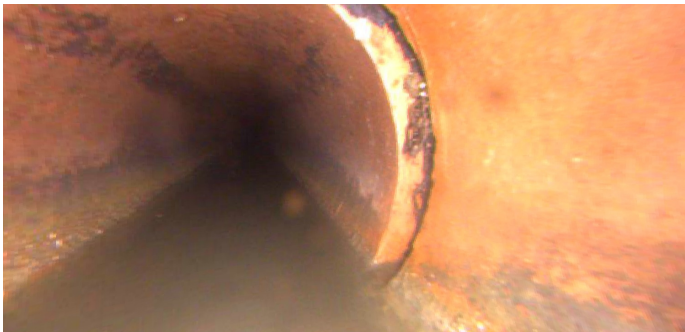
Code:	RFJ
Description:	Roots Fine Joint

Distance (ft):	5.2
Structural Grade:	0
O&M Grade:	1
Clock Start/From:	3
Clock To:	
1st Value:	
2nd Value:	
Value Percent:	
Continuous Index:	
Within 8" of Joint:	YES
Remarks:

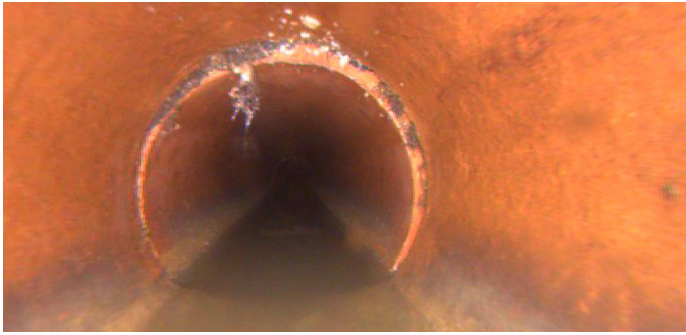
Code: **RFJ**
Description: **Roots Fine Joint**

Distance (ft): **17.7**
Structural Grade: **0**
O&M Grade: **1**
Clock Start/From: **11**
Clock To:
1st Value:
2nd Value:
Value Percent:
Continuous Index: **S01**
Within 8" of Joint: **YES**
Remarks: **wandering**

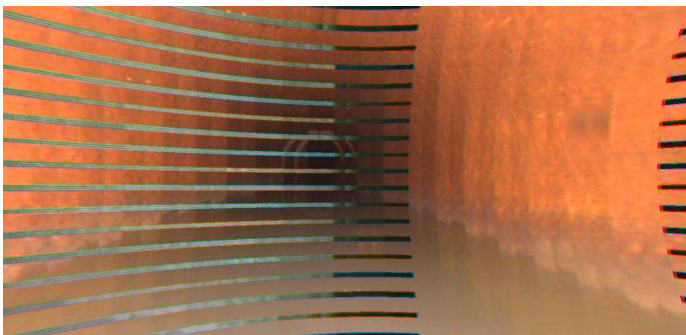
Code: **MGO**
Description: **General Observation**

Distance (ft): **62.3**
Structural Grade: **0**
O&M Grade: **0**
Clock Start/From:
Clock To:
1st Value:
2nd Value:
Value Percent:
Continuous Index:
Within 8" of Joint: **NO**
Remarks: **distortion in video**

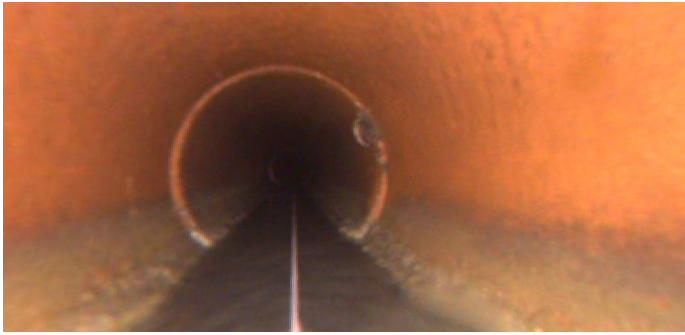
Code: **MGO**
Description: **General Observation**

Distance (ft): **62.3**
Structural Grade: **0**
O&M Grade: **0**
Clock Start/From:
Clock To:
1st Value:
2nd Value:
Value Percent:
Continuous Index:
Within 8" of Joint: **NO**
Remarks: **rear camera/distortion in video**

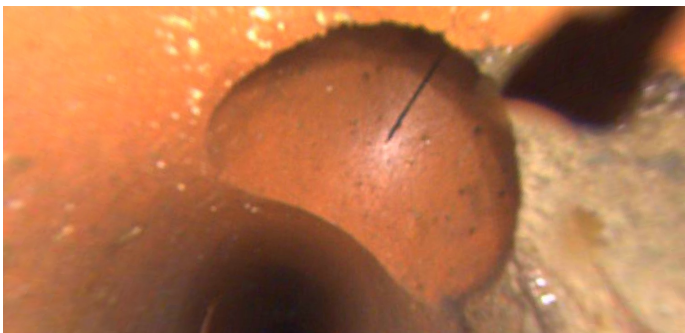
Code: **TF**
Description: **Tap Factory**

Distance (ft): **80.3**
Structural Grade: **0**
O&M Grade: **0**
Clock Start/From: **11**
Clock To:
1st Value: **4.000**
2nd Value:
Value Percent:
Continuous Index:
Within 8" of Joint:
Remarks:

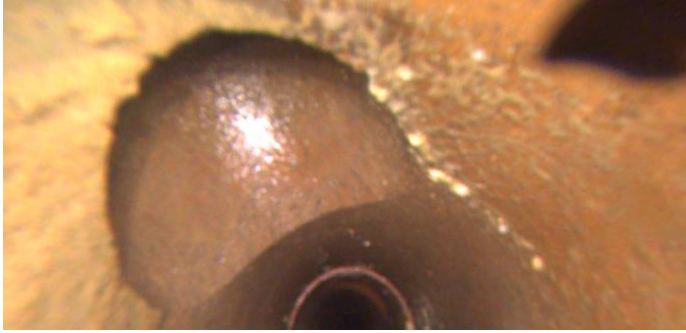
Code: **TF**
Description: **Tap Factory**

Distance (ft): **82.6**
Structural Grade: **0**
O&M Grade: **0**
Clock Start/From: **1**
Clock To:
1st Value: **4.000**
2nd Value:
Value Percent:
Continuous Index:
Within 8" of Joint:
Remarks:

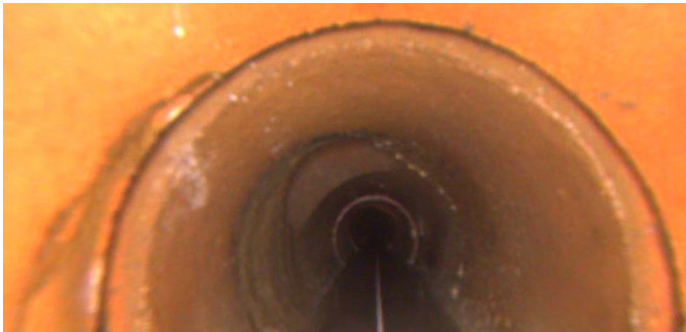
Code: **IW**
Description: **Infil Weeper**

Distance (ft): **83.2**
Structural Grade: **0**
O&M Grade: **2**
Clock Start/From: **1**
Clock To: **4**
1st Value:
2nd Value:
Value Percent:
Continuous Index:
Within 8" of Joint: **YES**
Remarks:

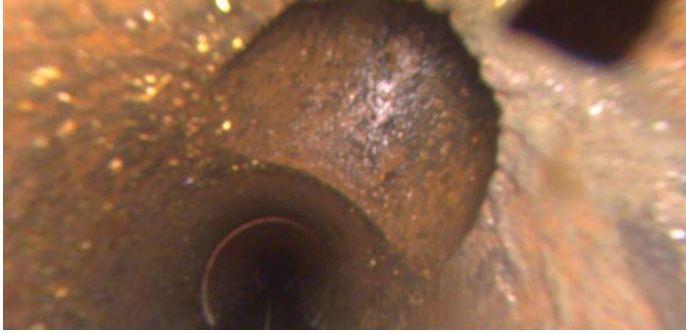
Code: **TF**
Description: **Tap Factory**

Distance (ft): **144.5**
Structural Grade: **0**
O&M Grade: **0**
Clock Start/From: **11**
Clock To:
1st Value: **4.000**
2nd Value:
Value Percent:
Continuous Index:
Within 8" of Joint:
Remarks:

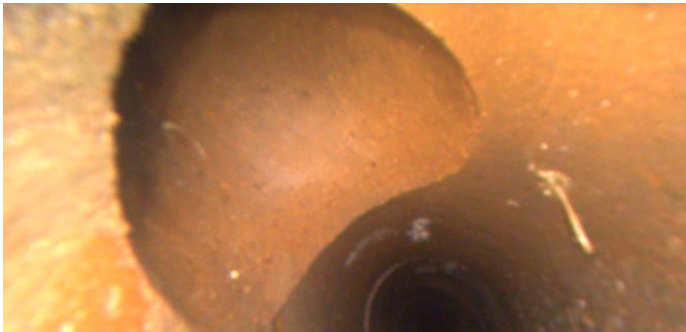
Code: **TF**
Description: **Tap Factory**

Distance (ft): **146.7**
Structural Grade: **0**
O&M Grade: **0**
Clock Start/From: **1**
Clock To:
1st Value: **4.000**
2nd Value:
Value Percent:
Continuous Index:
Within 8" of Joint:
Remarks:

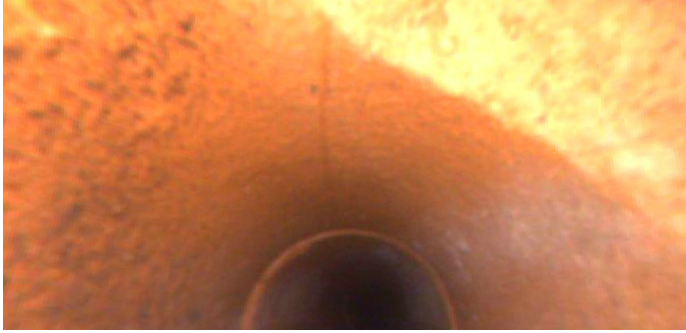
Code: **CL**
Description: **Crack Longitudinal**

Distance (ft): **204.0**
Structural Grade: **2**
O&M Grade: **0**
Clock Start/From: **12**
Clock To:
1st Value:
2nd Value:
Value Percent:
Continuous Index:
Within 8" of Joint: **YES**
Remarks:

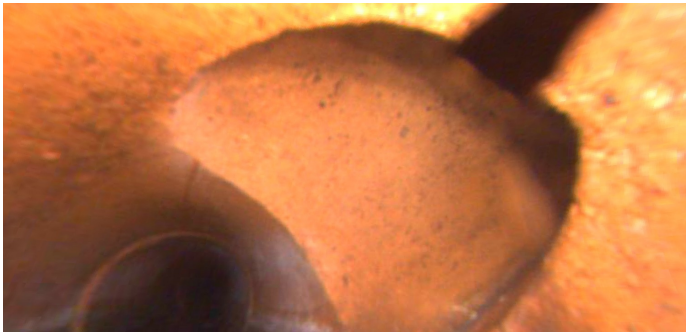
Code: **TF**
Description: **Tap Factory**

Distance (ft): **204.5**
Structural Grade: **0**
O&M Grade: **0**
Clock Start/From: **10**
Clock To:
1st Value: **4.000**
2nd Value:
Value Percent:
Continuous Index:
Within 8" of Joint:
Remarks:

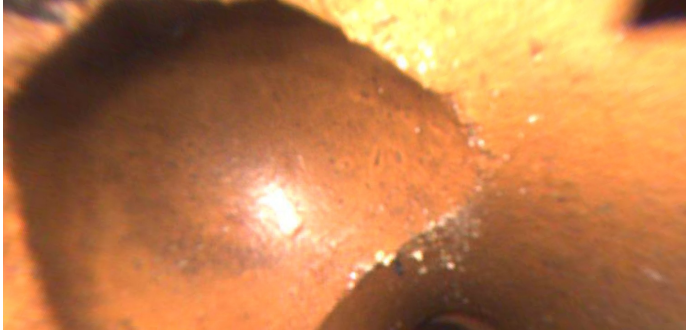
Code: **TF**
Description: **Tap Factory**

Distance (ft): **206.6**
Structural Grade: **0**
O&M Grade: **0**
Clock Start/From: **1**
Clock To:
1st Value: **4.000**
2nd Value:
Value Percent:
Continuous Index:
Within 8" of Joint:
Remarks:

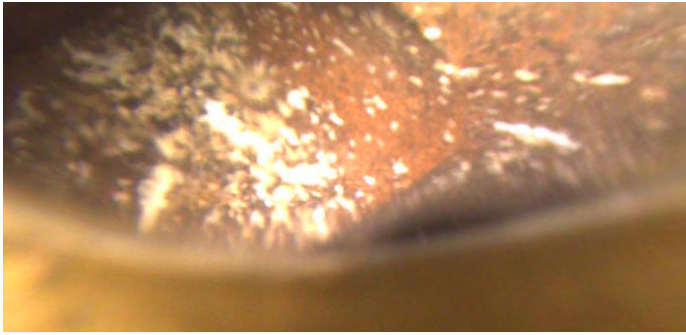
Code: **TF**
Description: **Tap Factory**

Distance (ft): **262.6**
Structural Grade: **0**
O&M Grade: **0**
Clock Start/From: **2**
Clock To:
1st Value: **4.000**
2nd Value:
Value Percent:
Continuous Index:
Within 8" of Joint:
Remarks:

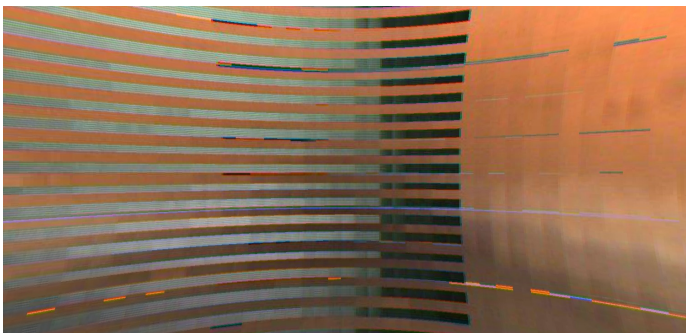
Code: **MSA**
Description: **Abandoned Survey**

Distance (ft): **266.5**
Structural Grade: **0**
O&M Grade: **0**
Clock Start/From:
Clock To:
1st Value:
2nd Value:
Value Percent:
Continuous Index:
Within 8" of Joint: **NO**
Remarks: **camera stopped/video distorted**
