# Profile/Photo Observation Report

Date:	<b>04/10/2018</b>	Weather:		Coding:	<b>PACP 6.0</b>
Pipe Length (ft):		Owner:	<b>City of Hobart</b>	Pre Clean:	<b>Not Known</b>
P.O.#:	<b>228</b>	Surveyor:	<b>B. Helbling</b>	PSR:	<b>P-209-027-022</b>
Customer:	<b>City of Hobart</b>	Clean Date:		Shape:	<b>C</b>

Street:	<b>Wisconsin Street</b>	Flow Control:	<b>Not Controlled</b>
City:	<b>Hobart, IN</b>	Year Renewed:	
Location:	<b>Yard</b>	Tape/Media #:	<b>DEP228</b>
Purpose:	<b>Routine Assessment</b>	Dia/Height:	<b>15"</b>
Use:	<b>Sanitary</b>	Material:	<b>VCP</b>
Drain Area:		Lining:	
Category:	<b>NA</b>		
Comment:	<b>YES501824 Submittal 2</b>		
Location Details:		Direction of Survey:	<b>Downstream</b>
US MH:	<b>M-209-022</b>	DS MH:	<b>M-209-027</b>
		Total Length Surveyed (ft):	<b>65.0</b>

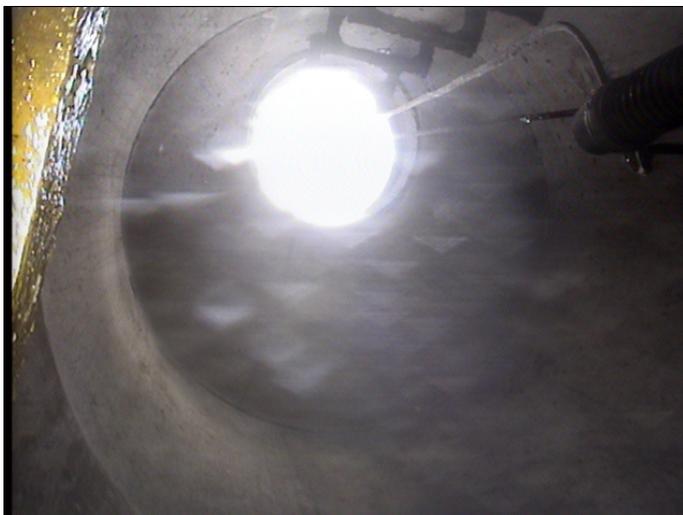
Code: **AMH**  
Description: **Manhole**

Distance (ft): **.0**  
Structural Grade: **0**  
O&M Grade: **0**  
Clock Start/From:  
Clock To:  
1st Value:  
2nd Value:  
Value Percent:  
Continuous Index:  
Within 8" of Joint: **NO**  
Remarks: **M-209-027**

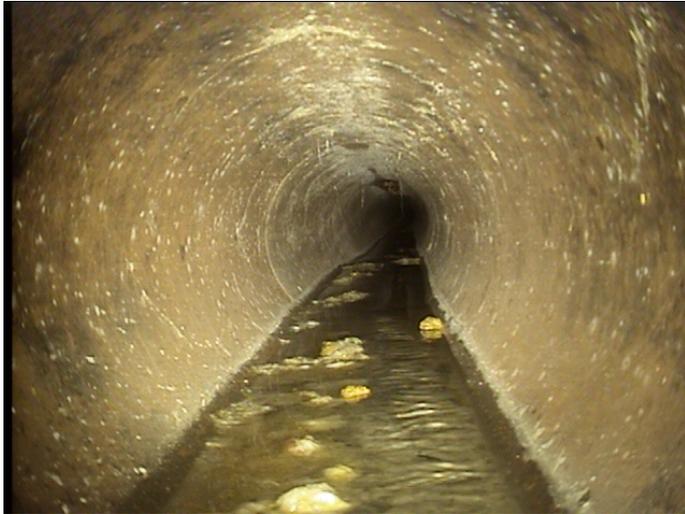
Code: **MWL**  
Description: **Water Level**

Distance (ft): **.0**  
Structural Grade: **0**  
O&M Grade: **0**  
Clock Start/From:  
Clock To:  
1st Value:  
2nd Value:  
Value Percent: **5.000**  
Continuous Index:  
Within 8" of Joint: **NO**  
Remarks:

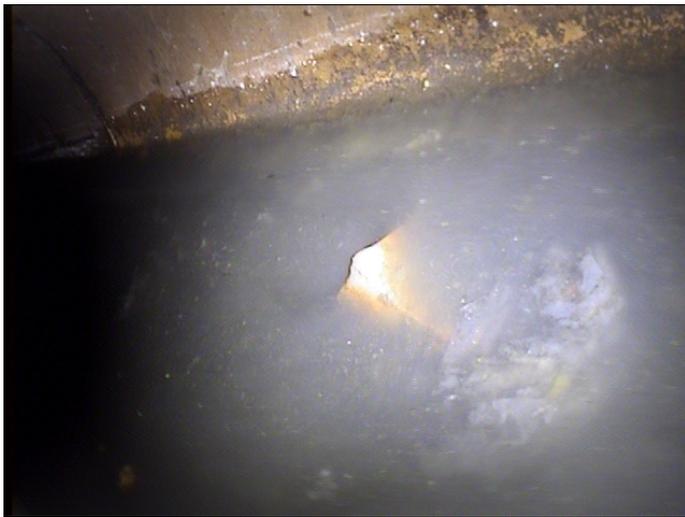
Code: **OBB**  
Description: **Obstacle Brick**

Distance (ft): **60.5**  
Structural Grade: **0**  
O&M Grade: **2**  
Clock Start/From: **5**  
Clock To:  
1st Value:  
2nd Value:  
Value Percent: **5.000**  
Continuous Index:  
Within 8" of Joint: **NO**  
Remarks:

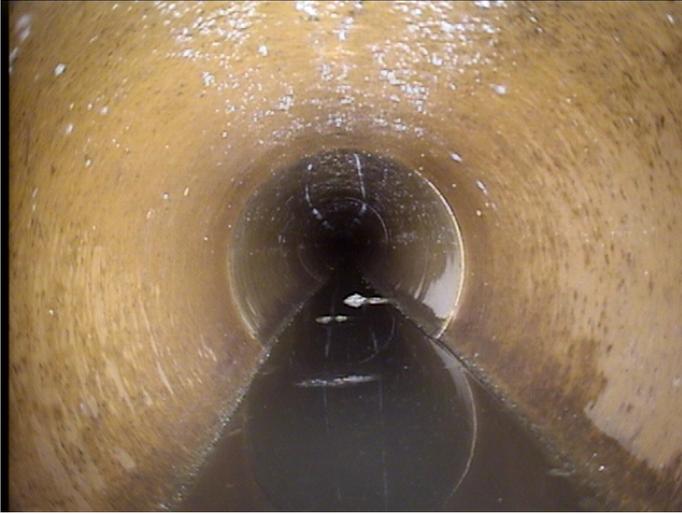
Code: **MSA**  
Description: **Abandoned Survey**

Distance (ft): **65.0**

Remarks: **Cannot pass brick in line**
