Profile/Photo Observation Report

Date: 04/11/2018 Weather: **PACP 6.0** Coding: Pipe Length (ft): Owner: **City of Hobart** Pre Clean: **Not Known** P.O.#: Surveyor: **B.** Helbling PSR: 237 P-209-027-022 Customer: **City of Hobart** Clean Date: Shape: **Wisconsin Street** Flow Control: **Not Controlled** Street: City: Hobart, IN Year Renewed: Yard Tape/Media #: Location: **DEP237** Purpose: **Routine Assessment** Dia/Height: 15" Use: Sanitary Material: **VCP** Drain Area: Lining:

US MH: M-209-022 M-209-027 Total Length Surveyed (ft): DS MH: 131.5

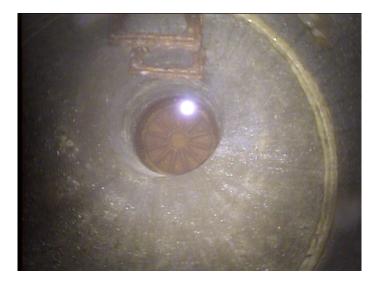
Code:	AMH
Description:	Manhole
Distance (ft):	.0
Structural Grade:	0
O&M Grade:	0
Clock Start/From:	
Clock To:	
1st Value:	
2nd Value:	
Value Percent:	
Continuous Index:	
Within 8" of Joint:	NO
Remarks:	M-209-027

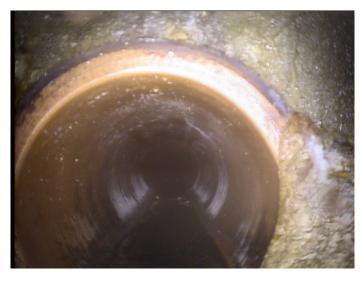
Code: MWL Description: **Water Level**

Distance (ft): .0 Structural Grade: 0 O&M Grade: 0

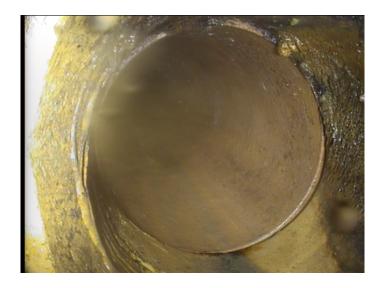
Code: **DSF**

Description: **Deposits Settled Fine**

Distance (ft): 36.7 Structural Grade: 0 O&M Grade: 2 Clock Start/From: 5 Clock To: 7

Value Percent: 5.000 Continuous Index: **S01** Within 8" of Joint: NO

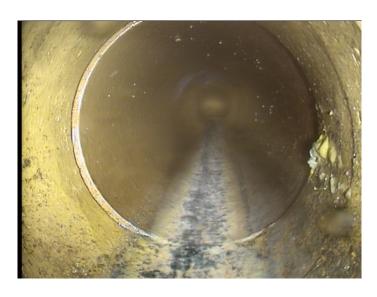
Code: TF

Description: **Tap Factory**

Distance (ft): 53.6 Structural Grade: 0 0 O&M Grade: Clock Start/From: 10

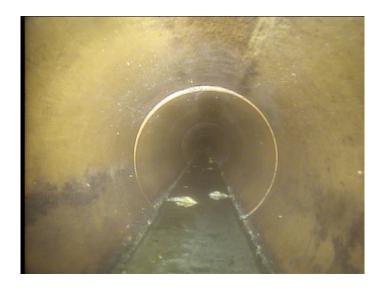
TFA Code:

Description: **Tap Factory Active**

Distance (ft): 56.7 Structural Grade: 0 O&M Grade: 0 Clock Start/From: 2

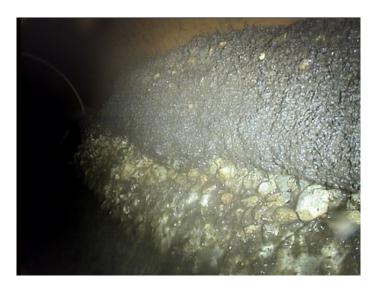
Code: **DSF**

Description: **Deposits Settled Fine**

Distance (ft): 81.5 Structural Grade: 0 2 O&M Grade: Clock Start/From: 5 Clock To: 7

5.000 Value Percent: Continuous Index: F01 Within 8" of Joint: NO

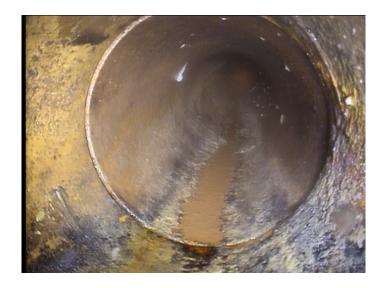
DNGV Code:

Description: **Deposits Ingressed Gravel**

Distance (ft): 110.9 Structural Grade: 0 O&M Grade: 2 Clock Start/From: 2 5 Clock To: 1st Value:

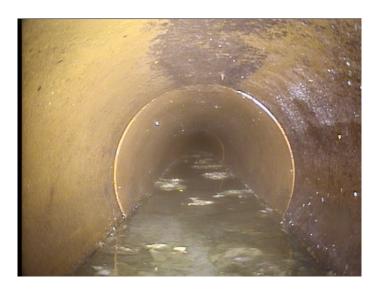
Code: TF

Description: **Tap Factory**

Distance (ft): 119.5 Structural Grade: 0 O&M Grade: 0 Clock Start/From: 2

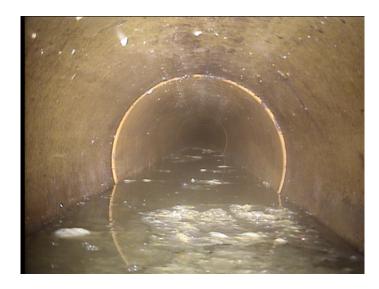
DSF Code:

Description: **Deposits Settled Fine**

Distance (ft): 124.8 Structural Grade: 0 O&M Grade: 3 Clock Start/From: 4 8 Clock To: 1st Value:

2nd Value: Value Percent: 15.000 Continuous Index: **S02** Within 8" of Joint: NO

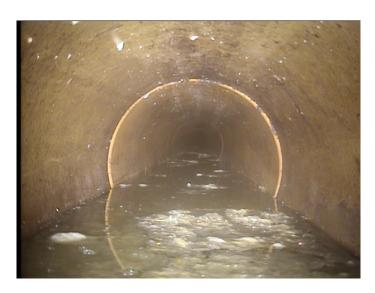
Code: **DSF**

Description: Deposits Settled Fine

Distance (ft): 131.5
Structural Grade: 0
O&M Grade: 3
Clock Start/From: 4
Clock To: 8

Value Percent: 15.000
Continuous Index: F02
Within 8" of Joint: NO
