Profile/Photo Observation Report

Date:	03/19/2018	Weather:		Coding:	PACP 6.0
Pipe Length (ft):	295.2	Owner:	NA	Pre Clean:	No Pre-Cleaning
P.O.#:		Surveyor:	John Kuglmaier	PSR:	P-209-020-024
Customer:		Clean Date:	01/01/1900	Shape:	C

Street:	E 61ST PL	Flow Control:	Not Controlled
City:	Hobart, IN	Year Renewed:	
Location:	Light Highway	Tape/Media #:	
Purpose:	Routine Assessment	Dia/Height:	12"
Use:	Sanitary	Material:	VCP
Drain Area:	NA	Lining:	
Category:	NA		
Comment:	P_C at 323 ft debris past MH at 296 .Flow direction wrong		
Location Details:		Direction of Survey:	Upstream
US MH:	M-209-024	DS MH:	M-209-020
		Total Length Surveyed (ft):	322.6

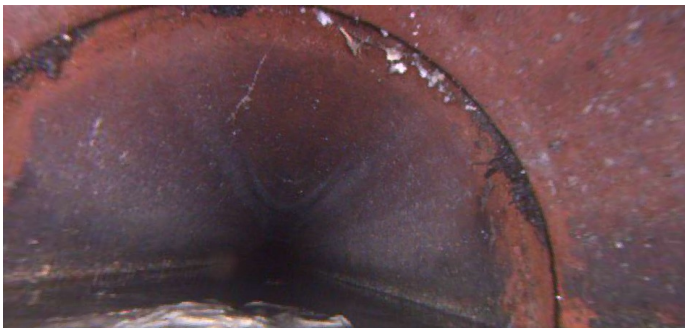
Code: **RFJ**
Description: **Roots Fine Joint**

Distance (ft): **13.9**
Structural Grade: **0**
O&M Grade: **1**
Clock Start/From: **2**
Clock To:
1st Value:
2nd Value:
Value Percent:
Continuous Index:
Within 8" of Joint: **YES**
Remarks:

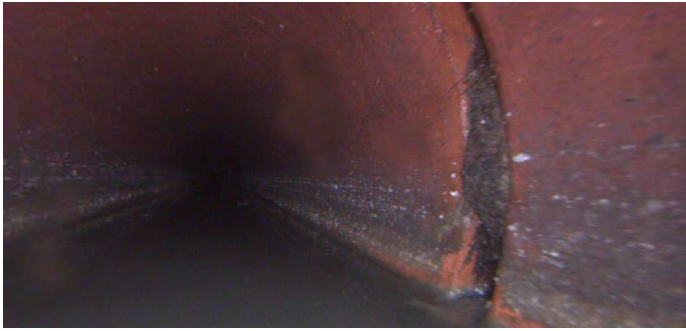
Code: **RFJ**
Description: **Roots Fine Joint**

Distance (ft): **34.4**
Structural Grade: **0**
O&M Grade: **1**
Clock Start/From: **2**
Clock To: **4**
1st Value:
2nd Value:
Value Percent:
Continuous Index:
Within 8" of Joint: **YES**
Remarks:

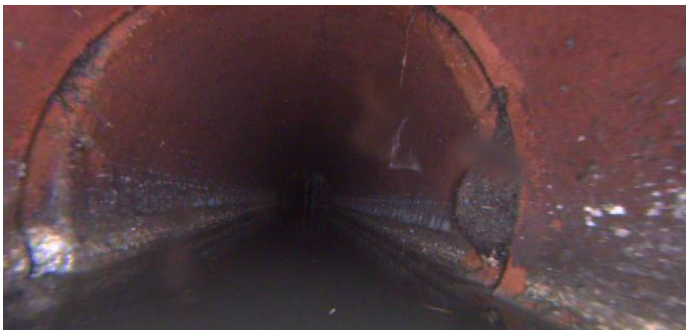
Code: **RMJ**
Description: **Roots Medium Joint**

Distance (ft): **39.3**
Structural Grade: **0**
O&M Grade: **3**
Clock Start/From: **2**
Clock To: **4**
1st Value:
2nd Value:
Value Percent: **5.000**
Continuous Index: **S01**
Within 8" of Joint: **YES**
Remarks:

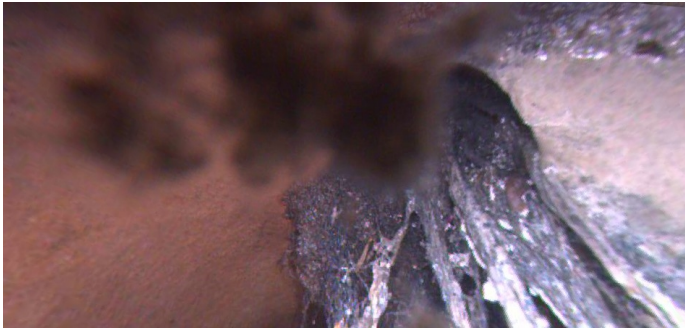
Code: **TFD**
Description: **Tap Factory Defective**

Distance (ft): **45.3**
Structural Grade: **0**
O&M Grade: **2**
Clock Start/From: **1**
Clock To:
1st Value: **4.000**
2nd Value:
Value Percent:
Continuous Index:
Within 8" of Joint:
Remarks: **RMC**

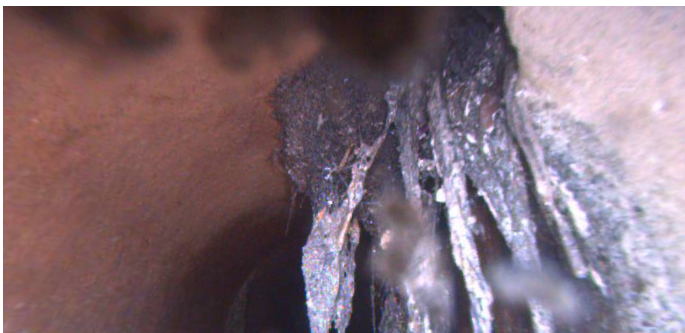
Code: **RML**
Description: **Roots Medium Lateral**

Distance (ft): **45.3**
Structural Grade: **0**
O&M Grade: **3**
Clock Start/From: **12**
Clock To: **2**
1st Value:
2nd Value:
Value Percent: **20.000**
Continuous Index:
Within 8" of Joint: **NO**
Remarks:

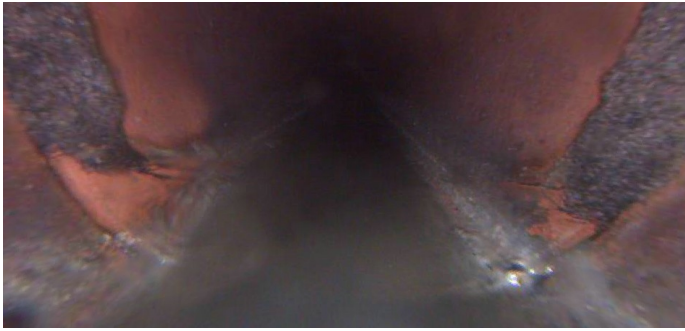
Code: **CS**
Description: **Crack Spiral**

Distance (ft): **46.6**
Structural Grade: **2**
O&M Grade: **0**
Clock Start/From: **5**
Clock To: **7**
1st Value:
2nd Value:
Value Percent:
Continuous Index:
Within 8" of Joint: **YES**
Remarks:

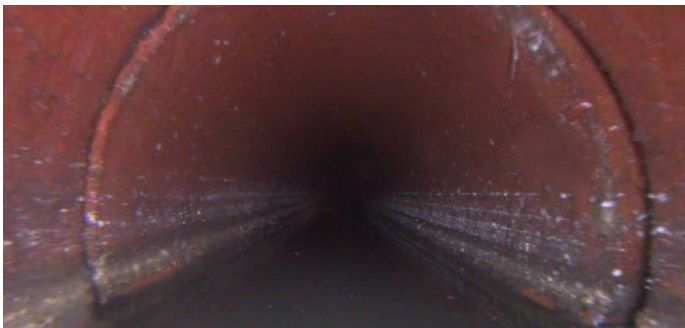
Code: **RMJ**
Description: **Roots Medium Joint**

Distance (ft): **51.6**
Structural Grade: **0**
O&M Grade: **3**
Clock Start/From: **2**
Clock To: **4**
1st Value:
2nd Value:
Value Percent: **5.000**
Continuous Index: **F01**
Within 8" of Joint: **YES**
Remarks: **Clock positions vary**

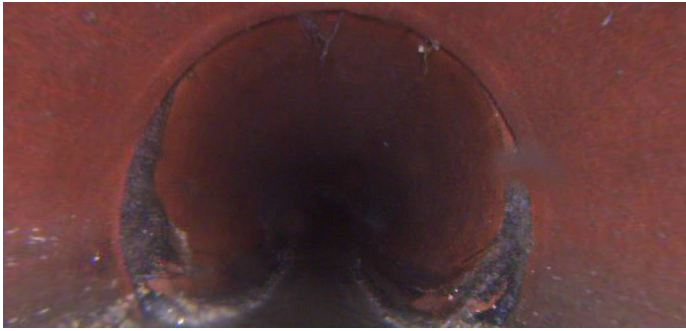
Code: **RFJ**
Description: **Roots Fine Joint**

Distance (ft): **61.7**
Structural Grade: **0**
O&M Grade: **1**
Clock Start/From: **7**
Clock To: **5**
1st Value:
2nd Value:
Value Percent:
Continuous Index:
Within 8" of Joint: **YES**
Remarks:

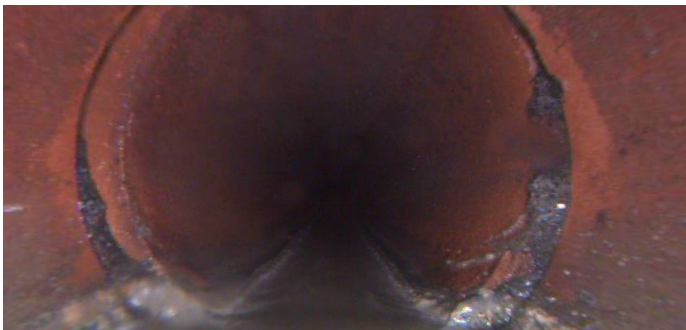
Code: **RFJ**
Description: **Roots Fine Joint**

Distance (ft): **77.0**
Structural Grade: **0**
O&M Grade: **1**
Clock Start/From: **2**
Clock To: **8**
1st Value:
2nd Value:
Value Percent:
Continuous Index:
Within 8" of Joint: **YES**
Remarks:

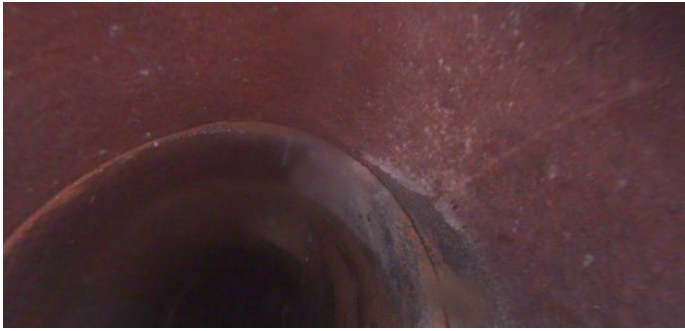
Code: **CL**
Description: **Crack Longitudinal**

Distance (ft): **114.8**
Structural Grade: **2**
O&M Grade: **0**
Clock Start/From: **2**
Clock To:
1st Value:
2nd Value:
Value Percent:
Continuous Index:
Within 8" of Joint: **YES**
Remarks:

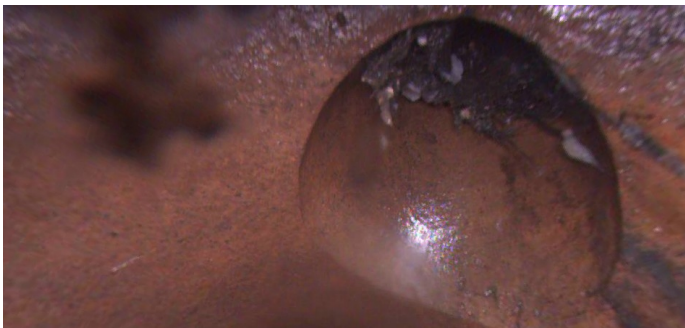
Code: **TFD**
Description: **Tap Factory Defective**

Distance (ft): **116.1**
Structural Grade: **0**
O&M Grade: **2**
Clock Start/From: **1**
Clock To:
1st Value: **4.000**
2nd Value:
Value Percent:
Continuous Index:
Within 8" of Joint:
Remarks: **RMC**

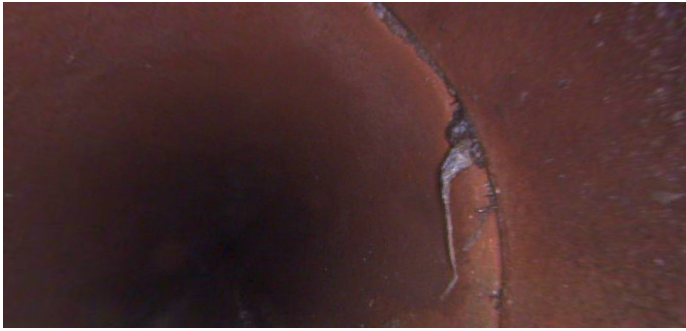
Code: **RFJ**
Description: **Roots Fine Joint**

Distance (ft): **117.2**
Structural Grade: **0**
O&M Grade: **1**
Clock Start/From: **2**
Clock To:
1st Value:
2nd Value:
Value Percent:
Continuous Index:
Within 8" of Joint: **YES**
Remarks:

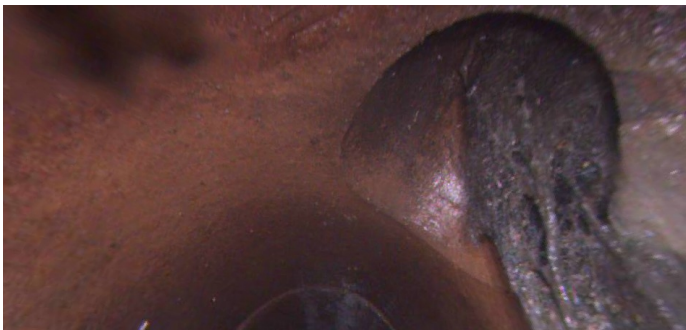
Code: **TFD**
Description: **Tap Factory Defective**

Distance (ft): **188.6**
Structural Grade: **0**
O&M Grade: **2**
Clock Start/From: **1**
Clock To:
1st Value: **4.000**
2nd Value:
Value Percent:
Continuous Index:
Within 8" of Joint:
Remarks: **RMC**

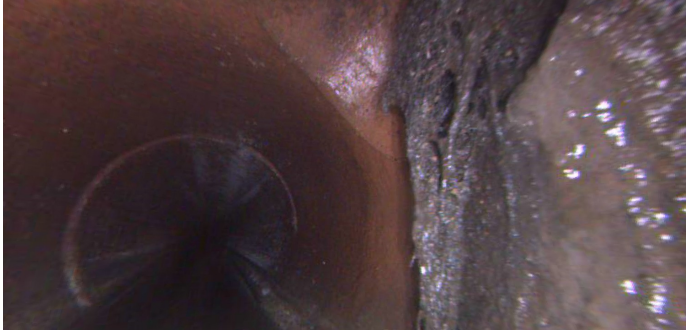
Code: **RML**
Description: **Roots Medium Lateral**

Distance (ft): **188.6**
Structural Grade: **0**
O&M Grade: **3**
Clock Start/From: **2**
Clock To:
1st Value:
2nd Value:
Value Percent: **5.000**
Continuous Index:
Within 8" of Joint: **NO**
Remarks:

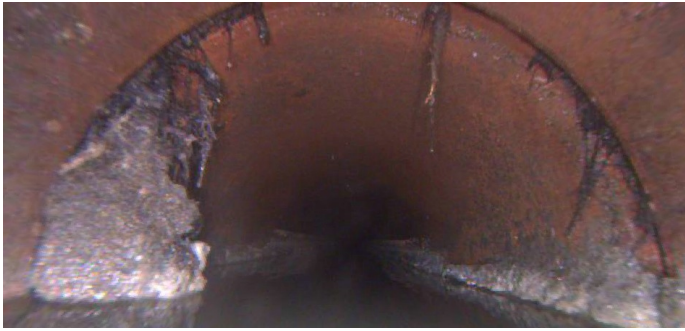
Code: **RMJ**
Description: **Roots Medium Joint**

Distance (ft): **252.7**
Structural Grade: **0**
O&M Grade: **3**
Clock Start/From: **9**
Clock To: **3**
1st Value:
2nd Value:
Value Percent: **15.000**
Continuous Index:
Within 8" of Joint: **YES**
Remarks:

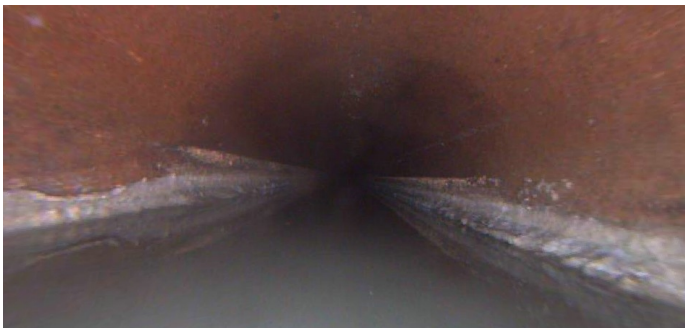
Code: **DAGS**
Description: **Deposits Attached Grease**

Distance (ft): **253.7**
Structural Grade: **0**
O&M Grade: **2**
Clock Start/From: **3**
Clock To: **9**
1st Value:
2nd Value:
Value Percent: **5.000**
Continuous Index: **S02**
Within 8" of Joint: **NO**
Remarks:

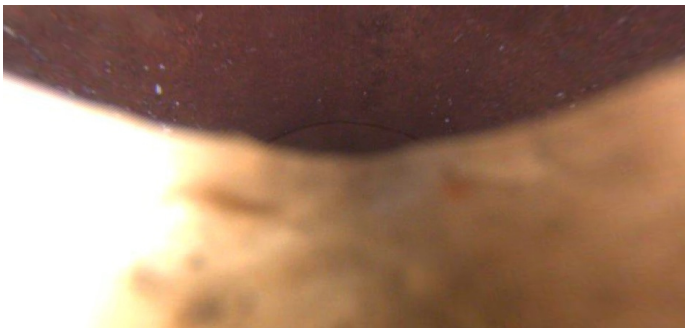
Code: **DAGS**
Description: **Deposits Attached Grease**

Distance (ft): **272.6**
Structural Grade: **0**
O&M Grade: **2**
Clock Start/From: **3**
Clock To: **9**
1st Value:
2nd Value:
Value Percent: **5.000**
Continuous Index: **F02**
Within 8" of Joint: **NO**
Remarks: **Clock positions vary**

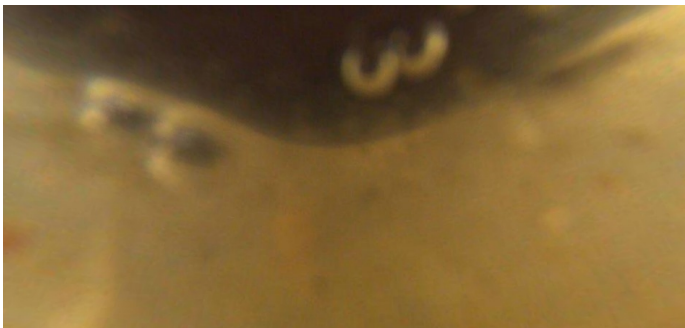
Code: **MCU**
Description: **Camera Underwater**

Distance (ft): **280.4**
Structural Grade: **0**
O&M Grade: **4**
Clock Start/From:
Clock To:
1st Value:
2nd Value:
Value Percent:
Continuous Index:
Within 8" of Joint: **NO**
Remarks:

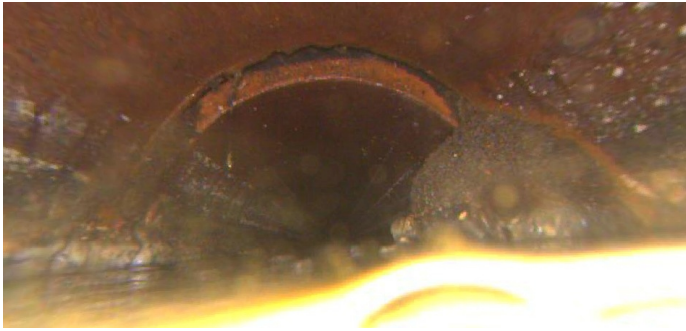
Code: **RMJ**
Description: **Roots Medium Joint**

Distance (ft): **284.3**
Structural Grade: **0**
O&M Grade: **3**
Clock Start/From: **9**
Clock To: **10**
1st Value:
2nd Value:
Value Percent: **20.000**
Continuous Index:
Within 8" of Joint: **YES**
Remarks:

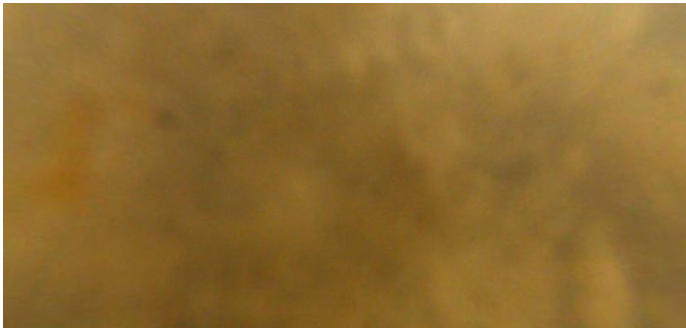
Code: **MCU**
Description: **Camera Underwater**

Distance (ft): **287.4**
Structural Grade: **0**
O&M Grade: **4**
Clock Start/From:
Clock To:
1st Value:
2nd Value:
Value Percent:
Continuous Index:
Within 8" of Joint: **NO**
Remarks:
