Profile/Photo Observation Report

Date:	03/19/2018	Weather:		Coding:	PACP 6.0
Pipe Length (ft):	295.2	Owner:	NA	Pre Clean:	No Pre-Cleaning
P.O.#:		Surveyor:	John Kuglmaier	PSR:	P-209-020-024
Customer:		Clean Date:	01/01/1900	Shape:	C

Street:	FOXCROFT STREET	Flow Control:	Not Controlled
City:	Hobart, IN	Year Renewed:	
Location:	Light Highway	Tape/Media #:	
Purpose:	Routine Assessment	Dia/Height:	12"
Use:	Sanitary	Material:	VCP
Drain Area:	NA	Lining:	
Category:	NA		
Comment:	P_C at 323 ft debris past MH at 296 .Flow direction wrong		
Location Details:		Direction of Survey:	Upstream
US MH:	M-209-024	DS MH:	M-209-020
		Total Length Surveyed (ft):	322.6

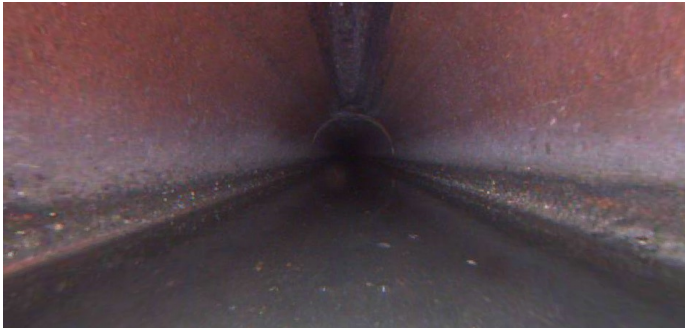
Code: **AMH**
Description: **Manhole**

Distance (ft): **.0**
Structural Grade: **0**
O&M Grade: **0**
Clock Start/From:
Clock To:
1st Value:
2nd Value:
Value Percent:
Continuous Index:
Within 8" of Joint: **NO**
Remarks: **M-209-020**

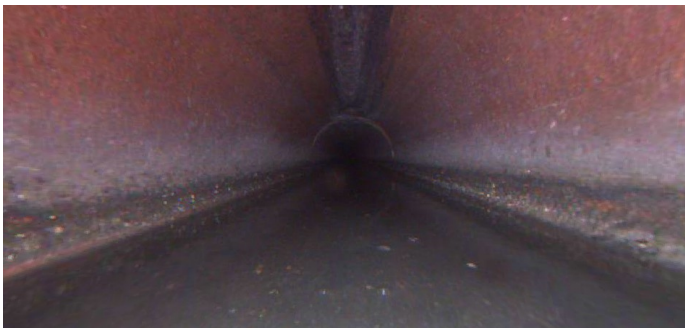
Code: **MWL**
Description: **Water Level**

Distance (ft): **.0**
Structural Grade: **0**
O&M Grade: **0**
Clock Start/From:
Clock To:
1st Value:
2nd Value:
Value Percent: **25.000**
Continuous Index:
Within 8" of Joint: **NO**
Remarks:

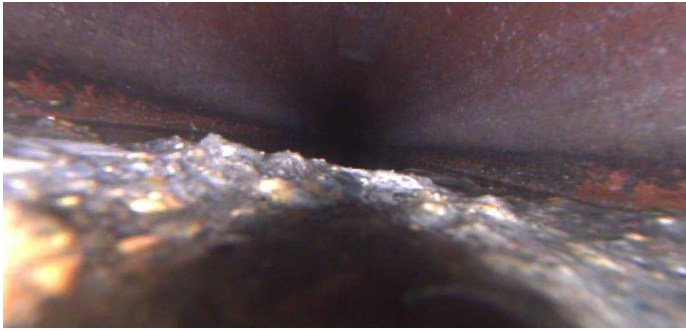
Code: **MWL**
Description: **Water Level**

Distance (ft): **5.7**
Structural Grade: **0**
O&M Grade: **0**
Clock Start/From:
Clock To:
1st Value:
2nd Value:
Value Percent: **35.000**
Continuous Index:
Within 8" of Joint: **NO**
Remarks:

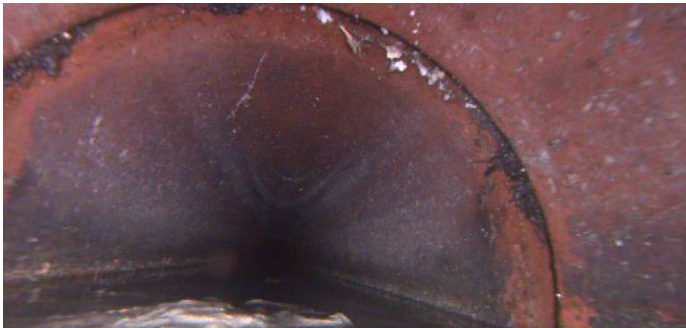
Code: **RFJ**
Description: **Roots Fine Joint**

Distance (ft): **13.9**
Structural Grade: **0**
O&M Grade: **1**
Clock Start/From: **2**
Clock To:
1st Value:
2nd Value:
Value Percent:
Continuous Index:
Within 8" of Joint: **YES**
Remarks:

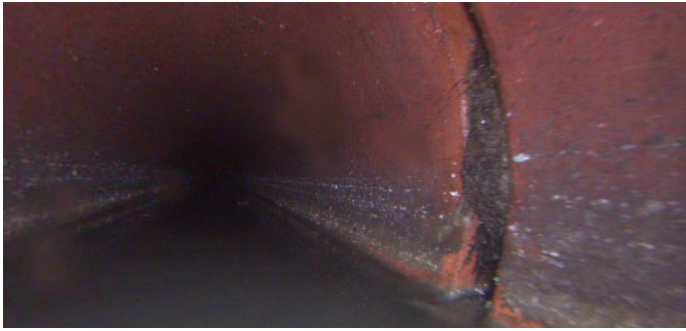
Code: **RFJ**
Description: **Roots Fine Joint**

Distance (ft): **34.4**
Structural Grade: **0**
O&M Grade: **1**
Clock Start/From: **2**
Clock To: **4**
1st Value:
2nd Value:
Value Percent:
Continuous Index:
Within 8" of Joint: **YES**
Remarks:

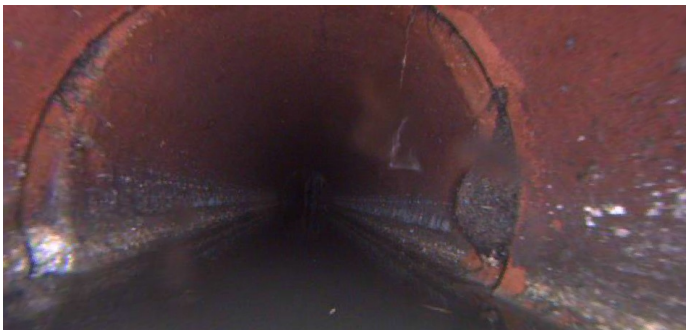
Code: **RMJ**
Description: **Roots Medium Joint**

Distance (ft): **39.3**
Structural Grade: **0**
O&M Grade: **3**
Clock Start/From: **2**
Clock To: **4**
1st Value:
2nd Value:
Value Percent: **5.000**
Continuous Index: **S01**
Within 8" of Joint: **YES**
Remarks:

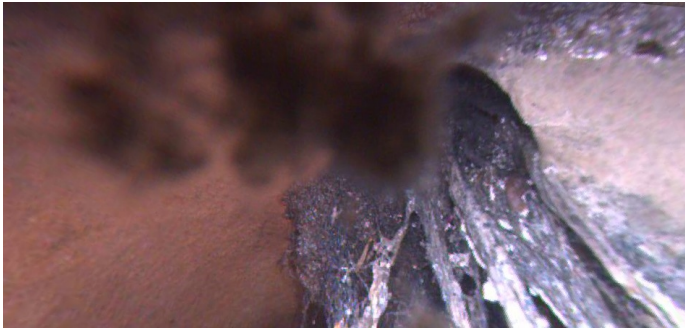
Code: **TFD**
Description: **Tap Factory Defective**

Distance (ft): **45.3**
Structural Grade: **0**
O&M Grade: **2**
Clock Start/From: **1**
Clock To:
1st Value: **4.000**
2nd Value:
Value Percent:
Continuous Index:
Within 8" of Joint:
Remarks: **RMC**

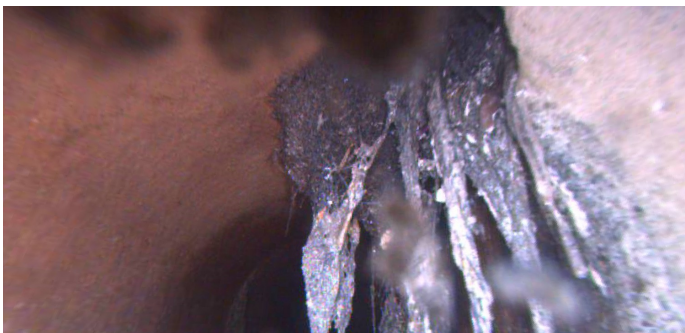
Code: **RML**
Description: **Roots Medium Lateral**

Distance (ft): **45.3**
Structural Grade: **0**
O&M Grade: **3**
Clock Start/From: **12**
Clock To: **2**
1st Value:
2nd Value:
Value Percent: **20.000**
Continuous Index:
Within 8" of Joint: **NO**
Remarks:

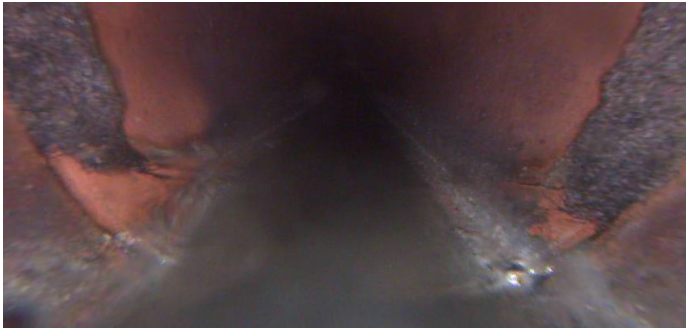
Code: **CS**
Description: **Crack Spiral**

Distance (ft): **46.6**
Structural Grade: **2**
O&M Grade: **0**
Clock Start/From: **5**
Clock To: **7**
1st Value:
2nd Value:
Value Percent:
Continuous Index:
Within 8" of Joint: **YES**
Remarks:

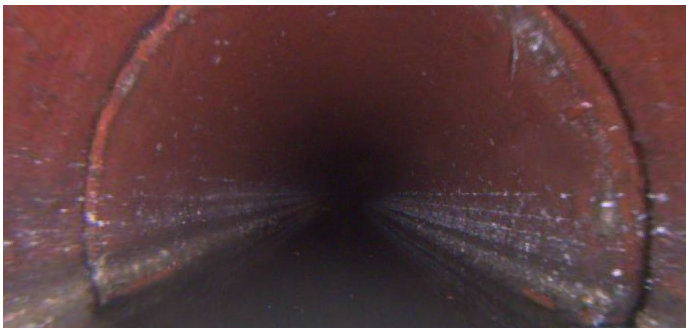
Code: **RMJ**
Description: **Roots Medium Joint**

Distance (ft): **51.6**
Structural Grade: **0**
O&M Grade: **3**
Clock Start/From: **2**
Clock To: **4**
1st Value:
2nd Value:
Value Percent: **5.000**
Continuous Index: **F01**
Within 8" of Joint: **YES**
Remarks: **Clock positions vary**

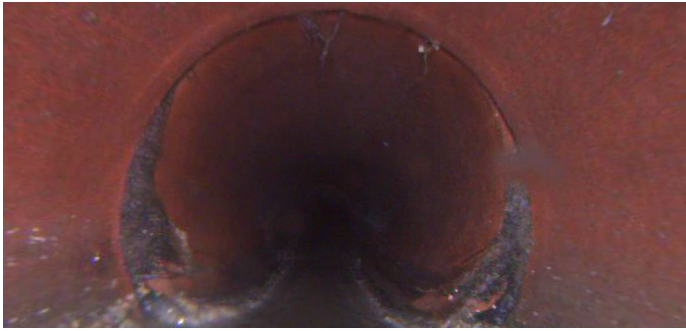
Code: **RFJ**
Description: **Roots Fine Joint**

Distance (ft): **61.7**
Structural Grade: **0**
O&M Grade: **1**
Clock Start/From: **7**
Clock To: **5**
1st Value:
2nd Value:
Value Percent:
Continuous Index:
Within 8" of Joint: **YES**
Remarks:

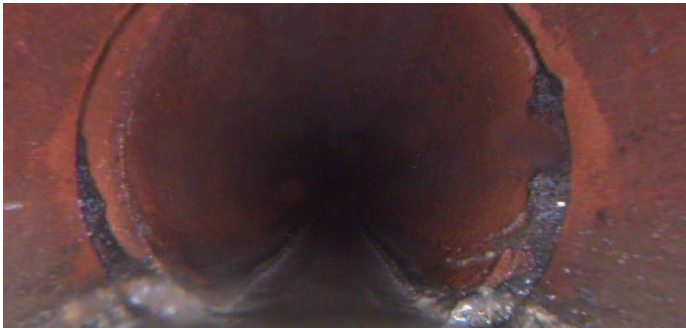
Code: **RFJ**
Description: **Roots Fine Joint**

Distance (ft): **77.0**
Structural Grade: **0**
O&M Grade: **1**
Clock Start/From: **2**
Clock To: **8**
1st Value:
2nd Value:
Value Percent:
Continuous Index:
Within 8" of Joint: **YES**
Remarks:

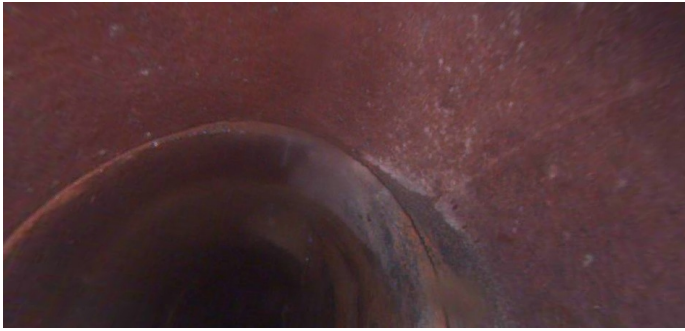
Code: **CL**
Description: **Crack Longitudinal**

Distance (ft): **114.8**
Structural Grade: **2**
O&M Grade: **0**
Clock Start/From: **2**
Clock To:
1st Value:
2nd Value:
Value Percent:
Continuous Index:
Within 8" of Joint: **YES**
Remarks:

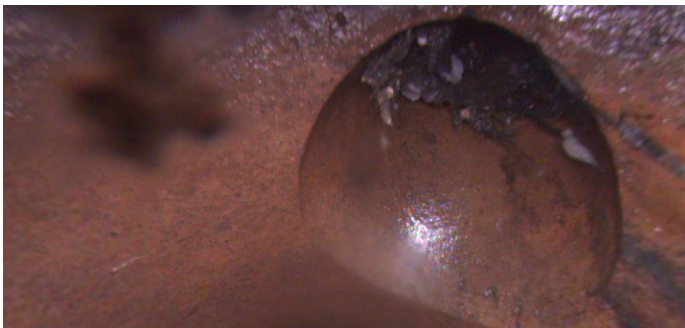
Code: **TFD**
Description: **Tap Factory Defective**

Distance (ft): **116.1**
Structural Grade: **0**
O&M Grade: **2**
Clock Start/From: **1**
Clock To:
1st Value: **4.000**
2nd Value:
Value Percent:
Continuous Index:
Within 8" of Joint:
Remarks: **RMC**

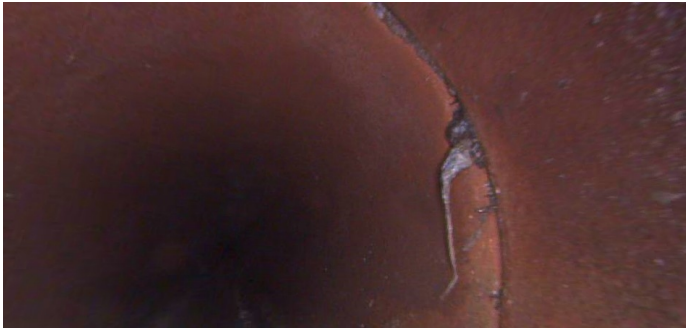
Code: **RFJ**
Description: **Roots Fine Joint**

Distance (ft): **117.2**
Structural Grade: **0**
O&M Grade: **1**
Clock Start/From: **2**
Clock To:
1st Value:
2nd Value:
Value Percent:
Continuous Index:
Within 8" of Joint: **YES**
Remarks:

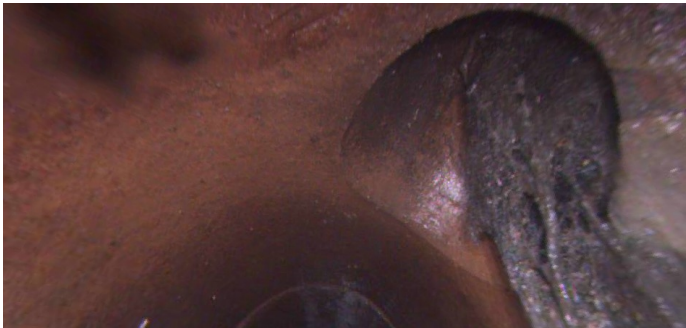
Code: **TFD**
Description: **Tap Factory Defective**

Distance (ft): **188.6**
Structural Grade: **0**
O&M Grade: **2**
Clock Start/From: **1**
Clock To:
1st Value: **4.000**
2nd Value:
Value Percent:
Continuous Index:
Within 8" of Joint:
Remarks: **RMC**

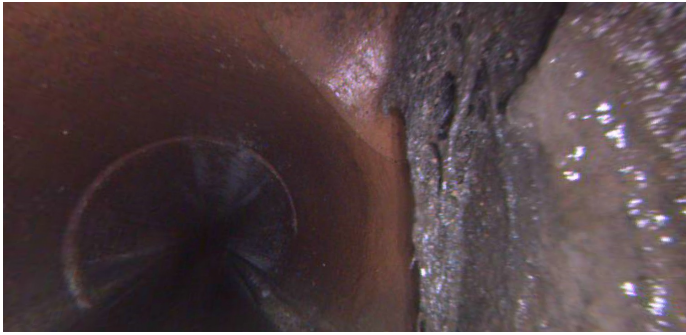
Code: **RML**
Description: **Roots Medium Lateral**

Distance (ft): **188.6**
Structural Grade: **0**
O&M Grade: **3**
Clock Start/From: **2**
Clock To:
1st Value:
2nd Value:
Value Percent: **5.000**
Continuous Index:
Within 8" of Joint: **NO**
Remarks:

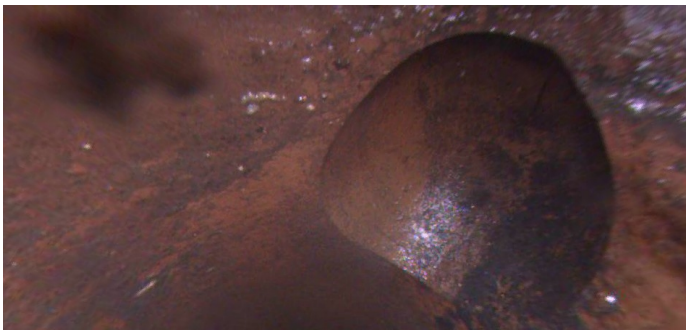
Code: **TF**
Description: **Tap Factory**

Distance (ft): **251.5**
Structural Grade: **0**
O&M Grade: **0**
Clock Start/From: **1**
Clock To:
1st Value: **4.000**
2nd Value:
Value Percent:
Continuous Index:
Within 8" of Joint:
Remarks:

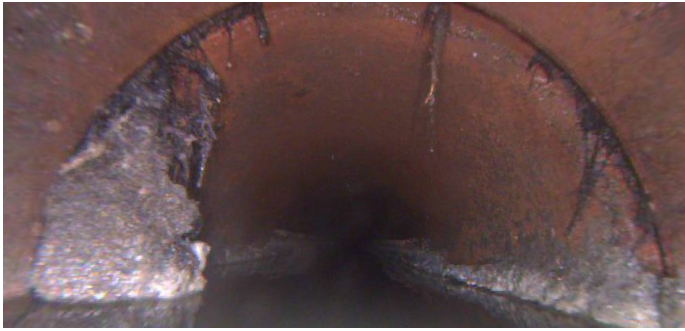
Code: **RMJ**
Description: **Roots Medium Joint**

Distance (ft): **252.7**
Structural Grade: **0**
O&M Grade: **3**
Clock Start/From: **9**
Clock To: **3**
1st Value:
2nd Value:
Value Percent: **15.000**
Continuous Index:
Within 8" of Joint: **YES**
Remarks:

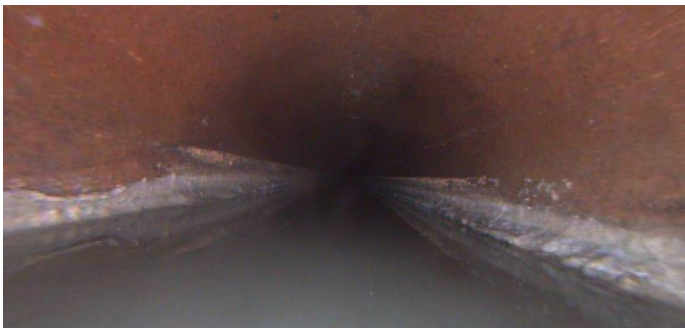
Code: **DAGS**
Description: **Deposits Attached Grease**

Distance (ft): **253.7**
Structural Grade: **0**
O&M Grade: **2**
Clock Start/From: **3**
Clock To: **9**
1st Value:
2nd Value:
Value Percent: **5.000**
Continuous Index: **S02**
Within 8" of Joint: **NO**
Remarks:

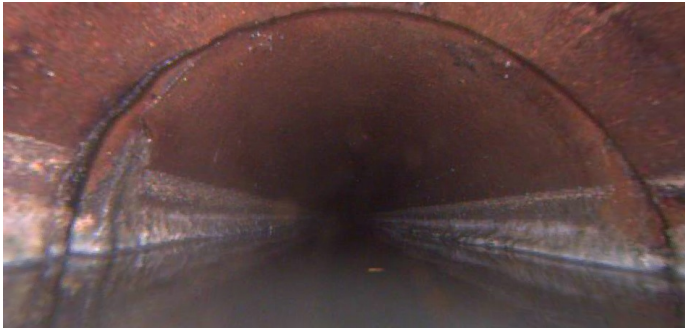
Code: **MWL**
Description: **Water Level**

Distance (ft): **257.9**
Structural Grade: **0**
O&M Grade: **0**
Clock Start/From:
Clock To:
1st Value:
2nd Value:
Value Percent: **50.000**
Continuous Index:
Within 8" of Joint: **NO**
Remarks:

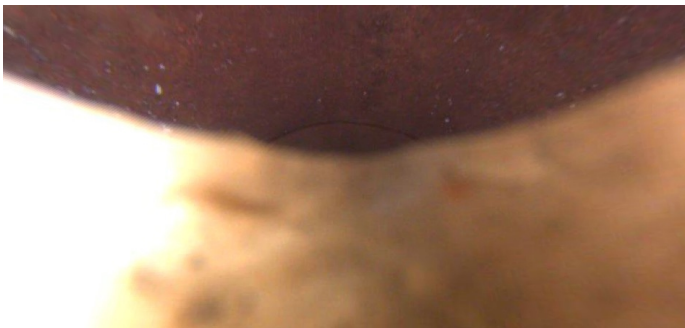
Code: **DAGS**
Description: **Deposits Attached Grease**

Distance (ft): **272.6**
Structural Grade: **0**
O&M Grade: **2**
Clock Start/From: **3**
Clock To: **9**
1st Value:
2nd Value:
Value Percent: **5.000**
Continuous Index: **F02**
Within 8" of Joint: **NO**
Remarks: **Clock positions vary**

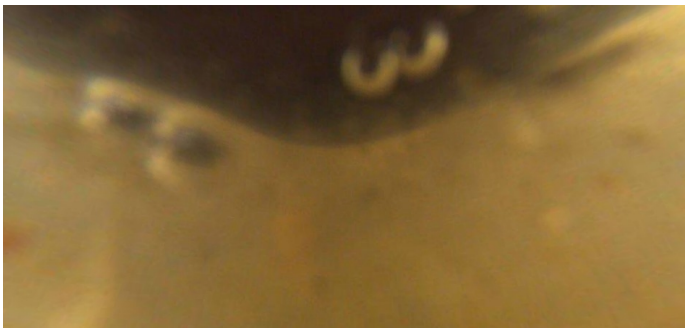
Code: **MCU**
Description: **Camera Underwater**

Distance (ft): **280.4**
Structural Grade: **0**
O&M Grade: **4**
Clock Start/From:
Clock To:
1st Value:
2nd Value:
Value Percent:
Continuous Index:
Within 8" of Joint: **NO**
Remarks:

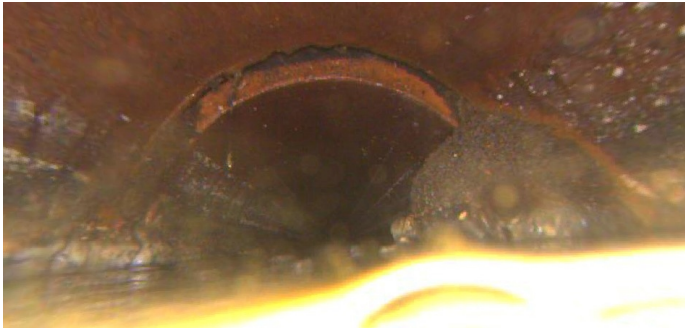
Code: **RMJ**
Description: **Roots Medium Joint**

Distance (ft): **284.3**
Structural Grade: **0**
O&M Grade: **3**
Clock Start/From: **9**
Clock To: **10**
1st Value:
2nd Value:
Value Percent: **20.000**
Continuous Index:
Within 8" of Joint: **YES**
Remarks:

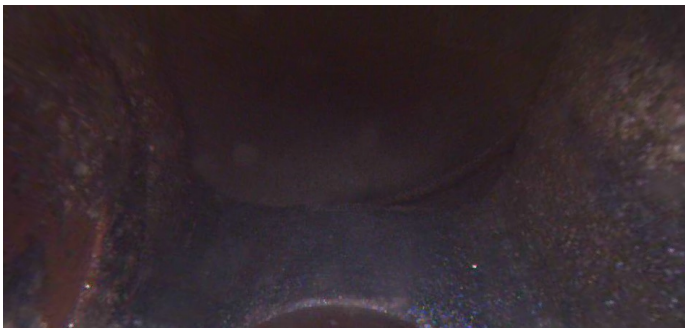
Code: **AMH**
Description: **Manhole**

Distance (ft): **294.3**
Structural Grade: **0**
O&M Grade: **0**
Clock Start/From:
Clock To:
1st Value:
2nd Value:
Value Percent:
Continuous Index:
Within 8" of Joint: **NO**
Remarks: **M-209-024**
