## Profile/Photo Observation Report

Date:	<b>01/17/2025</b>	Weather:		Coding:	<b>PACP 7.0</b>
Pipe Length (ft):	<b>156.0</b>	Owner:	<b>City of Hobart</b>	Pre Clean:	<b>Heavy Cleaning</b>
P.O.#:	<b>YES502259</b>	Surveyor:	<b>S. Bucklin</b>	PSR:	<b>P-209-024-025</b>
Customer:	<b>City of Hobart</b>	Clean Date:	<b>07/14/2024</b>	Shape:	<b>C</b>

Street:	<b>East 61st Place</b>	Flow Control:	<b>De-watered Using Jetter</b>
City:	<b>Hobart, IN</b>	Year Renewed:	
Location:	<b>Local rural streets with light traffic, t</b>	Tape/Media #:	
Purpose:	<b>Sewer System Evaluation Survey (SS</b>	Dia/Height:	<b>15"</b>
Use:	<b>Sanitary Sewage Pipe</b>	Material:	<b>VCP</b>
Drain Area:		Lining:	<b>None</b>
Category:	<b>NA</b>		
Comment:			
Location Details:		Direction of Survey:	<b>Upstream</b>
US MH:	<b>M-209-024</b>	DS MH:	<b>M-209-025</b>
		Total Length Surveyed (ft):	<b>154.6</b>

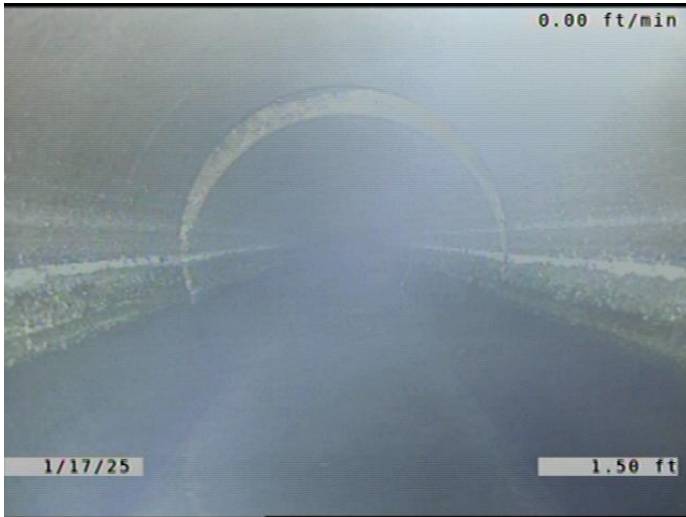
Code: **MGO**  
Description: **Miscellaneous General Observation**

Distance (ft): **1.5**  
Structural Grade: **0**  
O&M Grade: **0**  
Clock Start/From:  
Clock To:  
1st Value:  
2nd Value:  
Value Percent:  
Continuous Index:  
Within 8" of Joint: **NO**  
Remarks: **DROP INTO THE MANHOLE. HAD TO START IN THE PIPE.**

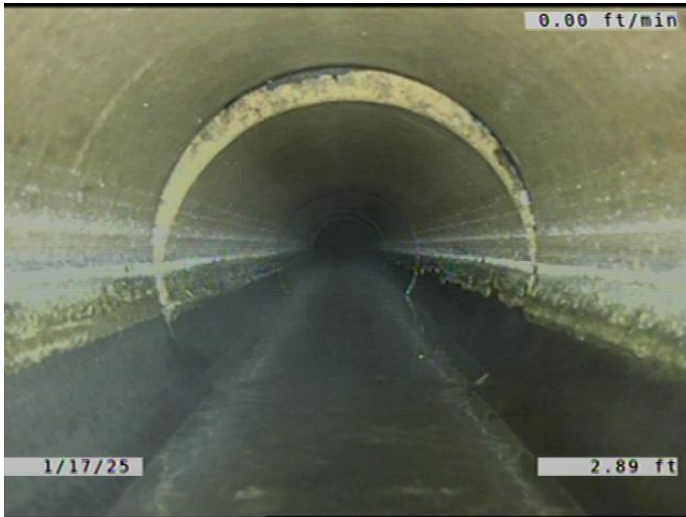
Code: **DAGS**  
Description: **Deposits Attached Grease**

Distance (ft): **2.9**  
Structural Grade: **0**  
O&M Grade: **2**  
Clock Start/From: **9**  
Clock To: **3**  
1st Value:  
2nd Value:  
Value Percent: **5.000**  
Continuous Index: **S01**  
Within 8" of Joint: **YES**  
Remarks:

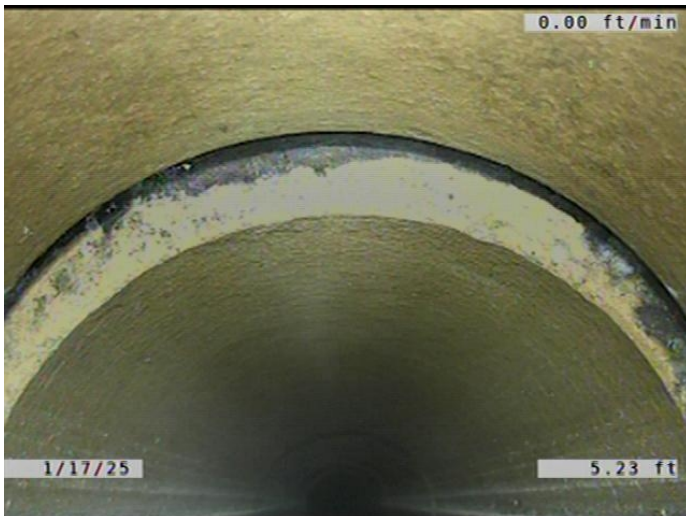
Code: **JOMD**  
Description: **Joint Offset Medium Defective**

Distance (ft): **5.2**  
Structural Grade: **3**  
O&M Grade: **0**  
Clock Start/From:  
Clock To:  
1st Value:  
2nd Value:  
Value Percent:  
Continuous Index:  
Within 8" of Joint: **NO**  
Remarks:

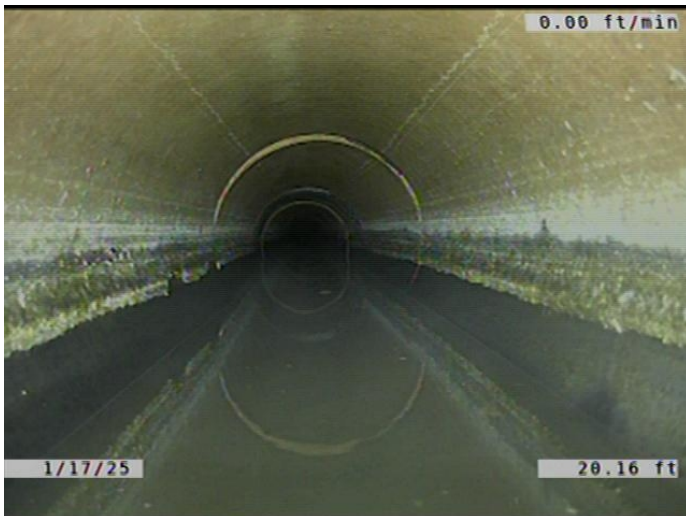
Code: **LL**  
 Description: **Line Left**

Distance (ft): **20.2**  
 Structural Grade: **0**  
 O&M Grade: **1**  
 Clock Start/From:  
 Clock To:  
 1st Value:  
 2nd Value:  
 Value Percent: **5.000**  
 Continuous Index:  
 Within 8" of Joint: **NO**  
 Remarks:

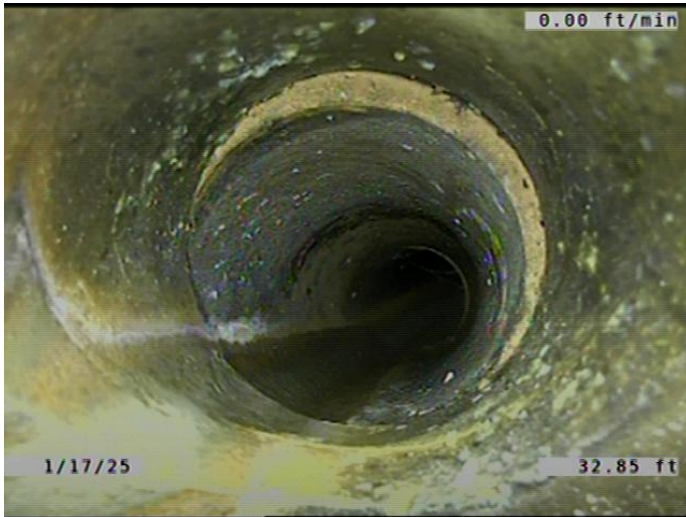
Code:	<b>TF</b>
Description:	<b>Tap Factory</b>
Distance (ft):	<b>32.8</b>
Structural Grade:	<b>0</b>
O&M Grade:	<b>0</b>
Clock Start/From:	<b>11</b>
Clock To:	
1st Value:	<b>6.000</b>
2nd Value:	
Value Percent:	
Continuous Index:	
Within 8" of Joint:	<b>YES</b>
Remarks:	<b>SERVICE TO MAIN CONNECTION OFFSET.</b>

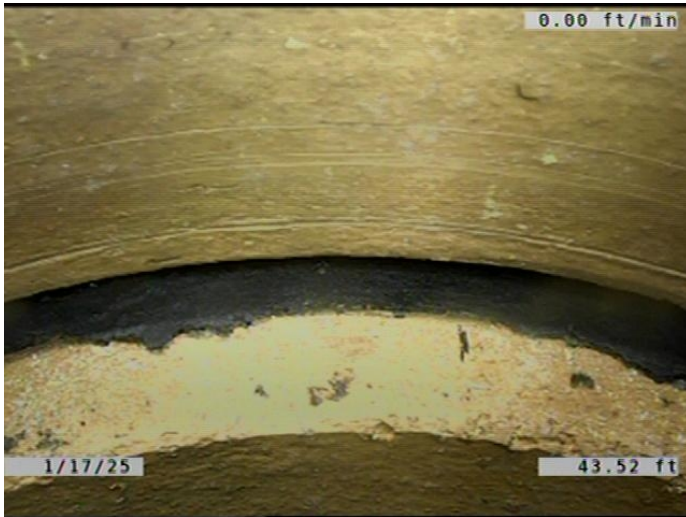
Code: **JOMD**  
Description: **Joint Offset Medium Defective**

Distance (ft): **43.5**  
Structural Grade: **3**  
O&M Grade: **0**  
Clock Start/From:  
Clock To:  
1st Value:  
2nd Value:  
Value Percent:  
Continuous Index:  
Within 8" of Joint: **NO**  
Remarks:

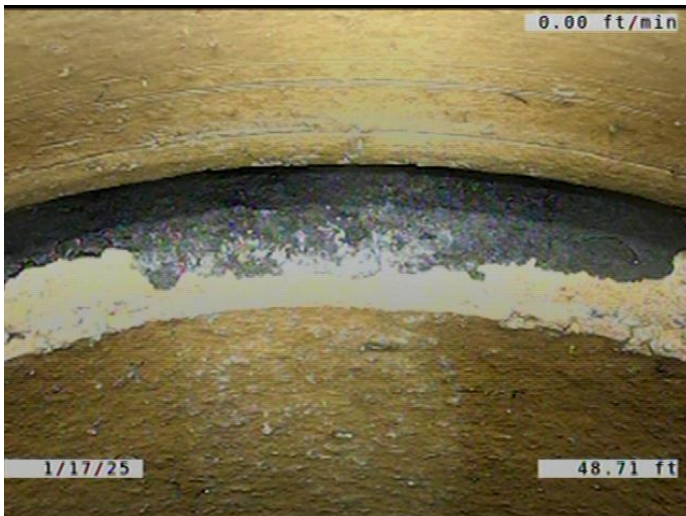
Code: **JOMD**  
Description: **Joint Offset Medium Defective**

Distance (ft): **48.7**  
Structural Grade: **3**  
O&M Grade: **0**  
Clock Start/From:  
Clock To:  
1st Value:  
2nd Value:  
Value Percent:  
Continuous Index:  
Within 8" of Joint: **NO**  
Remarks:

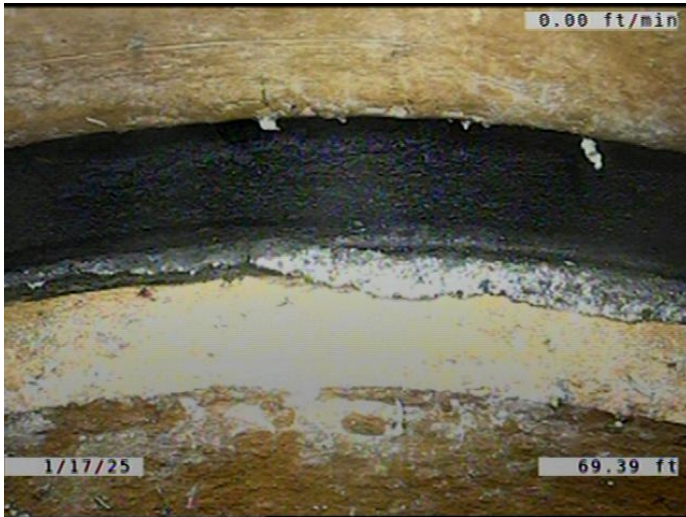
Code: **JOMD**  
 Description: **Joint Offset Medium Defective**

Distance (ft): **69.4**  
 Structural Grade: **3**  
 O&M Grade: **0**  
 Clock Start/From:  
 Clock To:  
 1st Value:  
 2nd Value:  
 Value Percent:  
 Continuous Index:  
 Within 8" of Joint: **NO**  
 Remarks:

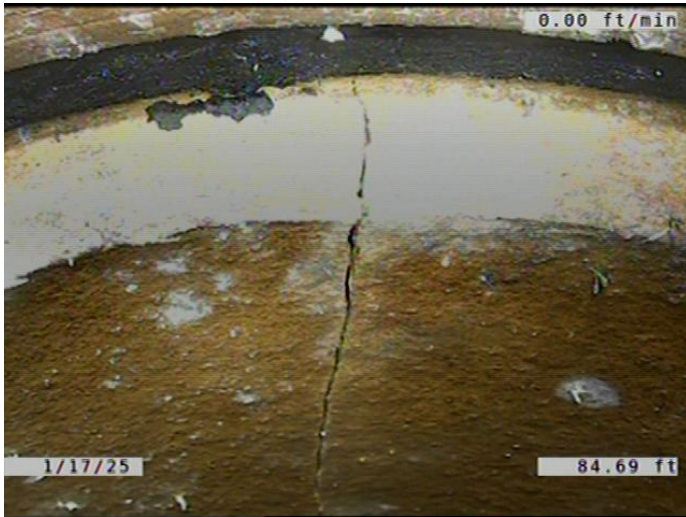
Code: **FM**  
 Description: **Fracture Multiple**

Distance (ft): **84.7**  
 Structural Grade: **4**  
 O&M Grade: **0**  
 Clock Start/From: **12**  
 Clock To: **2**  
 1st Value:  
 2nd Value:  
 Value Percent:  
 Continuous Index: **S02**  
 Within 8" of Joint: **YES**  
 Remarks:

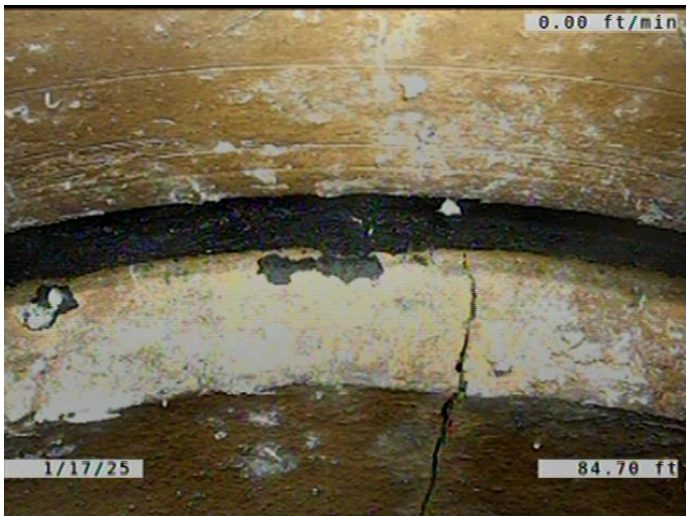
Code: **JOMD**  
 Description: **Joint Offset Medium Defective**

Distance (ft): **84.7**  
 Structural Grade: **3**  
 O&M Grade: **0**  
 Clock Start/From:  
 Clock To:  
 1st Value:  
 2nd Value:  
 Value Percent:  
 Continuous Index: **S03**  
 Within 8" of Joint: **NO**  
 Remarks:

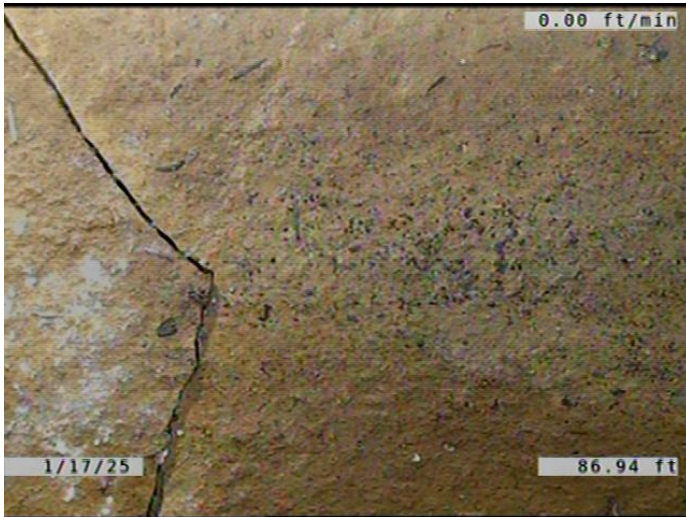
Code: **ISB**  
Description: **Infiltration Stain Barrel**

Distance (ft): **86.9**  
Structural Grade: **0**  
O&M Grade: **1**  
Clock Start/From: **2**  
Clock To: **4**  
1st Value:  
2nd Value:  
Value Percent:  
Continuous Index:  
Within 8" of Joint: **YES**  
Remarks:

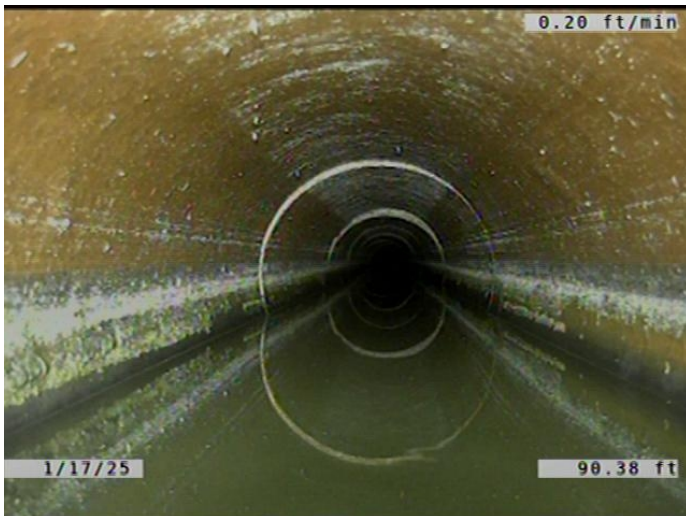
Code: **FM**  
Description: **Fracture Multiple**

Distance (ft): **90.4**  
Structural Grade: **4**  
O&M Grade: **0**  
Clock Start/From: **12**  
Clock To: **2**  
1st Value:  
2nd Value:  
Value Percent:  
Continuous Index: **F02**  
Within 8" of Joint: **YES**  
Remarks:

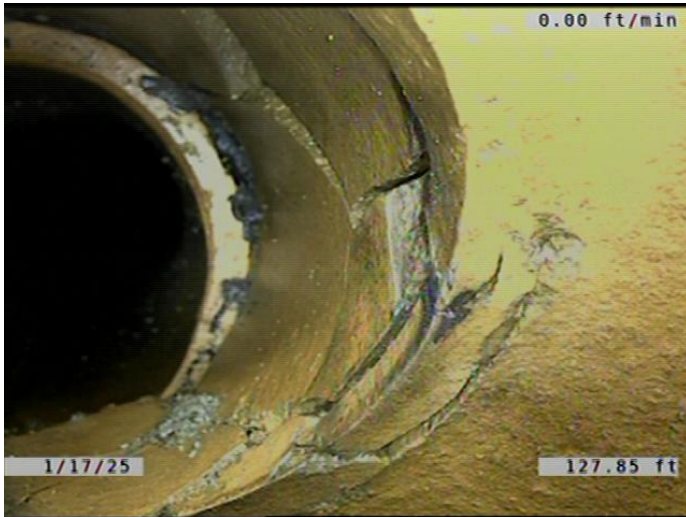
Code: **B**  
Description: **Broken**

Distance (ft): **127.8**  
Structural Grade: **4**  
O&M Grade: **0**  
Clock Start/From: **11**  
Clock To: **12**  
1st Value:  
2nd Value:  
Value Percent:  
Continuous Index:  
Within 8" of Joint: **YES**  
Remarks:

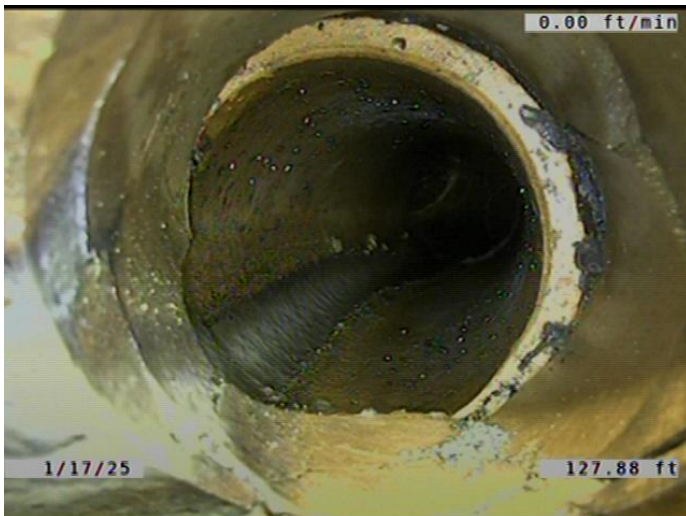
Code: **TFD**  
Description: **Tap Factory Defective**

Distance (ft): **127.9**  
Structural Grade: **0**  
O&M Grade: **3**  
Clock Start/From: **11**  
Clock To:  
1st Value: **6.000**  
2nd Value:  
Value Percent:  
Continuous Index:  
Within 8" of Joint: **YES**  
Remarks: **TAP BROKEN. SERVICE OFFSET.**

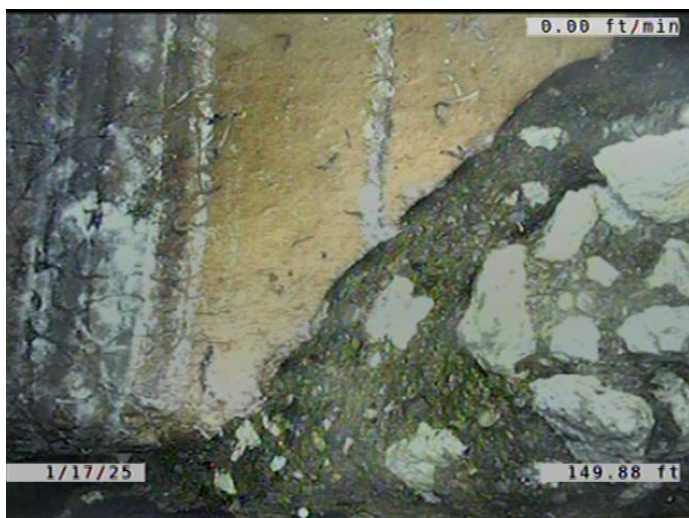
Code: **HSV**  
 Description: **Hole Soil Visible**

Distance (ft): **149.9**  
 Structural Grade: **5**  
 O&M Grade: **0**  
 Clock Start/From: **9**  
 Clock To: **2**  
 1st Value:  
 2nd Value:  
 Value Percent:  
 Continuous Index:  
 Within 8" of Joint: **YES**  
 Remarks:

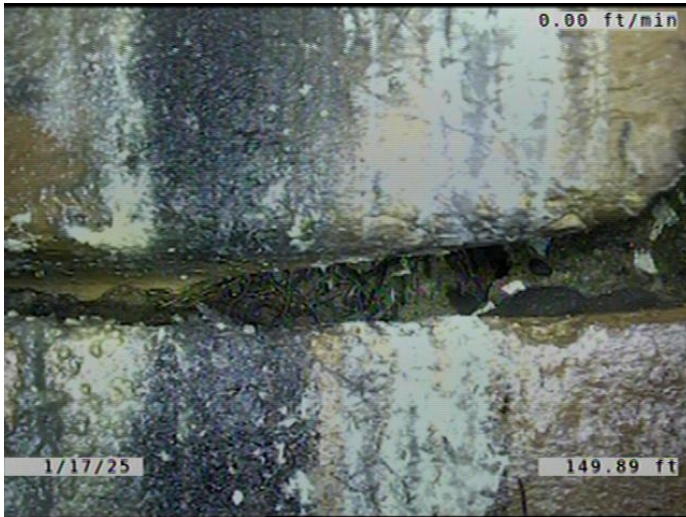
Code: **RFB**  
 Description: **Roots Fine Barrel**

Distance (ft): **149.9**  
 Structural Grade: **0**  
 O&M Grade: **2**  
 Clock Start/From: **9**  
 Clock To: **10**  
 1st Value:  
 2nd Value:  
 Value Percent:  
 Continuous Index:  
 Within 8" of Joint: **NO**  
 Remarks:

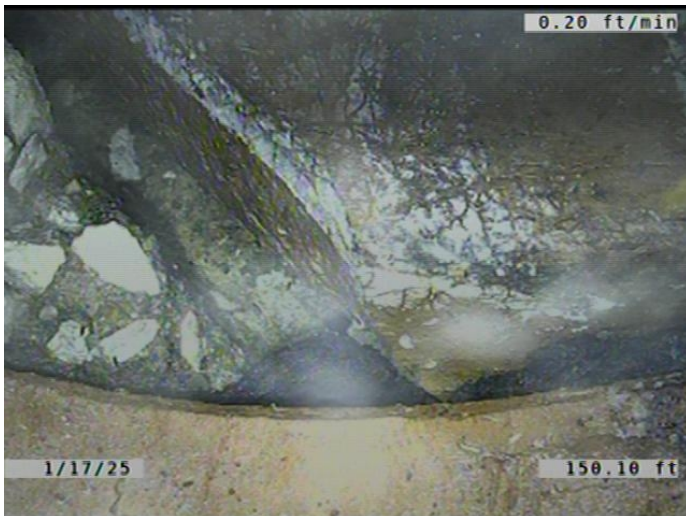
Code: **JOMD**  
 Description: **Joint Offset Medium Defective**

Distance (ft): **150.1**  
 Structural Grade: **3**  
 O&M Grade: **0**  
 Clock Start/From:  
 Clock To:  
 1st Value:  
 2nd Value:  
 Value Percent:  
 Continuous Index:  
 Within 8" of Joint: **NO**  
 Remarks:

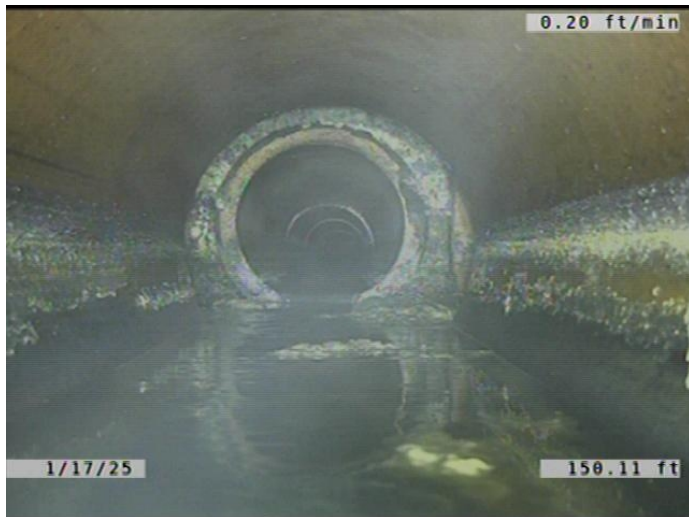
Code: **JOMD**  
 Description: **Joint Offset Medium Defective**

Distance (ft): **150.1**  
 Structural Grade: **3**  
 O&M Grade: **0**  
 Clock Start/From:  
 Clock To:  
 1st Value:  
 2nd Value:  
 Value Percent:  
 Continuous Index: **F03**  
 Within 8" of Joint: **NO**  
 Remarks:

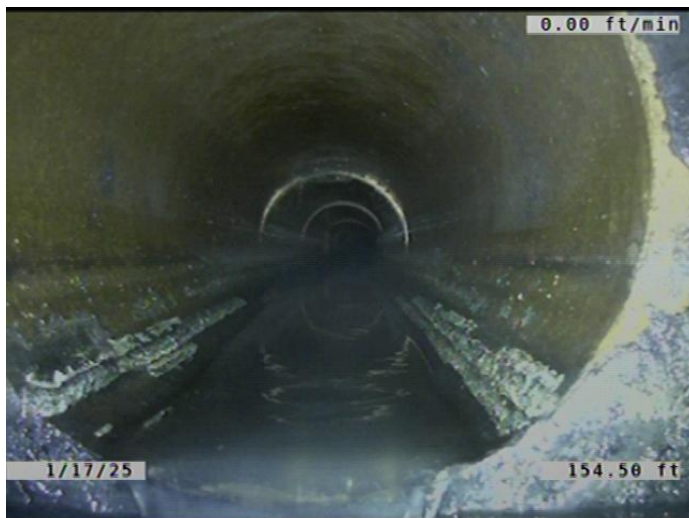
Code: **DAGS**  
 Description: **Deposits Attached Grease**

Distance (ft): **154.5**  
 Structural Grade: **0**  
 O&M Grade: **2**  
 Clock Start/From: **9**  
 Clock To: **3**  
 1st Value:  
 2nd Value:  
 Value Percent: **5.000**  
 Continuous Index: **F01**  
 Within 8" of Joint: **YES**  
 Remarks:
