Profile/Photo Observation Report

Street:	FOXCROFT STREET	Flow Control:	Not Controlled
City:	Hobart, IN	Year Renewed:	
Location:	Light Highway	Tape/Media #:	
Purpose:	Routine Assessment	Dia/Height:	10"
Use:	Sanitary	Material:	VCP
Drain Area:	NA	Lining:	
Category:	NA		
Comment:	Flow direction wrong

Location Details:		Direction of Survey:	Upstream
US MH:	M-209-027	DS MH:	M-209-026
		Total Length Surveyed (ft):	76.0

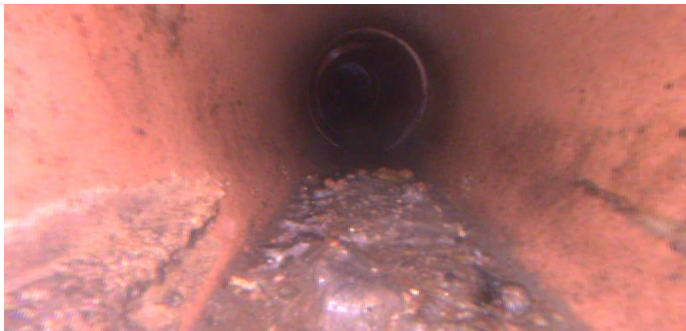
Code: **AMH**
Description: **Manhole**

Distance (ft): **.0**
Structural Grade: **0**
O&M Grade: **0**
Clock Start/From:
Clock To:
1st Value:
2nd Value:
Value Percent:
Continuous Index:
Within 8" of Joint: **NO**
Remarks: **M-209-026**

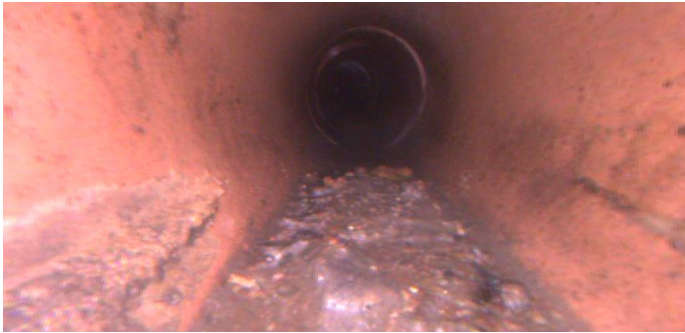
Code:	MWL
Description:	Water Level

Distance (ft):	.0
Structural Grade:	0
O&M Grade:	0
Clock Start/From:	
Clock To:	
1st Value:	
2nd Value:	
Value Percent:	5.000
Continuous Index:	
Within 8" of Joint:	NO
Remarks:

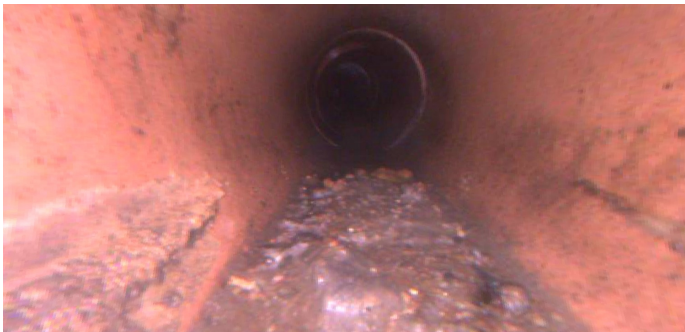
Code:	DSZ
Description:	Deposits Settled Other

Distance (ft):	.0
Structural Grade:	0
O&M Grade:	2
Clock Start/From:	6
Clock To:	
1st Value:	
2nd Value:	
Value Percent:	5.000
Continuous Index:	
Within 8" of Joint:	NO
Remarks:	debris

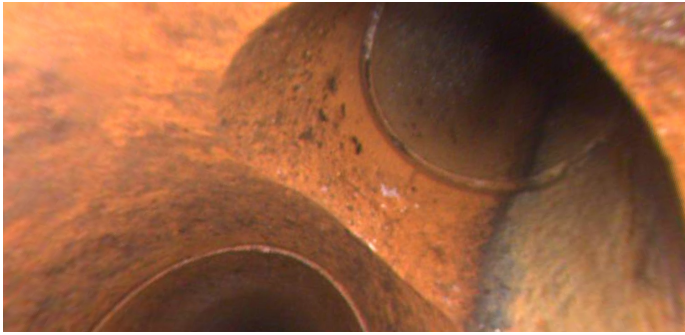
Code: **TF**
Description: **Tap Factory**

Distance (ft): **3.8**
Structural Grade: **0**
O&M Grade: **0**
Clock Start/From: **11**
Clock To:
1st Value: **4.000**
2nd Value:
Value Percent:
Continuous Index:
Within 8" of Joint:
Remarks:

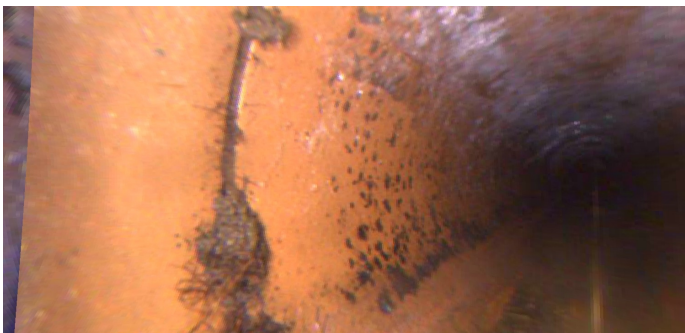
Code: **RFJ**
Description: **Roots Fine Joint**

Distance (ft): **15.2**
Structural Grade: **0**
O&M Grade: **1**
Clock Start/From: **7**
Clock To: **5**
1st Value:
2nd Value:
Value Percent:
Continuous Index:
Within 8" of Joint: **YES**
Remarks:

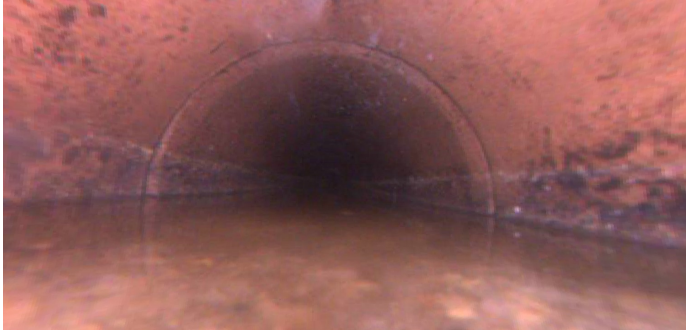
Code: **MWL**
Description: **Water Level**

Distance (ft): **44.6**
Structural Grade: **0**
O&M Grade: **0**
Clock Start/From:
Clock To:
1st Value:
2nd Value:
Value Percent: **25.000**
Continuous Index:
Within 8" of Joint: **NO**
Remarks:

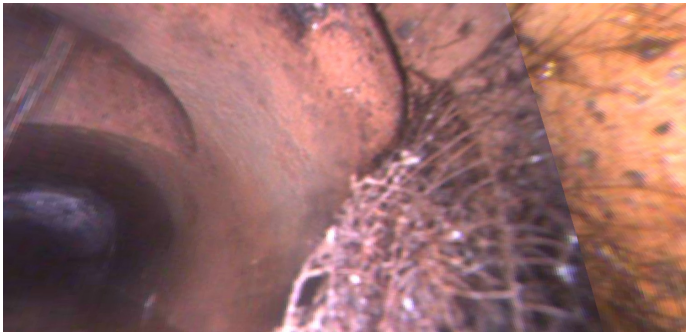
Code: **RMJ**
Description: **Roots Medium Joint**

Distance (ft): **50.1**
Structural Grade: **0**
O&M Grade: **3**
Clock Start/From: **2**
Clock To: **5**
1st Value:
2nd Value:
Value Percent: **5.000**
Continuous Index:
Within 8" of Joint: **YES**
Remarks:

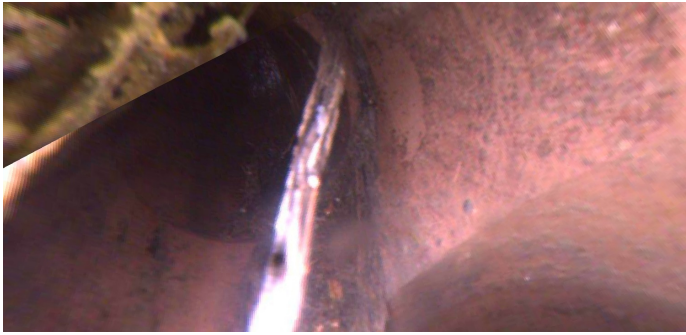
Code: **TFD**
Description: **Tap Factory Defective**

Distance (ft): **50.6**
Structural Grade: **0**
O&M Grade: **2**
Clock Start/From: **11**
Clock To:
1st Value: **4.000**
2nd Value:
Value Percent:
Continuous Index:
Within 8" of Joint: **YES**
Remarks: **roots**

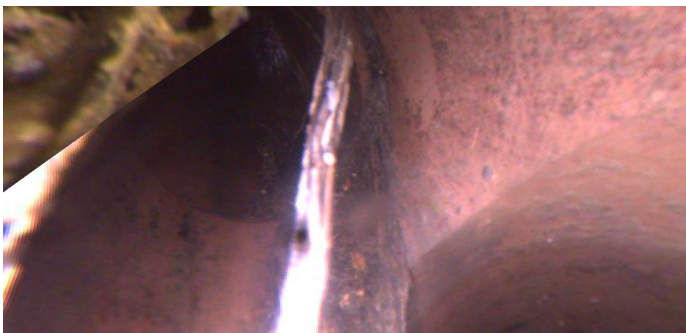
Code: **RML**
Description: **Roots Medium Lateral**

Distance (ft): **50.6**
Structural Grade: **0**
O&M Grade: **3**
Clock Start/From: **7**
Clock To: **5**
1st Value:
2nd Value:
Value Percent: **10.000**
Continuous Index:
Within 8" of Joint: **NO**
Remarks:

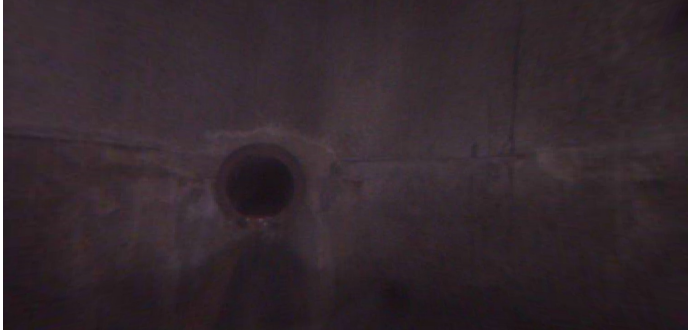
Code:	AMH
Description:	Manhole
Distance (ft):	76.0
Structural Grade:	0
O&M Grade:	0
Clock Start/From:	
Clock To:	
1st Value:	
2nd Value:	
Value Percent:	
Continuous Index:	
Within 8" of Joint:	NO
Remarks:	M-209-027
