## Profile/Photo Observation Report

Date:	<b>03/22/2018</b>	Weather:		Coding:	<b>PACP 6.0</b>
Pipe Length (ft):	<b>347.0</b>	Owner:	<b>NA</b>	Pre Clean:	<b>No Pre-Cleaning</b>
P.O.#:		Surveyor:	<b>Selasie Honu</b>	PSR:	<b>P-209-028-029</b>
Customer:		Clean Date:	<b>01/01/1900</b>	Shape:	<b>C</b>

Street:	<b>COLORADO ST</b>	Flow Control:	<b>Not Controlled</b>
City:	<b>Hobart, IN</b>	Year Renewed:	
Location:	<b>Light Highway</b>	Tape/Media #:	
Purpose:	<b>Routine Assessment</b>	Dia/Height:	<b>10"</b>
Use:	<b>Sanitary</b>	Material:	<b>PVC</b>
Drain Area:	<b>NA</b>	Lining:	
Category:	<b>NA</b>		
Comment:	<b>P_C at 328 ft nothing visible . Flow direction wrong</b>		
Location Details:		Direction of Survey:	<b>Upstream</b>
US MH:	<b>M-209-029</b>	DS MH:	<b>M-209-028</b>
		Total Length Surveyed (ft):	<b>329.6</b>

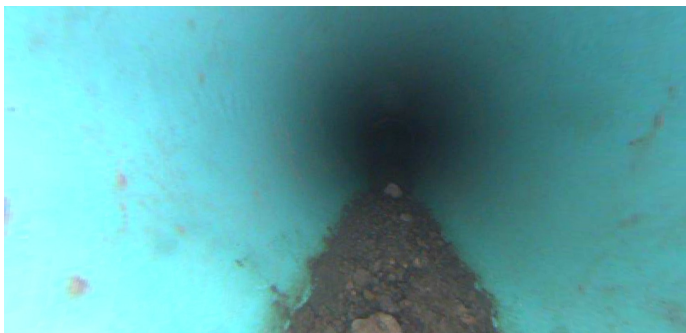
Code: **AMH**  
Description: **Manhole**

Distance (ft): **.0**  
Structural Grade: **0**  
O&M Grade: **0**  
Clock Start/From:  
Clock To:  
1st Value:  
2nd Value:  
Value Percent:  
Continuous Index:  
Within 8" of Joint: **NO**  
Remarks: **M-209-028**

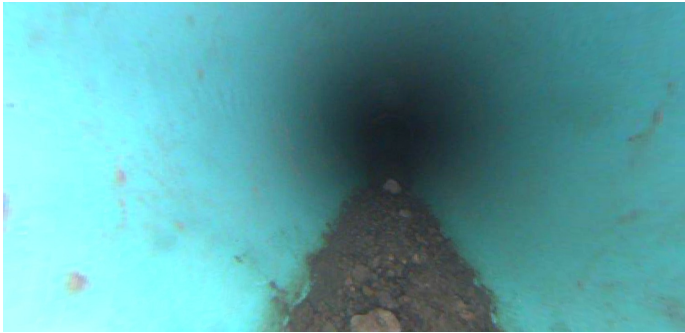
Code:	<b>MWL</b>
Description:	<b>Water Level</b>

Distance (ft):	<b>.0</b>
Structural Grade:	<b>0</b>
O&M Grade:	<b>0</b>
Clock Start/From:	
Clock To:	
1st Value:	
2nd Value:	
Value Percent:	<b>5.000</b>
Continuous Index:	
Within 8" of Joint:	<b>NO</b>
Remarks:

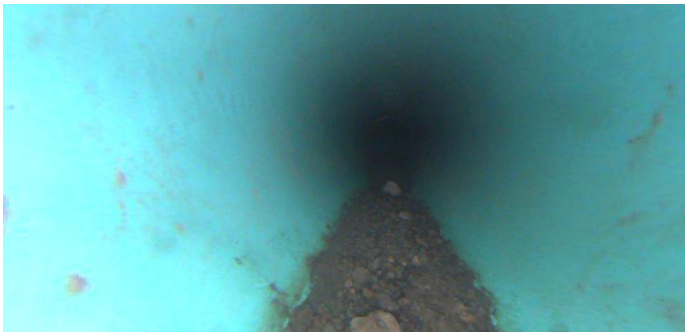
Code:	<b>DSGV</b>
Description:	<b>Deposits Settled Gravel</b>

Distance (ft):	<b>.0</b>
Structural Grade:	<b>0</b>
O&M Grade:	<b>2</b>
Clock Start/From:	<b>5</b>
Clock To:	<b>7</b>
1st Value:	
2nd Value:	
Value Percent:	<b>10.000</b>
Continuous Index:	<b>S01</b>
Within 8" of Joint:	<b>NO</b>
Remarks:

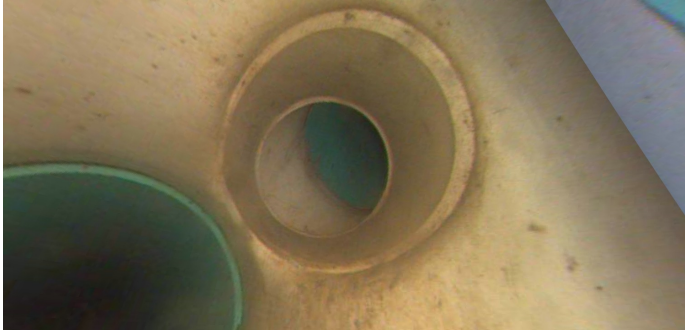
Code: **TF**  
Description: **Tap Factory**

Distance (ft): **6.8**  
Structural Grade: **0**  
O&M Grade: **0**  
Clock Start/From: **10**  
Clock To:  
1st Value: **4.000**  
2nd Value:  
Value Percent:  
Continuous Index:  
Within 8" of Joint:  
Remarks:

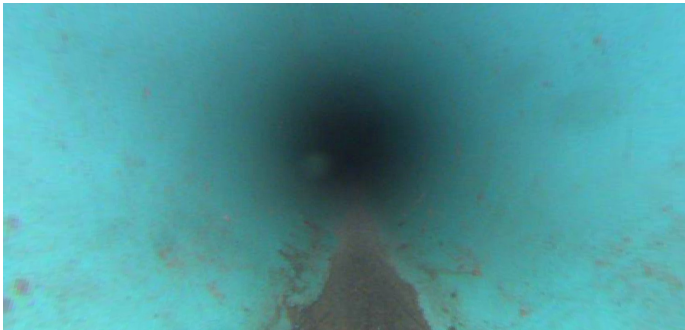
Code: **DSGV**  
Description: **Deposits Settled Gravel**

Distance (ft): **9.4**  
Structural Grade: **0**  
O&M Grade: **2**  
Clock Start/From: **5**  
Clock To: **7**  
1st Value:  
2nd Value:  
Value Percent: **10.000**  
Continuous Index: **F01**  
Within 8" of Joint: **NO**  
Remarks:

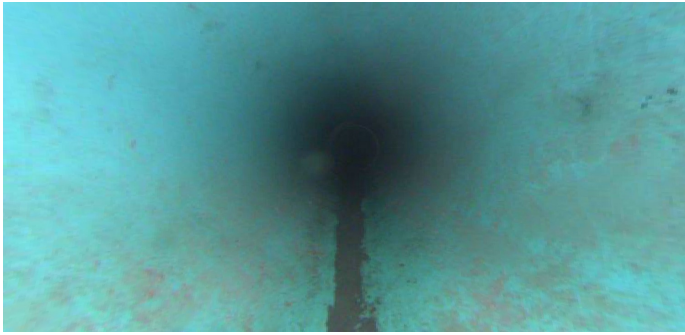
Code: **DNF**  
Description: **Deposits Ingressed Fine**

Distance (ft): **44.5**  
Structural Grade: **0**  
O&M Grade: **2**  
Clock Start/From: **5**  
Clock To: **7**  
1st Value:  
2nd Value:  
Value Percent: **5.000**  
Continuous Index: **S02**  
Within 8" of Joint:  
Remarks:

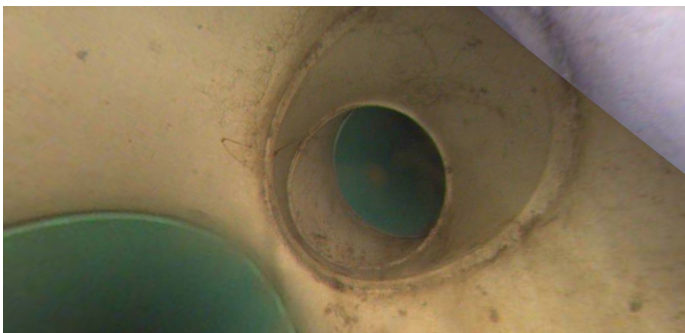
Code: **TF**  
Description: **Tap Factory**

Distance (ft): **49.3**  
Structural Grade: **0**  
O&M Grade: **0**  
Clock Start/From: **10**  
Clock To:  
1st Value: **4.000**  
2nd Value:  
Value Percent:  
Continuous Index:  
Within 8" of Joint:  
Remarks:

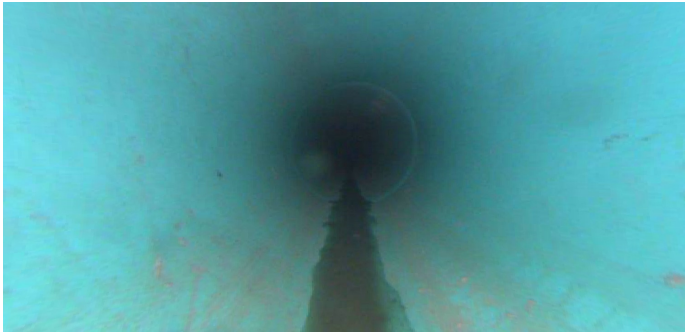
Code: **DNF**  
Description: **Deposits Ingressed Fine**

Distance (ft): **75.5**  
Structural Grade: **0**  
O&M Grade: **2**  
Clock Start/From: **5**  
Clock To: **7**  
1st Value:  
2nd Value:  
Value Percent: **5.000**  
Continuous Index: **F02**  
Within 8" of Joint:  
Remarks:

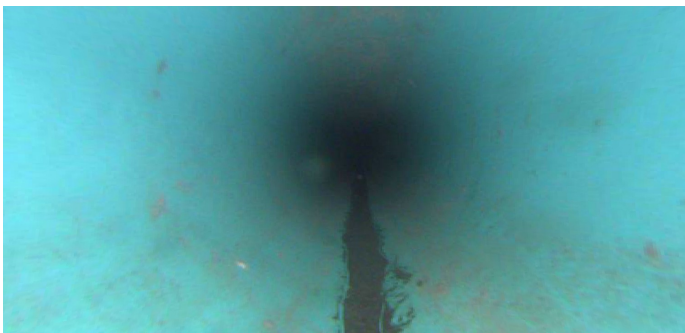
Code: **DNF**  
Description: **Deposits Ingressed Fine**

Distance (ft): **91.4**  
Structural Grade: **0**  
O&M Grade: **2**  
Clock Start/From: **6**  
Clock To:  
1st Value:  
2nd Value:  
Value Percent: **5.000**  
Continuous Index: **S03**  
Within 8" of Joint: **NO**  
Remarks:

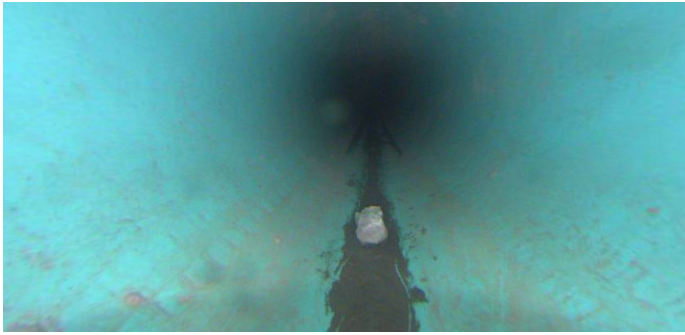
Code: **OBR**  
Description: **Obstacle Rocks**

Distance (ft): **94.3**  
Structural Grade: **0**  
O&M Grade: **2**  
Clock Start/From: **6**  
Clock To:  
1st Value:  
2nd Value:  
Value Percent: **5.000**  
Continuous Index:  
Within 8" of Joint: **NO**  
Remarks:

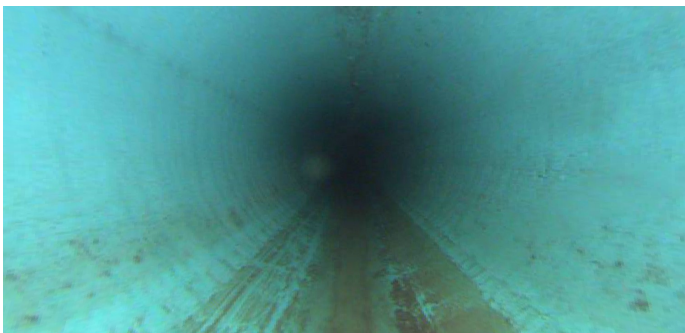
Code: **DNF**  
Description: **Deposits Ingressed Fine**

Distance (ft): **213.2**  
Structural Grade: **0**  
O&M Grade: **2**  
Clock Start/From: **6**  
Clock To:  
1st Value:  
2nd Value:  
Value Percent: **5.000**  
Continuous Index: **F03**  
Within 8" of Joint: **NO**  
Remarks:

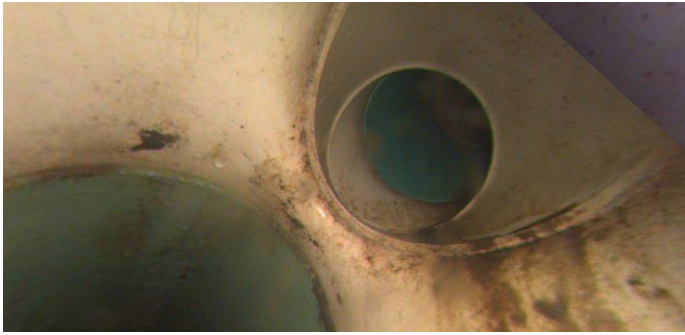
Code: **TF**  
Description: **Tap Factory**

Distance (ft): **314.2**  
Structural Grade: **0**  
O&M Grade: **0**  
Clock Start/From: **10**  
Clock To:  
1st Value: **4.000**  
2nd Value:  
Value Percent:  
Continuous Index:  
Within 8" of Joint:  
Remarks:

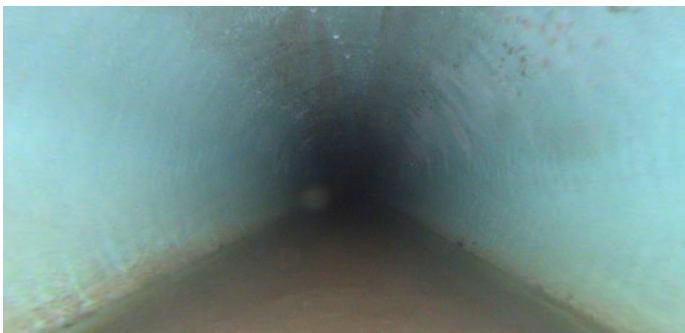
Code: **MWL**  
Description: **Water Level**

Distance (ft): **322.9**  
Structural Grade: **0**  
O&M Grade: **0**  
Clock Start/From:  
Clock To:  
1st Value:  
2nd Value:  
Value Percent: **20.000**  
Continuous Index:  
Within 8" of Joint: **NO**  
Remarks:

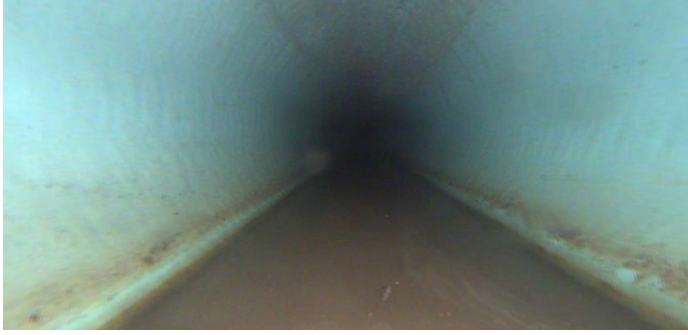
Code:	<b>AMH</b>
Description:	<b>Manhole</b>
Distance (ft):	<b>329.6</b>
Structural Grade:	<b>0</b>
O&M Grade:	<b>0</b>
Clock Start/From:	
Clock To:	
1st Value:	
2nd Value:	
Value Percent:	
Continuous Index:	
Within 8" of Joint:	<b>NO</b>
Remarks:	<b>M-209-029</b>
