Profile/Photo Observation Report

| Profile/Photo Observation Report | | | | | | | | |
|---|--|--|---|---|---|---|--|--|
| Street: | Old Ridge Road | | Flow Control: | | Not Controlled | | | |
| US MH: | M-303-001 | DS MH: | M-304-003 | ٦ | Total Length Surveyed (ft): | 356.1 | | |

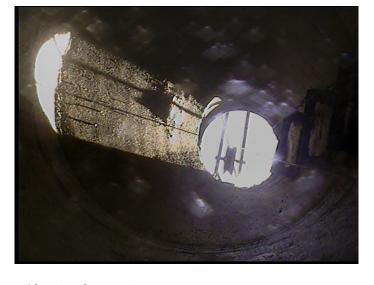
| Code: Description: | AMH Manhole |
| Distance (ft): | .0 |

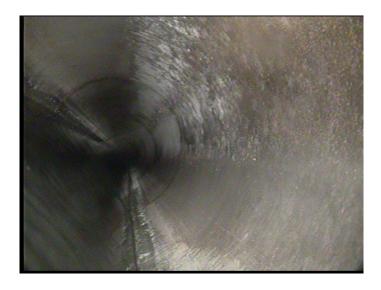
Code: MWL

Description: **Water Level**

Distance (ft): .0 Structural Grade: 0 O&M Grade: 0

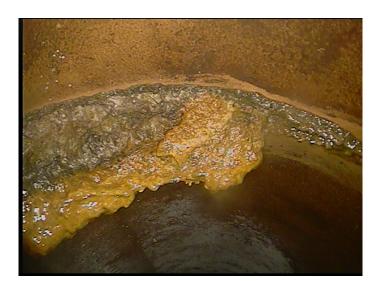
Code: DAE

Description: **Deposits Attached Encrustation**

Distance (ft): 125.6 Structural Grade: 0 O&M Grade: 2 Clock Start/From: 7 Clock To: 11 1st Value:

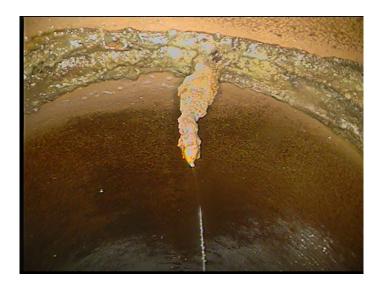
Code: IR

Description: **Infil Runner**

Distance (ft): 181.4 Structural Grade: 0 O&M Grade: 4 Clock Start/From: 12

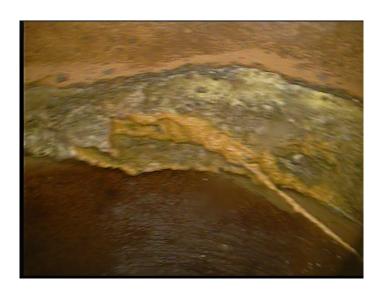
Code: DAE

Description: **Deposits Attached Encrustation**

Distance (ft): 191.6 Structural Grade: 0 O&M Grade: 2 Clock Start/From: 1 5 Clock To: 1st Value:

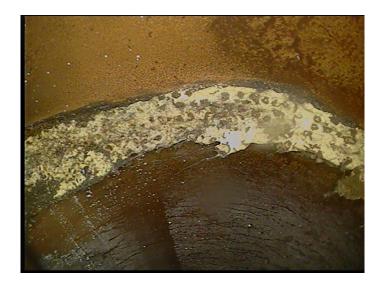
Code: DAE

Description: **Deposits Attached Encrustation**

Distance (ft): 201.4 Structural Grade: 0 2 O&M Grade: Clock Start/From: 7 Clock To: 11

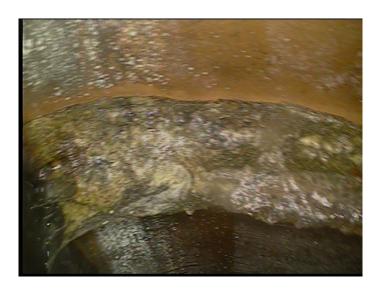
Code: DAE

Description: **Deposits Attached Encrustation**

Distance (ft): 206.5 Structural Grade: 0 O&M Grade: 2 Clock Start/From: 7 Clock To: 11 1st Value:

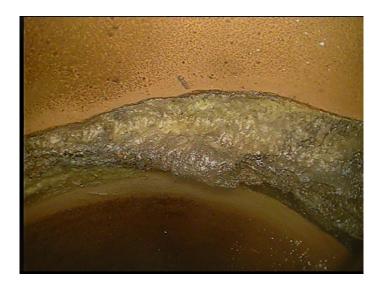
Code: DAE

Description: Deposits Attached Encrustation

Distance (ft): 221.6
Structural Grade: 0
O&M Grade: 2
Clock Start/From: 7
Clock To: 5

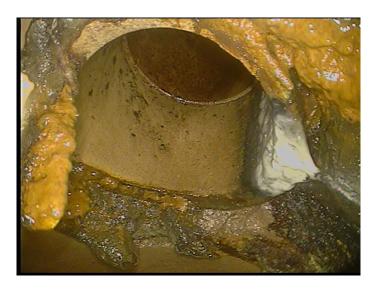
Code: TBA

Description: Tap Break-in Active

Distance (ft): 258.1
Structural Grade: 0
O&M Grade: 0
Clock Start/From: 2

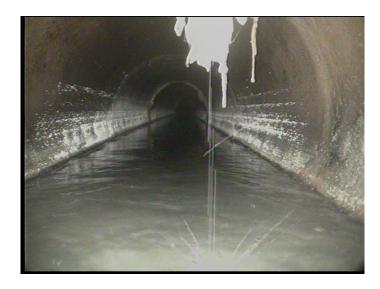
Code: DAE

Description: Deposits Attached Encrustation

Distance (ft): 258.1
Structural Grade: 0
O&M Grade: 2
Clock Start/From: 7
Clock To: 5

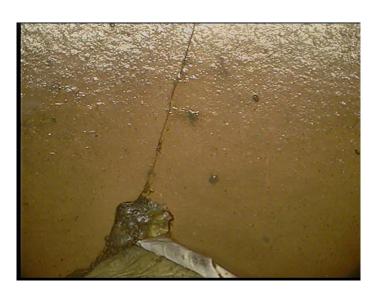
Code: CL

Description: Crack Longitudinal

Distance (ft): 259.2
Structural Grade: 2
O&M Grade: 0
Clock Start/From: 12

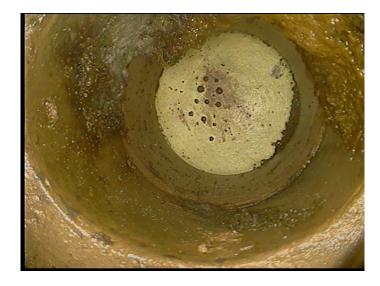
Code: TFC

Description: **Tap Factory Capped**

Distance (ft): 268.9 Structural Grade: 0 O&M Grade: 0 Clock Start/From: 2

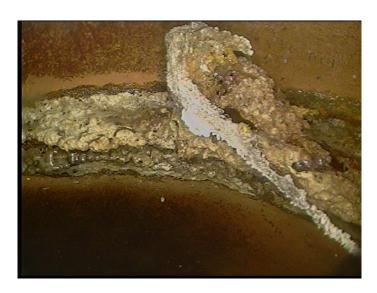
Code: DAE

Description: **Deposits Attached Encrustation**

Distance (ft): 285.6 Structural Grade: 0 O&M Grade: 2 Clock Start/From: 7 5 Clock To: 1st Value:

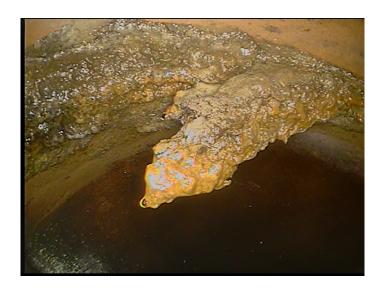
Code: ID

Description: **Infil Dripper**

Distance (ft): 335.7 Structural Grade: 0 3 O&M Grade: Clock Start/From: 11

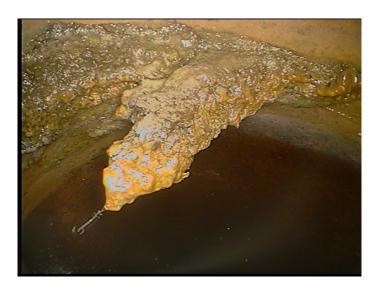
Code: DAE

Description: **Deposits Attached Encrustation**

Distance (ft): 335.7 Structural Grade: 0 O&M Grade: 2 Clock Start/From: 7 5 Clock To: 1st Value:

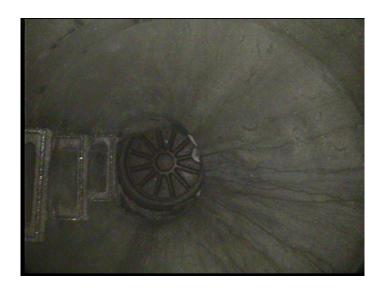
Code: AMH
Description: Manhole

Distance (ft): 356.1
Structural Grade: 0
O&M Grade: 0
