Profile/Photo Observation Report

Profile/Photo Observation Report							
Date: Pipe Length (ft) P.O.#: Customer:	04/07/2018): 12-1 City of Hobart	Weather: Owner: Surveyor: Clean Date:	City of Hoba M. Pielacha	rt	Coding: Pre Clean: PSR: Shape:	PACP 6.0 No Pre-Cleaning M-303-002-M-303-001 C	
Street:	West Old Ridge Road		Flow Control:		Not Controlled		
City:	Hobart, IN		Year Renewed	:			
Location:	Other		Tape/Media#	:	DEP 12		
Purpose:	Routine Assessment		Dia/Height:		18"		
Use:	Sanitary		Material:		VCP		
Drain Area:			Lining:				
Category:	NA						
Comment:							
Location Detail	s:		Direction of Su	ırvey:	Upstream		
US MH:	M-303-002	DS MH:	M-303-001	Total	Length Surveyed (ft):	164.3	
O&M Index:	2.24	O&M Quick:	34	42A	O&M Rating:	38.00	
Structural Index:	0.00	— Structural Qu	ick:	000	Structural Rating:	0.00	
Overall Index:	2.24	— Overall Quick	: 34	42A	Overall Rating:	38.00

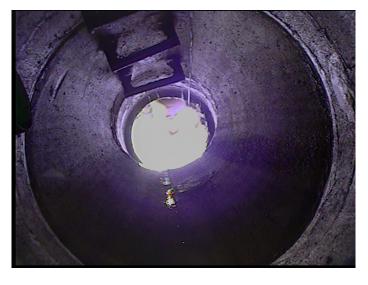
Code:	АМН
Description:	Manhole
Distance (ft):	.0
Structural Grade:	0
O&M Grade:	0
Clock Start/From:	
Clock To:	
1st Value:	
2nd Value:	
Value Percent:	
Continuous Index:	
Within 8" of Joint:	NO
Remarks:	M-303-001

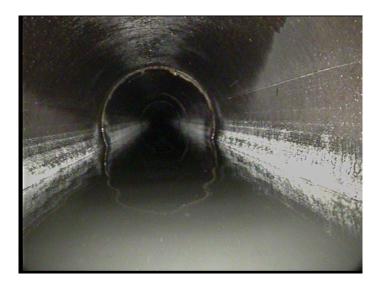
Code: MWL

Description: Water Level

Distance (ft): .0
Structural Grade: 0
O&M Grade: 0

Value Percent: 15.000

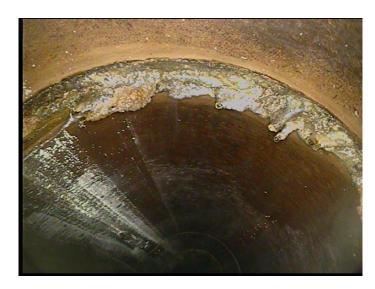
Code: DAE

Description: Deposits Attached Encrustation

Distance (ft): 23.1
Structural Grade: 0

O&M Grade: 2

Clock Start/From: 10

Clock To: 2

Value Percent: 5.000

Within 8" of Joint: YES

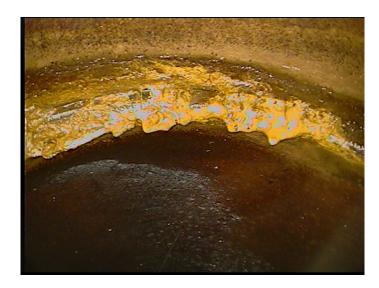
Code: **ID**

Description: Infil Dripper

Distance (ft): 33.9
Structural Grade: 0

O&M Grade: 3

Clock Start/From: 11

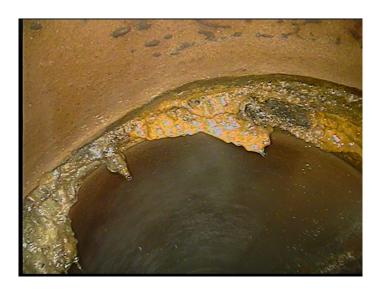
Code: ID

Description: Infil Dripper

Distance (ft): 84.9
Structural Grade: 0
O&M Grade: 3
Clock Start/From: 12
Clock To: 1
1st Value:
2nd Value:

Within 8" of Joint: YES

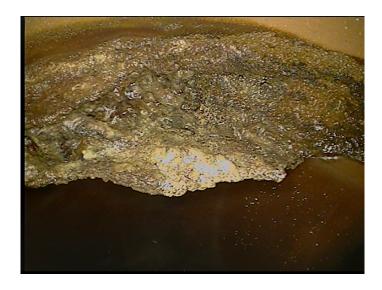
Code: DAE

Description: Deposits Attached Encrustation

Distance (ft): 104.5
Structural Grade: 0
O&M Grade: 2
Clock Start/From: 7
Clock To: 5

Value Percent: 10.000
Continuous Index: S01
Within 8" of Joint: YES

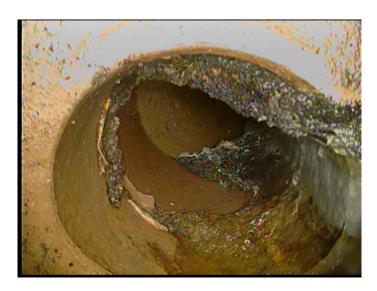
Code: **TF**

Description: Tap Factory

Distance (ft): 122.4
Structural Grade: 0
O&M Grade: 0
Clock Start/From: 2

1st Value: **4.000**

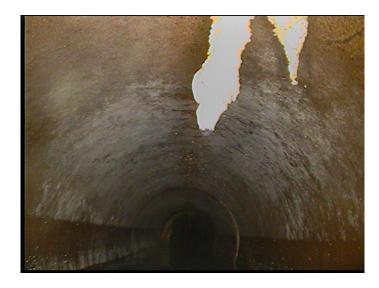
Code: ID

Description: **Infil Dripper**

Distance (ft): 137.9 Structural Grade: 0 3 O&M Grade: Clock Start/From: 12

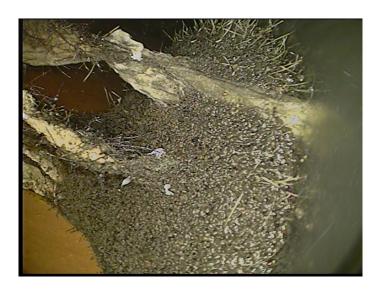
RMJ Code:

Description: **Roots Medium Joint**

Distance (ft): 163.1 Structural Grade: 0 O&M Grade: 3 Clock Start/From: 4 8 Clock To: 1st Value:

20.000

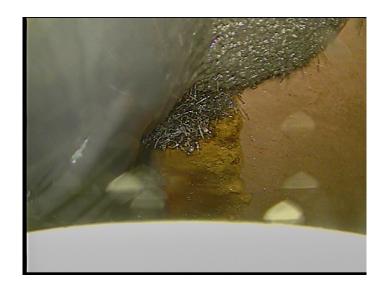
Code: DAE

Description: Deposits Attached Encrustation

Distance (ft): 164.3
Structural Grade: 0
O&M Grade: 2
Clock Start/From: 7
Clock To: 5

Value Percent: 10.000
Continuous Index: F01
Within 8" of Joint: NO

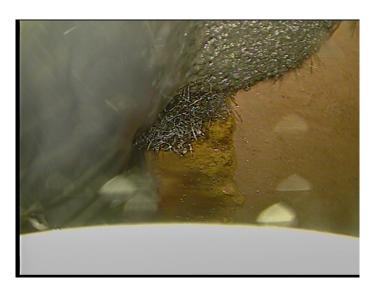
Code: MSA

Description: Abandoned Survey

Distance (ft): 164.3
Structural Grade: 0
O&M Grade: 0

Within 8" of Joint: NO Remarks: roots
