Profile/Photo Observation Report

Date:	04/07/2018	Weather:		Coding:	PACP 6.0
Pipe Length (ft):		Owner:	City of Hobart	Pre Clean:	No Pre-Cleaning
P.O.#:	12-1	Surveyor:	M. Pielacha	PSR:	M-303-002-M-303-001
Customer:	City of Hobart	Clean Date:		Shape:	C

Street:	West Old Ridge Road	Flow Control:	Not Controlled
City:	Hobart, IN	Year Renewed:	
Location:	Other	Tape/Media #:	DEP 12
Purpose:	Routine Assessment	Dia/Height:	18"
Use:	Sanitary	Material:	VCP
Drain Area:		Lining:	
Category:	NA		
Comment:			
Location Details:		Direction of Survey:	Upstream
US MH:	M-303-002	DS MH:	M-303-001
		Total Length Surveyed (ft):	164.3

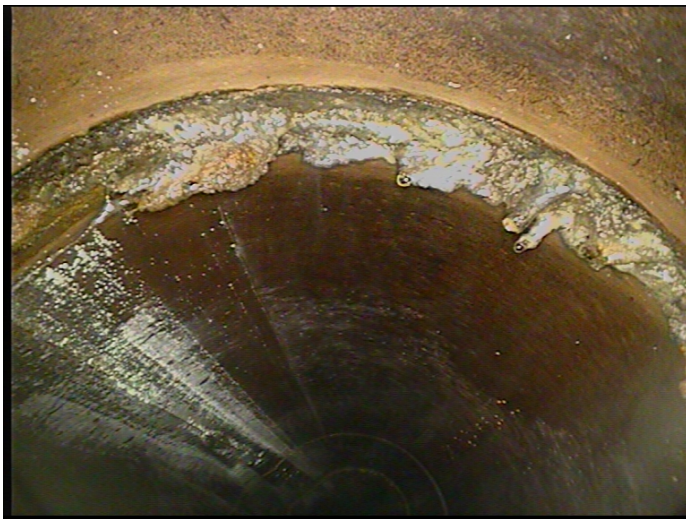
Code: **DAE**
Description: **Deposits Attached Encrustation**

Distance (ft): **23.1**
Structural Grade: **0**
O&M Grade: **2**
Clock Start/From: **10**
Clock To: **2**
1st Value:
2nd Value:
Value Percent: **5.000**
Continuous Index:
Within 8" of Joint: **YES**
Remarks:

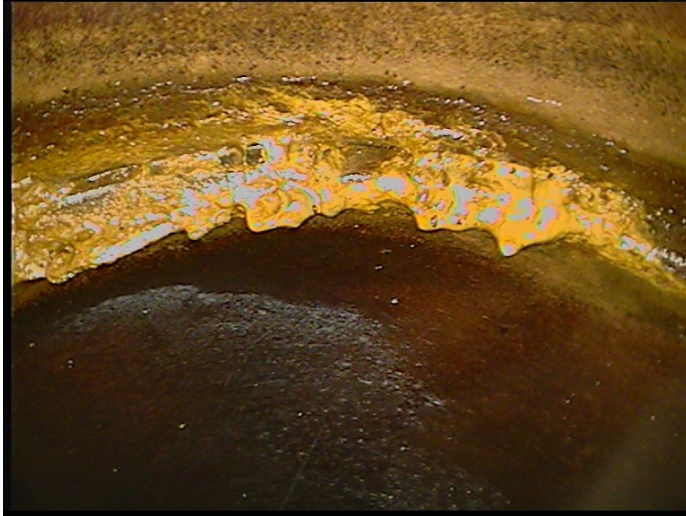
Code: **ID**
Description: **Infil Dripper**

Distance (ft): **33.9**
Structural Grade: **0**
O&M Grade: **3**
Clock Start/From: **11**
Clock To:
1st Value:
2nd Value:
Value Percent:
Continuous Index:
Within 8" of Joint: **YES**
Remarks:

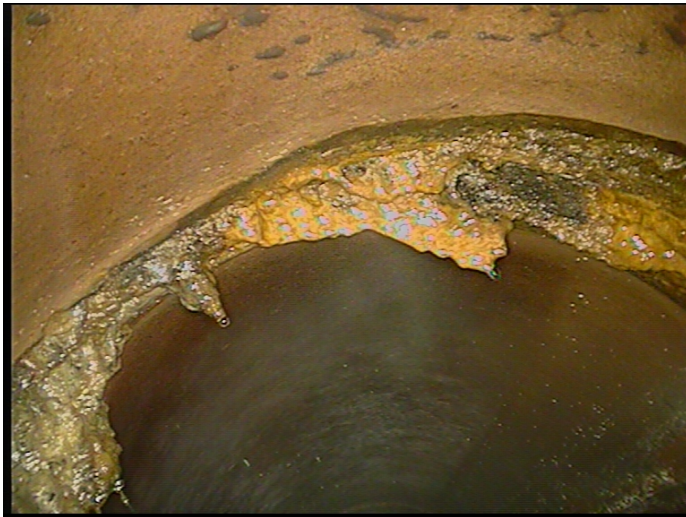
Code: **ID**
Description: **Infil Dripper**

Distance (ft): **84.9**
Structural Grade: **0**
O&M Grade: **3**
Clock Start/From: **12**
Clock To: **1**
1st Value:
2nd Value:
Value Percent:
Continuous Index:
Within 8" of Joint: **YES**
Remarks:

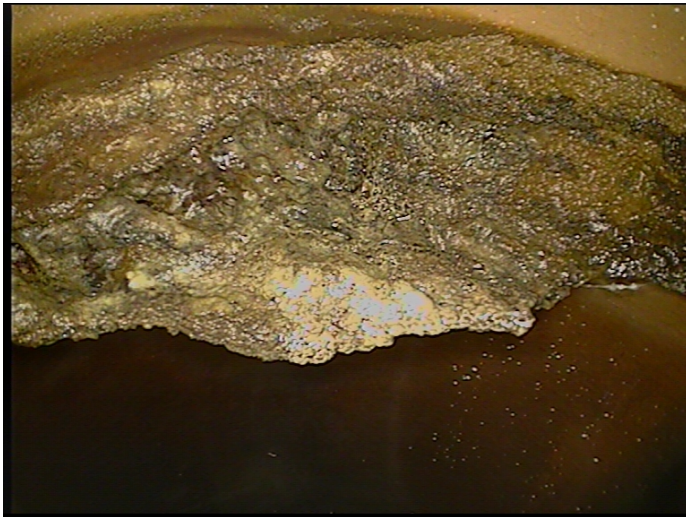
Code:	DAE
Description:	Deposits Attached Encrustation
Distance (ft):	104.5
Structural Grade:	0
O&M Grade:	2
Clock Start/From:	7
Clock To:	5
1st Value:	
2nd Value:	
Value Percent:	10.000
Continuous Index:	S01
Within 8" of Joint:	YES
Remarks:

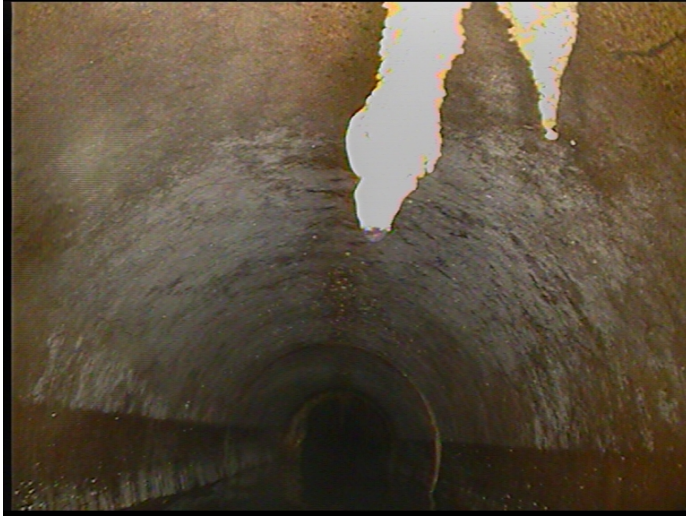
Code: **ID**
Description: **Infil Dripper**

Distance (ft): **137.9**
Structural Grade: **0**
O&M Grade: **3**
Clock Start/From: **12**
Clock To:
1st Value:
2nd Value:
Value Percent:
Continuous Index:
Within 8" of Joint: **YES**
Remarks:

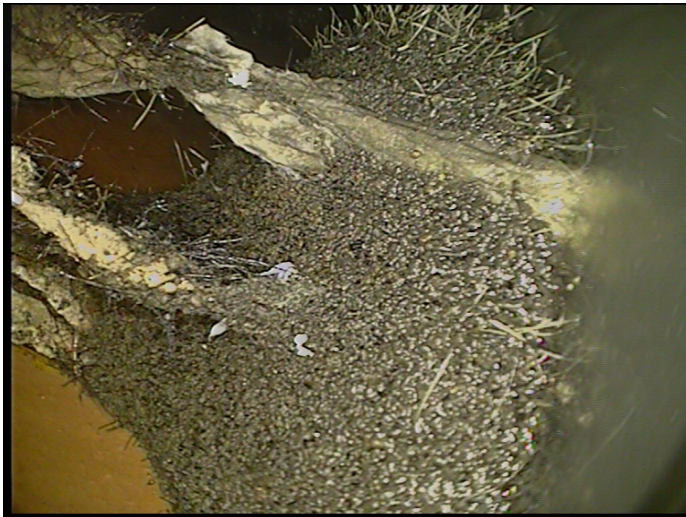
Code: **RMJ**
Description: **Roots Medium Joint**

Distance (ft): **163.1**
Structural Grade: **0**
O&M Grade: **3**
Clock Start/From: **4**
Clock To: **8**
1st Value:
2nd Value:
Value Percent: **20.000**
Continuous Index:
Within 8" of Joint: **YES**
Remarks:

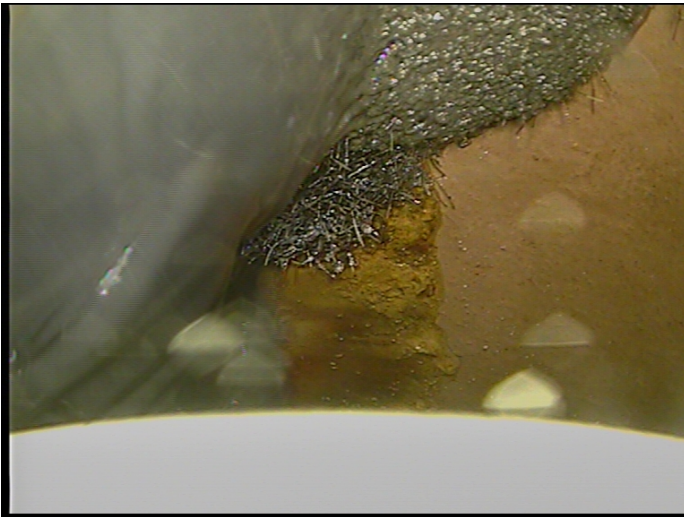
Code: **DAE**
Description: **Deposits Attached Encrustation**

Distance (ft): **164.3**
Structural Grade: **0**
O&M Grade: **2**
Clock Start/From: **7**
Clock To: **5**
1st Value:
2nd Value:
Value Percent: **10.000**
Continuous Index: **F01**
Within 8" of Joint: **NO**
Remarks:

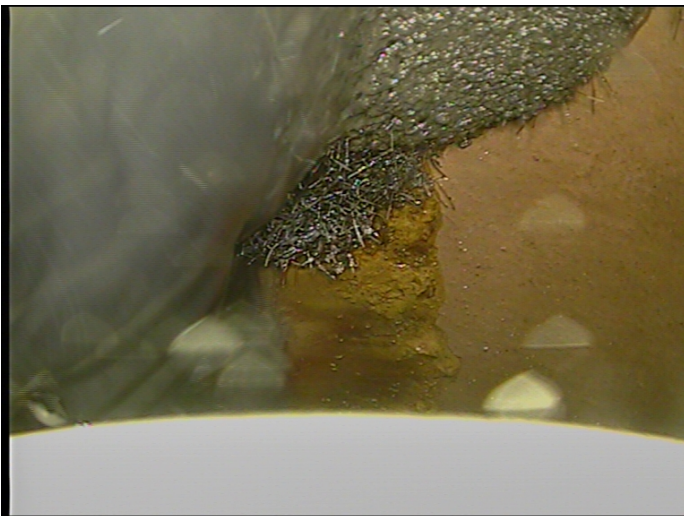
Code: **MSA**
Description: **Abandoned Survey**

Distance (ft): **164.3**
Structural Grade: **0**
O&M Grade: **0**
Clock Start/From:
Clock To:
1st Value:
2nd Value:
Value Percent:
Continuous Index:
Within 8" of Joint: **NO**
Remarks: **roots**
