## Profile/Photo Observation Report

Date:	<b>01/25/2025</b>	Weather:		Coding:	<b>PACP 7.0</b>
Pipe Length (ft):	<b>268.0</b>	Owner:	<b>City of Hobart</b>	Pre Clean:	<b>Heavy Cleaning</b>
P.O.#:	<b>YES502259</b>	Surveyor:	<b>S. Bucklin</b>	PSR:	<b>P-303-003-002</b>
Customer:	<b>City of Hobart</b>	Clean Date:	<b>10/18/2024</b>	Shape:	<b>C</b>

Street:	<b>West Old Ridge Road</b>	Flow Control:	<b>Not Controlled</b>
City:	<b>Hobart, IN</b>	Year Renewed:	
Location:	<b>Easement/Right of Way</b>	Tape/Media #:	
Purpose:	<b>Sewer System Evaluation Survey (SS</b>	Dia/Height:	<b>18"</b>
Use:	<b>Sanitary Sewage Pipe</b>	Material:	<b>VCP</b>
Drain Area:		Lining:	<b>None</b>
Category:	<b>NA</b>		
Comment:			
Location Details:		Direction of Survey:	<b>Downstream</b>
US MH:	<b>M-303-003</b>	DS MH:	<b>M-303-002</b>
		Total Length Surveyed (ft):	<b>245.1</b>

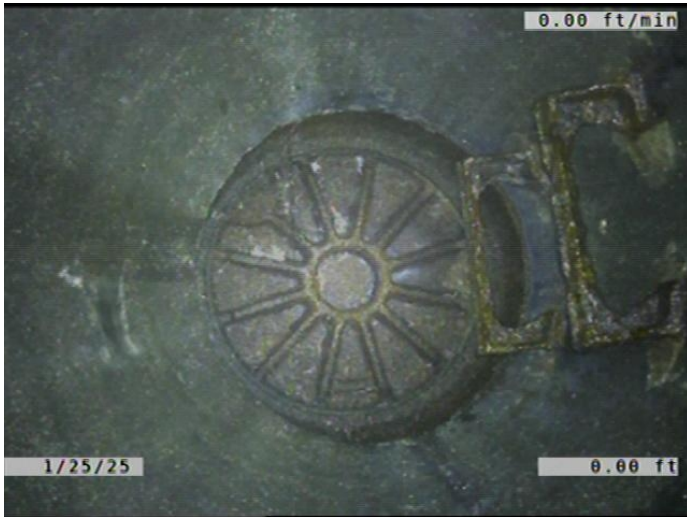
Code: **AMH**  
Description: **Manhole**

Distance (ft): **.0**  
Structural Grade: **0**  
O&M Grade: **0**  
Clock Start/From:  
Clock To:  
1st Value:  
2nd Value:  
Value Percent:  
Continuous Index:  
Within 8" of Joint: **NO**  
Remarks: **M-303-003**

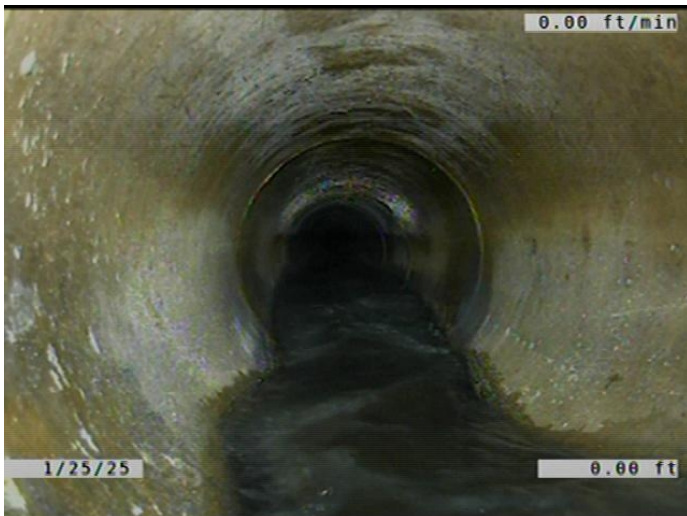
Code: **MWL**  
Description: **Miscellaneous Water Level**

Distance (ft): **.0**  
Structural Grade: **0**  
O&M Grade: **0**  
Clock Start/From:  
Clock To:  
1st Value:  
2nd Value:  
Value Percent: **10.000**  
Continuous Index:  
Within 8" of Joint: **NO**  
Remarks:

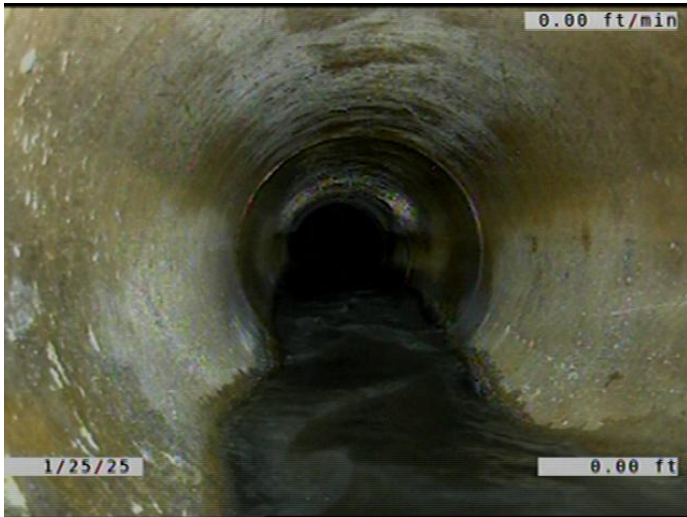
Code: **LD**  
Description: **Line Down**

Distance (ft): **.0**  
Structural Grade: **0**  
O&M Grade: **1**  
Clock Start/From:  
Clock To:  
1st Value:  
2nd Value:  
Value Percent: **10.000**  
Continuous Index:  
Within 8" of Joint: **NO**  
Remarks:

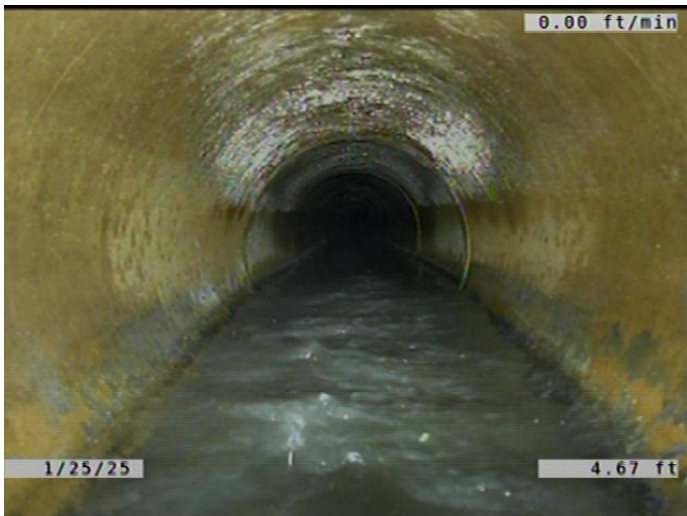
Code: **MWL**  
Description: **Miscellaneous Water Level**

Distance (ft): **4.7**  
Structural Grade: **0**  
O&M Grade: **0**  
Clock Start/From:  
Clock To:  
1st Value:  
2nd Value:  
Value Percent: **25.000**  
Continuous Index:  
Within 8" of Joint: **NO**  
Remarks:

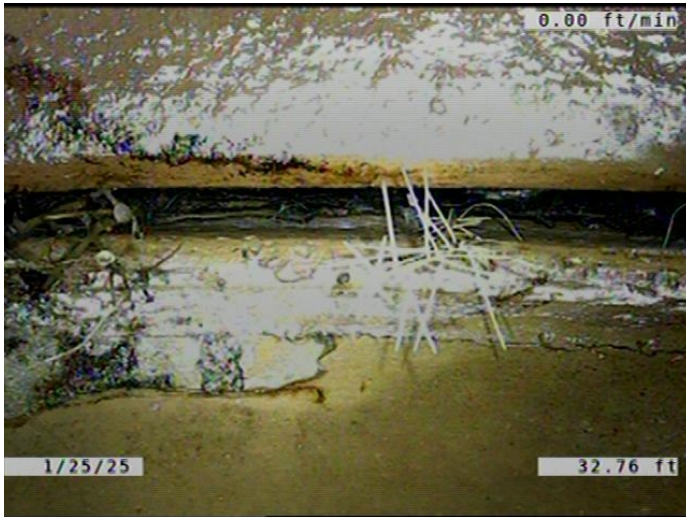
Code: **RFJ**  
 Description: **Roots Fine Joint**

Distance (ft): **32.8**  
 Structural Grade: **0**  
 O&M Grade: **1**  
 Clock Start/From: **8**  
 Clock To: **3**  
 1st Value:  
 2nd Value:  
 Value Percent:  
 Continuous Index:  
 Within 8" of Joint: **YES**  
 Remarks:

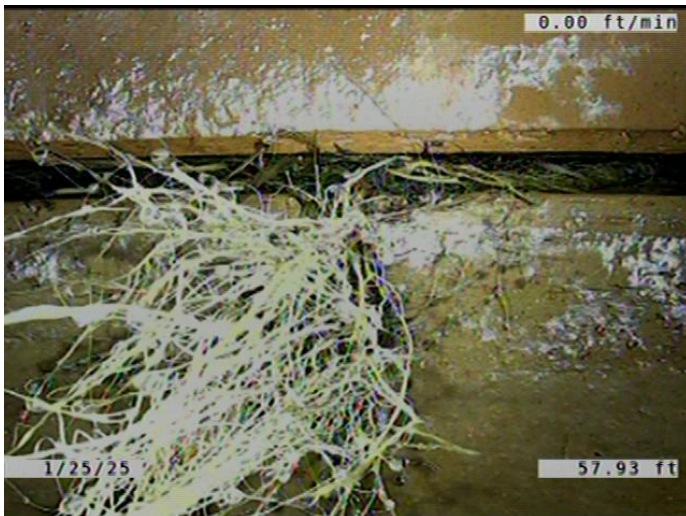
Code: **RMJ**  
 Description: **Roots Medium Joint**

Distance (ft): **57.9**  
 Structural Grade: **0**  
 O&M Grade: **3**  
 Clock Start/From: **10**  
 Clock To: **12**  
 1st Value:  
 2nd Value:  
 Value Percent: **5.000**  
 Continuous Index:  
 Within 8" of Joint: **YES**  
 Remarks:

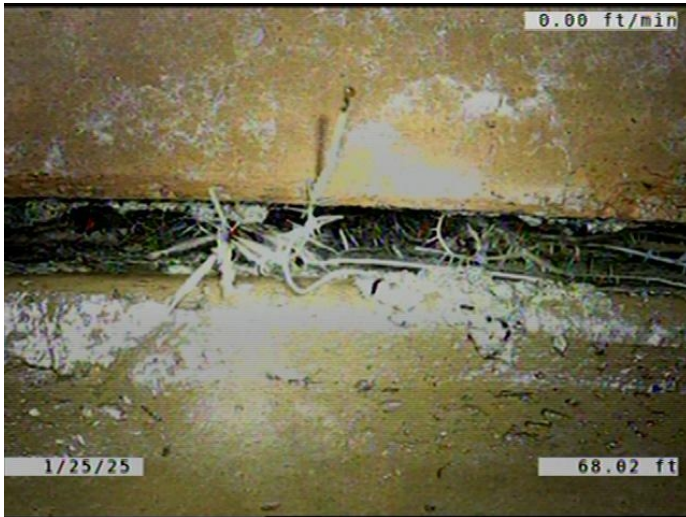
Code: **RFJ**  
 Description: **Roots Fine Joint**

Distance (ft): **68.0**  
 Structural Grade: **0**  
 O&M Grade: **1**  
 Clock Start/From: **10**  
 Clock To: **4**  
 1st Value:  
 2nd Value:  
 Value Percent:  
 Continuous Index: **S03**  
 Within 8" of Joint: **YES**  
 Remarks:

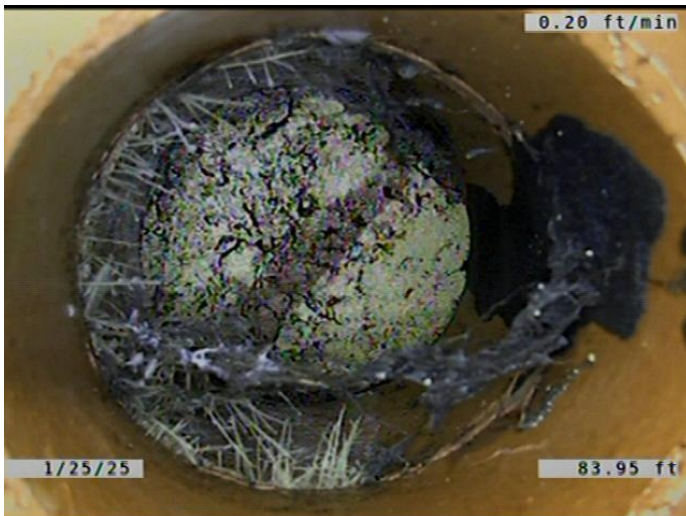
Code: **TFD**  
 Description: **Tap Factory Defective**

Distance (ft): **83.9**  
 Structural Grade: **0**  
 O&M Grade: **3**  
 Clock Start/From: **3**  
 Clock To:  
 1st Value: **6.000**  
 2nd Value:  
 Value Percent:  
 Continuous Index:  
 Within 8" of Joint: **YES**  
 Remarks: **CAPPED. ROOTS GROWING IN THE JOINT AND AROUND THE CAP.**

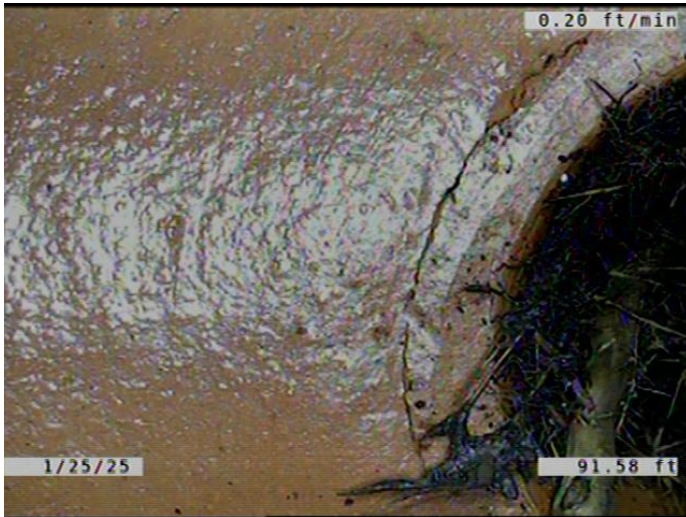
Code: **CS**  
 Description: **Crack Spiral**

Distance (ft): **91.6**  
 Structural Grade: **2**  
 O&M Grade: **0**  
 Clock Start/From: **9**  
 Clock To: **11**  
 1st Value:  
 2nd Value:  
 Value Percent:  
 Continuous Index:  
 Within 8" of Joint: **NO**  
 Remarks:

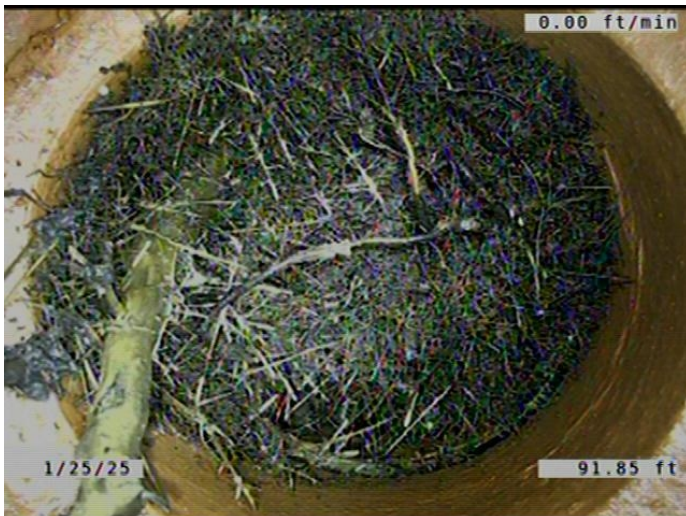
Code: **TFD**  
 Description: **Tap Factory Defective**

Distance (ft): **91.8**  
 Structural Grade: **0**  
 O&M Grade: **3**  
 Clock Start/From: **10**  
 Clock To:  
 1st Value: **6.000**  
 2nd Value:  
 Value Percent:  
 Continuous Index:  
 Within 8" of Joint: **YES**  
 Remarks: **95% PLUGGED WITH ROOTS. ROOTS GROWING FROM THE TAP INTO THE**

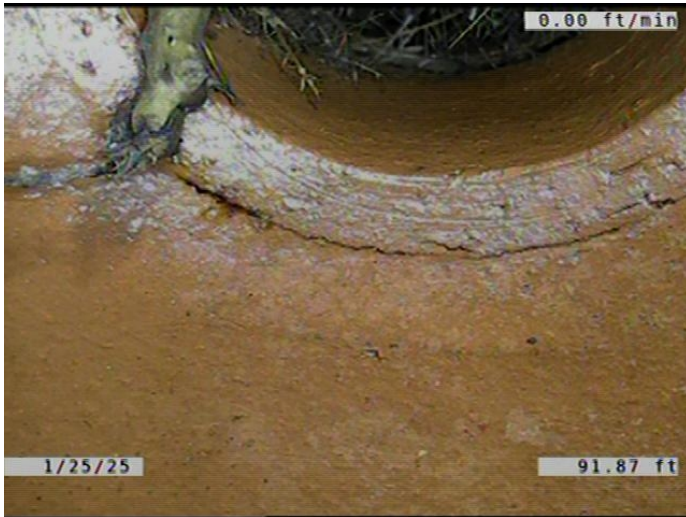
Code: **ISB**  
Description: **Infiltration Stain Barrel**

Distance (ft): **91.9**  
Structural Grade: **0**  
O&M Grade: **1**  
Clock Start/From: **9**  
Clock To: **10**  
1st Value:  
2nd Value:  
Value Percent:  
Continuous Index:  
Within 8" of Joint: **NO**  
Remarks:

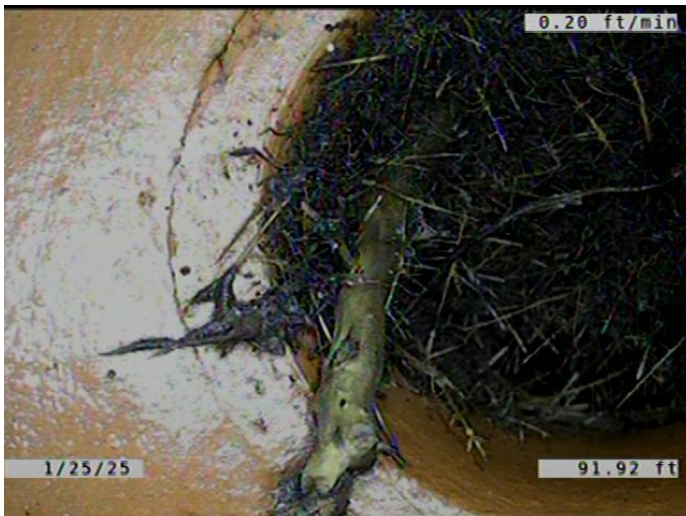
Code: **RTL**  
Description: **Roots Tap Lateral**

Distance (ft): **91.9**  
Structural Grade: **0**  
O&M Grade: **2**  
Clock Start/From: **9**  
Clock To: **10**  
1st Value:  
2nd Value:  
Value Percent: **5.000**  
Continuous Index:  
Within 8" of Joint: **NO**  
Remarks:

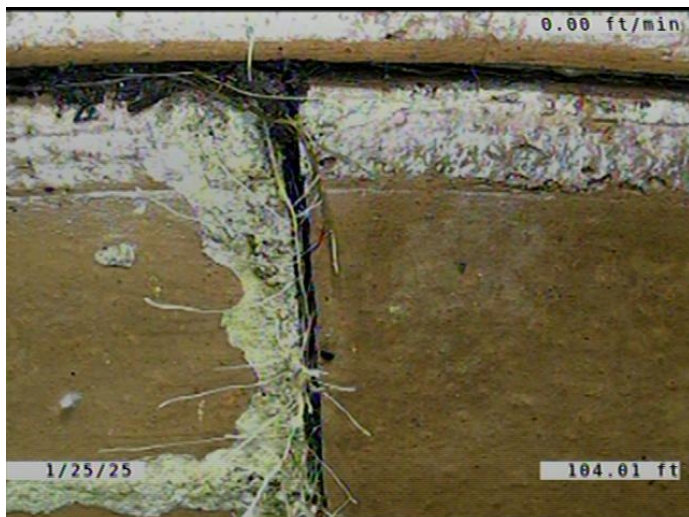
Code: **FM**  
 Description: **Fracture Multiple**

Distance (ft): **104.0**  
 Structural Grade: **4**  
 O&M Grade: **0**  
 Clock Start/From: **8**  
 Clock To: **4**  
 1st Value:  
 2nd Value:  
 Value Percent:  
 Continuous Index: **S01**  
 Within 8" of Joint: **YES**  
 Remarks:

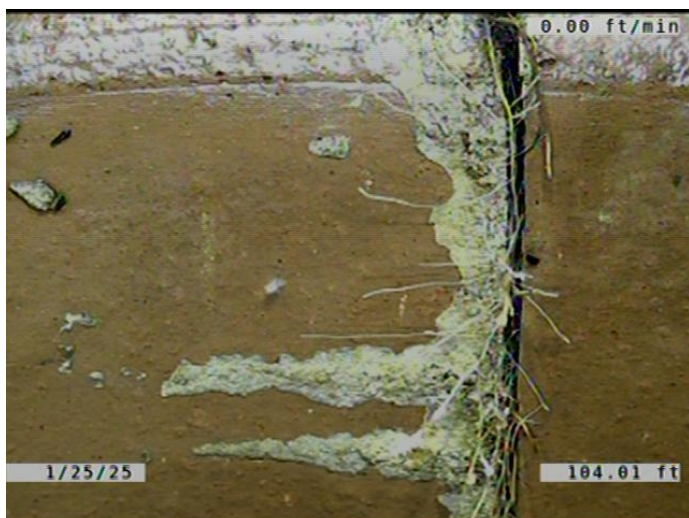
Code: **DAE**  
 Description: **Deposits Attached Encrustation**

Distance (ft): **104.0**  
 Structural Grade: **0**  
 O&M Grade: **2**  
 Clock Start/From: **10**  
 Clock To: **12**  
 1st Value:  
 2nd Value:  
 Value Percent: **5.000**  
 Continuous Index: **S02**  
 Within 8" of Joint: **YES**  
 Remarks:

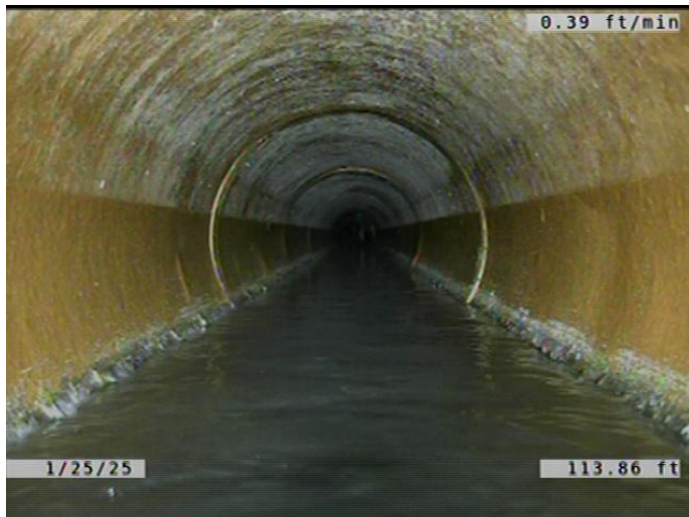
Code: **FM**  
 Description: **Fracture Multiple**

Distance (ft): **113.8**  
 Structural Grade: **4**  
 O&M Grade: **0**  
 Clock Start/From: **8**  
 Clock To: **4**  
 1st Value:  
 2nd Value:  
 Value Percent:  
 Continuous Index: **F01**  
 Within 8" of Joint: **YES**  
 Remarks:

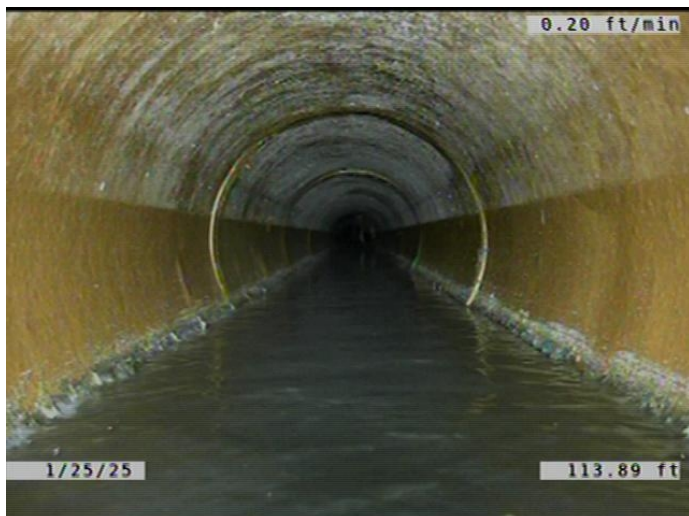
Code: **DAE**  
 Description: **Deposits Attached Encrustation**

Distance (ft): **113.9**  
 Structural Grade: **0**  
 O&M Grade: **2**  
 Clock Start/From: **10**  
 Clock To: **12**  
 1st Value:  
 2nd Value:  
 Value Percent: **5.000**  
 Continuous Index: **F02**  
 Within 8" of Joint: **YES**  
 Remarks:

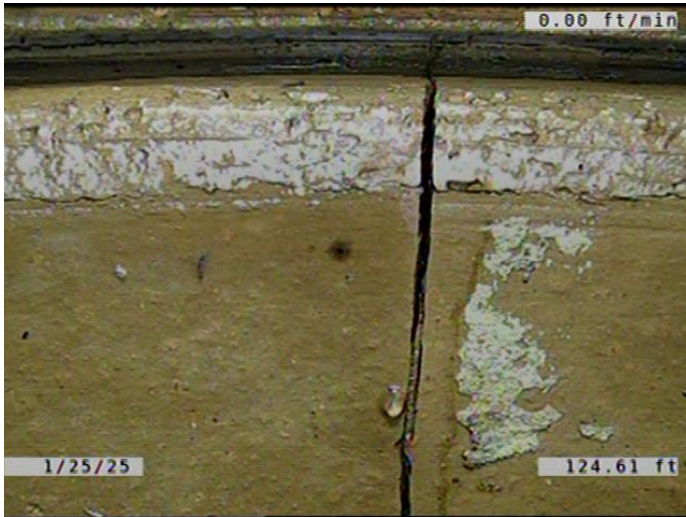
Code: **FS**  
 Description: **Fracture Spiral**

Distance (ft): **124.6**  
 Structural Grade: **3**  
 O&M Grade: **0**  
 Clock Start/From: **11**  
 Clock To: **12**  
 1st Value:  
 2nd Value:  
 Value Percent:  
 Continuous Index:  
 Within 8" of Joint: **YES**  
 Remarks:

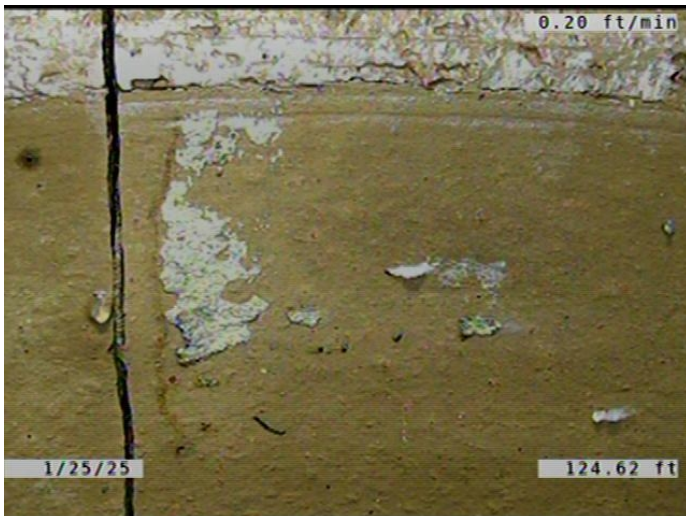
Code: **DAE**  
 Description: **Deposits Attached Encrustation**

Distance (ft): **124.6**  
 Structural Grade: **0**  
 O&M Grade: **2**  
 Clock Start/From: **12**  
 Clock To: **1**  
 1st Value:  
 2nd Value:  
 Value Percent: **5.000**  
 Continuous Index:  
 Within 8" of Joint: **YES**  
 Remarks:

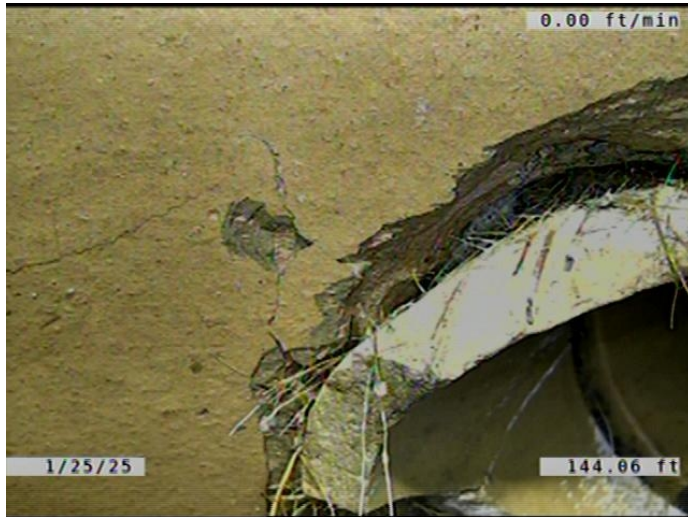
Code: **B**  
Description: **Broken**

Distance (ft): **144.0**  
Structural Grade: **4**  
O&M Grade: **0**  
Clock Start/From: **9**  
Clock To: **3**  
1st Value:  
2nd Value:  
Value Percent:  
Continuous Index: **S04**  
Within 8" of Joint: **YES**  
Remarks:

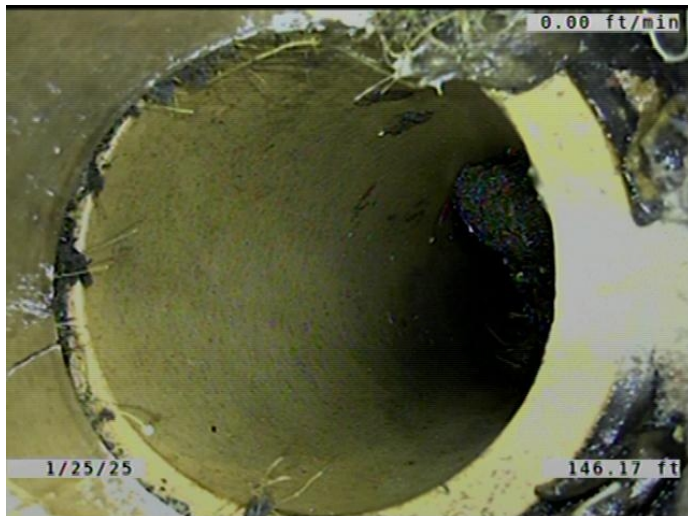
Code: **TBI**  
Description: **Tap Break-in Intruding**

Distance (ft): **146.2**  
Structural Grade: **0**  
O&M Grade: **2**  
Clock Start/From: **1**  
Clock To:  
1st Value: **6.000**  
2nd Value: **1.000**  
Value Percent:  
Continuous Index:  
Within 8" of Joint: **YES**  
Remarks: **ACTIVITY. DEFECTIVE. ROOTS GROWING IN THE SERVICE AND ARO**

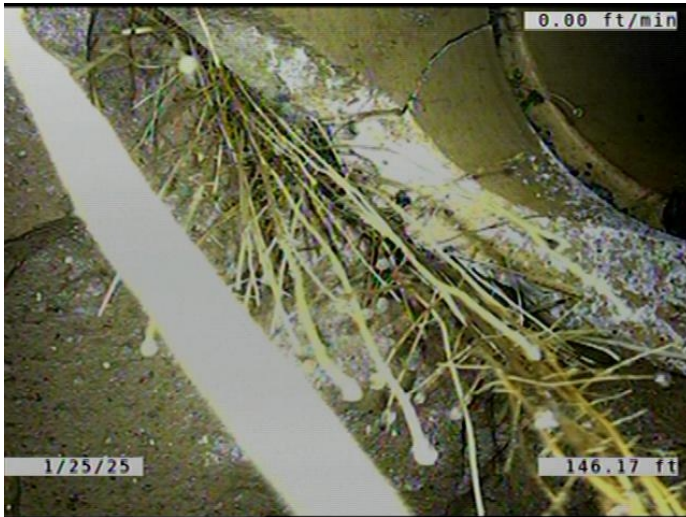
Code: **RFB**  
 Description: **Roots Fine Barrel**

Distance (ft): **146.2**  
 Structural Grade: **0**  
 O&M Grade: **2**  
 Clock Start/From: **11**  
 Clock To: **3**  
 1st Value:  
 2nd Value:  
 Value Percent:  
 Continuous Index: **S05**  
 Within 8" of Joint: **NO**  
 Remarks:

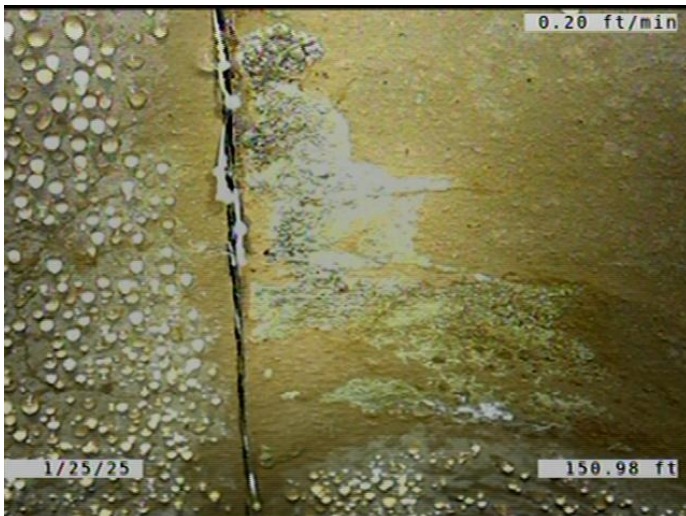
Code: **DAE**  
 Description: **Deposits Attached Encrustation**

Distance (ft): **151.0**  
 Structural Grade: **0**  
 O&M Grade: **2**  
 Clock Start/From: **10**  
 Clock To: **2**  
 1st Value:  
 2nd Value:  
 Value Percent: **5.000**  
 Continuous Index: **S06**  
 Within 8" of Joint: **YES**  
 Remarks:

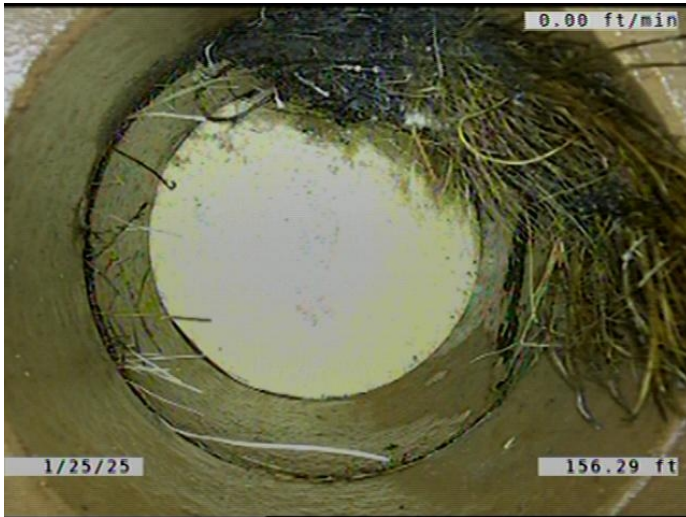
Code:	<b>TFD</b>
Description:	<b>Tap Factory Defective</b>
Distance (ft):	<b>156.3</b>
Structural Grade:	<b>0</b>
O&M Grade:	<b>3</b>
Clock Start/From:	<b>2</b>
Clock To:	
1st Value:	<b>6.000</b>
2nd Value:	
Value Percent:	
Continuous Index:	
Within 8" of Joint:	<b>YES</b>
Remarks:	<b>CAPPED. TAP CRACKED. ROOTS GROWING FROM THE JOINT INTO T</b>

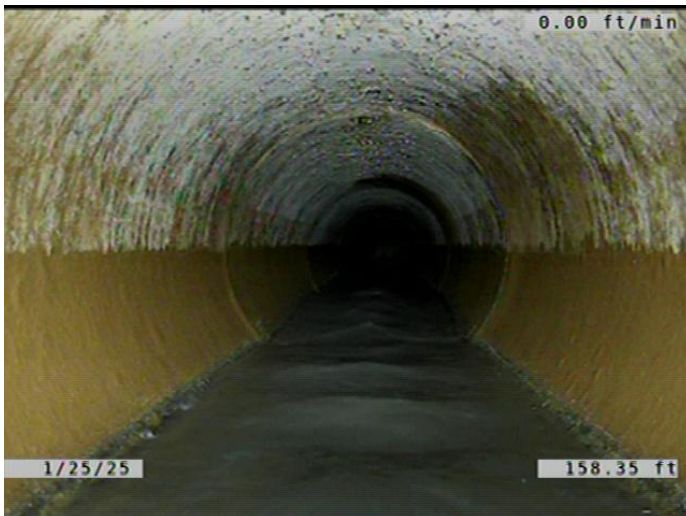
Code:	<b>B</b>
Description:	<b>Broken</b>
Distance (ft):	<b>158.4</b>
Structural Grade:	<b>4</b>
O&M Grade:	<b>0</b>
Clock Start/From:	<b>9</b>
Clock To:	<b>3</b>
1st Value:	
2nd Value:	
Value Percent:	
Continuous Index:	<b>F04</b>
Within 8" of Joint:	<b>YES</b>
Remarks:

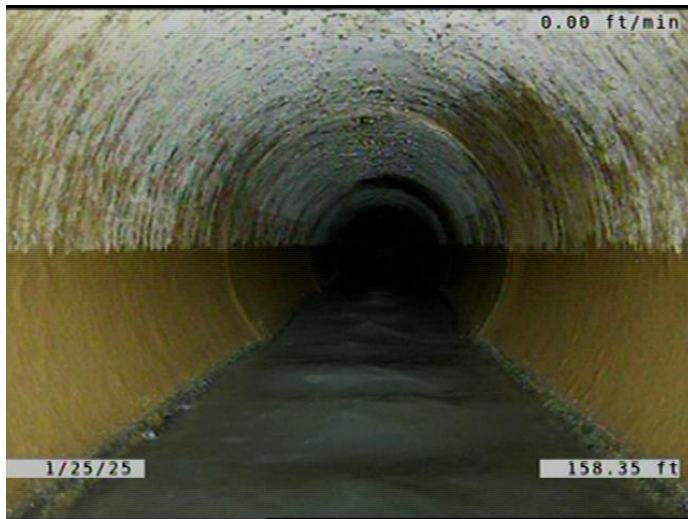
Code: **RFB**  
Description: **Roots Fine Barrel**

Distance (ft): **158.4**  
Structural Grade: **0**  
O&M Grade: **2**  
Clock Start/From: **11**  
Clock To: **3**  
1st Value:  
2nd Value:  
Value Percent:  
Continuous Index: **F05**  
Within 8" of Joint: **NO**  
Remarks:

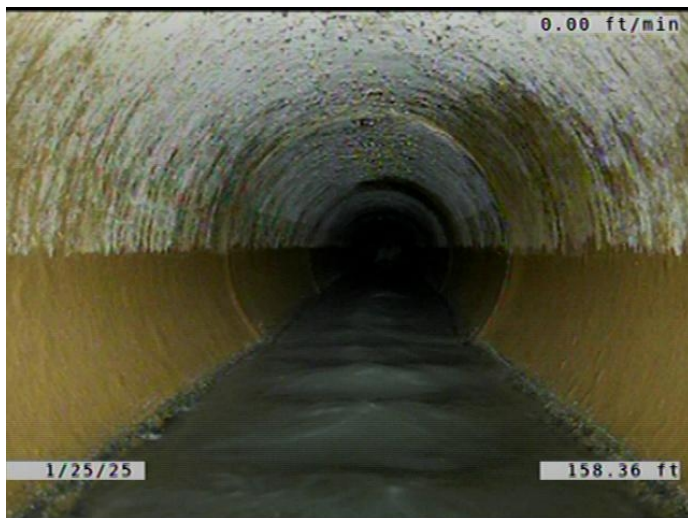
Code: **DAE**  
Description: **Deposits Attached Encrustation**

Distance (ft): **158.4**  
Structural Grade: **0**  
O&M Grade: **2**  
Clock Start/From: **10**  
Clock To: **2**  
1st Value:  
2nd Value:  
Value Percent: **5.000**  
Continuous Index: **F06**  
Within 8" of Joint: **YES**  
Remarks:

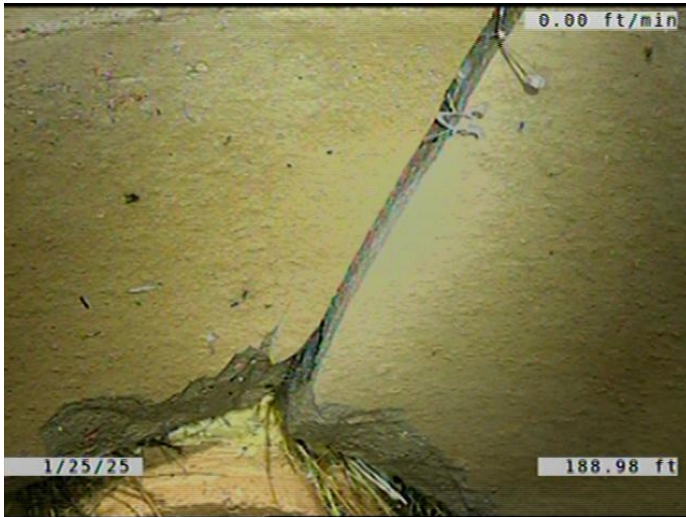
Code: **B**  
Description: **Broken**

Distance (ft): **189.0**  
Structural Grade: **4**  
O&M Grade: **0**  
Clock Start/From: **12**  
Clock To: **12**  
1st Value:  
2nd Value:  
Value Percent:  
Continuous Index: **S07**  
Within 8" of Joint: **YES**  
Remarks:

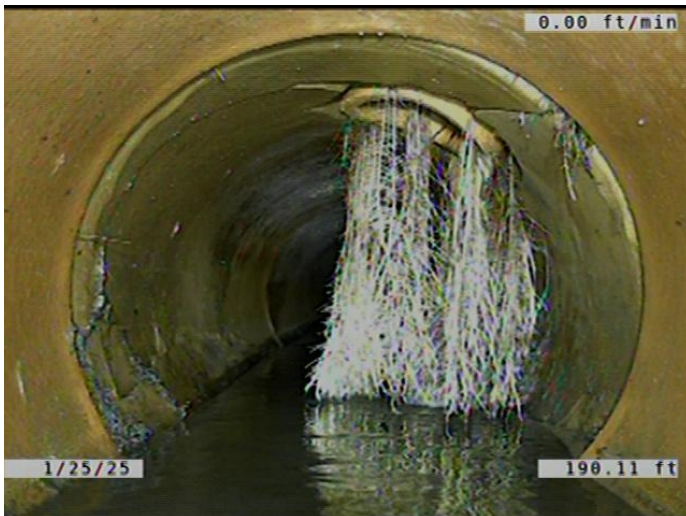
Code: **RMC**  
Description: **Roots Medium Connection**

Distance (ft): **190.1**  
Structural Grade: **0**  
O&M Grade: **3**  
Clock Start/From: **8**  
Clock To: **3**  
1st Value:  
2nd Value:  
Value Percent: **40.000**  
Continuous Index:  
Within 8" of Joint: **NO**  
Remarks:

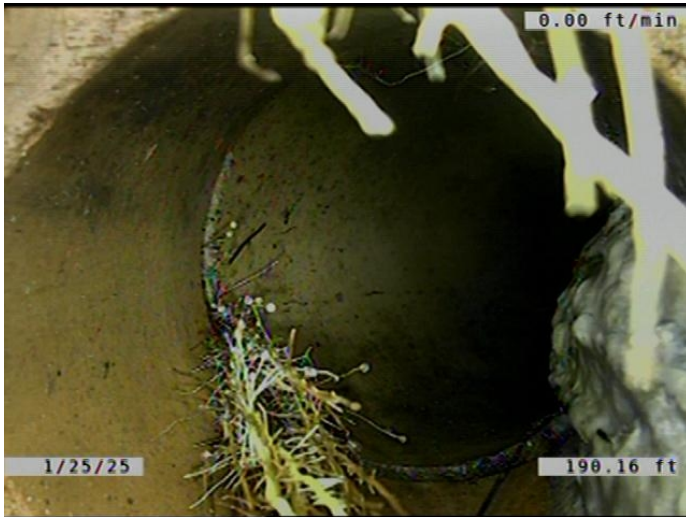
Code:	<b>TBD</b>
Description:	<b>Tap Break-in/Hammer Defective</b>
Distance (ft):	<b>190.2</b>
Structural Grade:	<b>0</b>
O&M Grade:	<b>3</b>
Clock Start/From:	<b>1</b>
Clock To:	
1st Value:	<b>6.000</b>
2nd Value:	
Value Percent:	
Continuous Index:	
Within 8" of Joint:	<b>YES</b>
Remarks:	<b>BROKEN. ROOTS GROWING IN THE JOINTS AND FROM THE SERVICE TO</b>

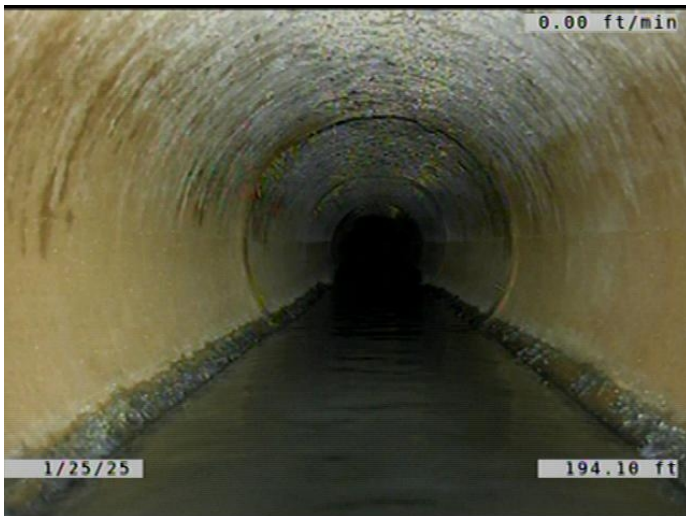
Code:	<b>B</b>
Description:	<b>Broken</b>
Distance (ft):	<b>194.1</b>
Structural Grade:	<b>4</b>
O&M Grade:	<b>0</b>
Clock Start/From:	<b>12</b>
Clock To:	<b>12</b>
1st Value:	
2nd Value:	
Value Percent:	
Continuous Index:	<b>F07</b>
Within 8" of Joint:	<b>YES</b>
Remarks:

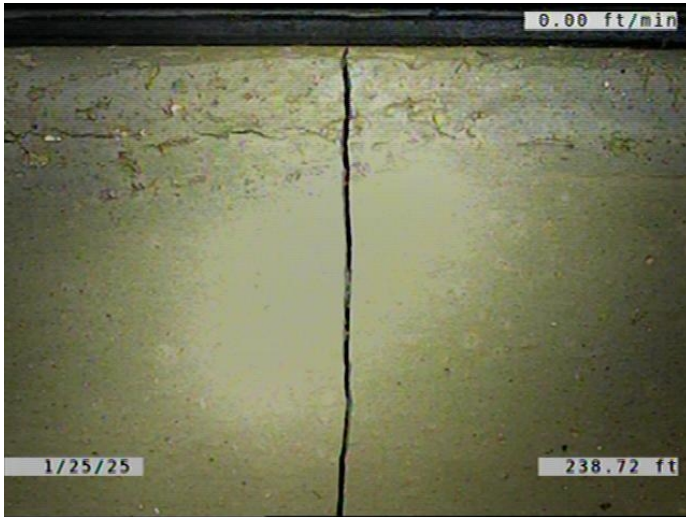
Code: **FL**  
Description: **Fracture Longitudinal**

Distance (ft): **238.7**  
Structural Grade: **3**  
O&M Grade: **0**  
Clock Start/From: **12**  
Clock To:  
1st Value:  
2nd Value:  
Value Percent:  
Continuous Index:  
Within 8" of Joint: **YES**  
Remarks:

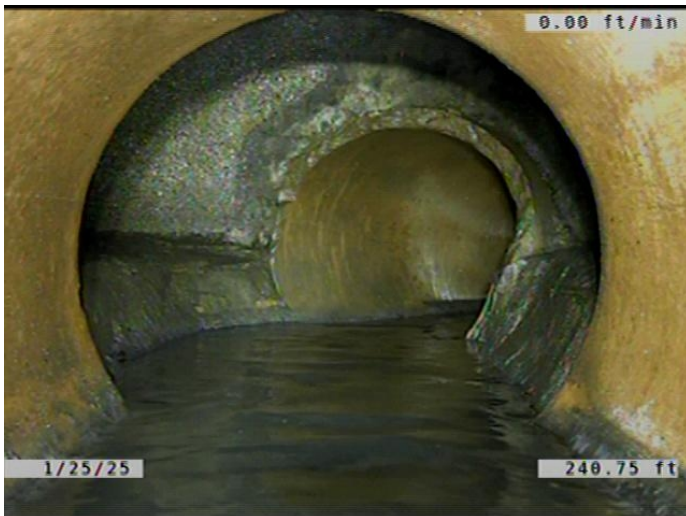
Code: **RFJ**  
Description: **Roots Fine Joint**

Distance (ft): **240.8**  
Structural Grade: **0**  
O&M Grade: **1**  
Clock Start/From: **10**  
Clock To: **4**  
1st Value:  
2nd Value:  
Value Percent:  
Continuous Index: **F03**  
Within 8" of Joint: **YES**  
Remarks:

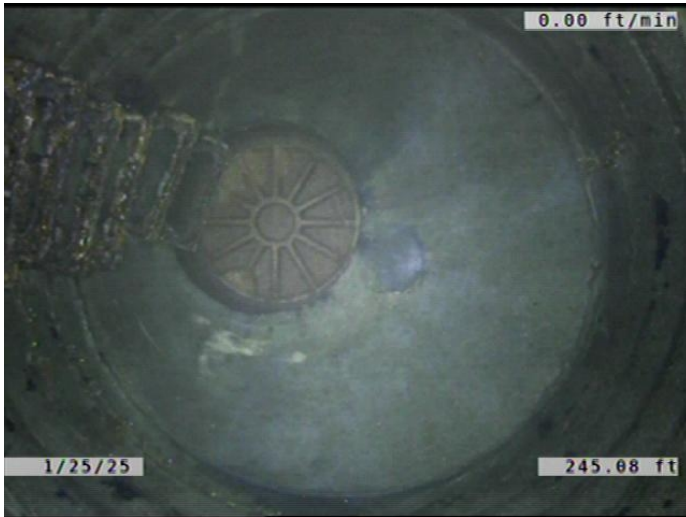
Code:	<b>AMH</b>
Description:	<b>Manhole</b>
Distance (ft):	<b>245.1</b>
Structural Grade:	<b>0</b>
O&M Grade:	<b>0</b>
Clock Start/From:	
Clock To:	
1st Value:	
2nd Value:	
Value Percent:	
Continuous Index:	
Within 8" of Joint:	<b>NO</b>
Remarks:	<b>M-303-002</b>
