Profile/Photo Observation Report

Street:	Ridgelawn Drive	Flow Control:	Not Controlled
City:	Hobart, IN	Year Renewed:	
Location:	Light Highway	Tape/Media #:	DEP 10
Purpose:	Routine Assessment	Dia/Height:	18"
Use:	Sanitary	Material:	VCP
Drain Area:		Lining:

US MH: **M-303-004** DS MH: **M-303-003** Total Length Surveyed (ft): **44.3**

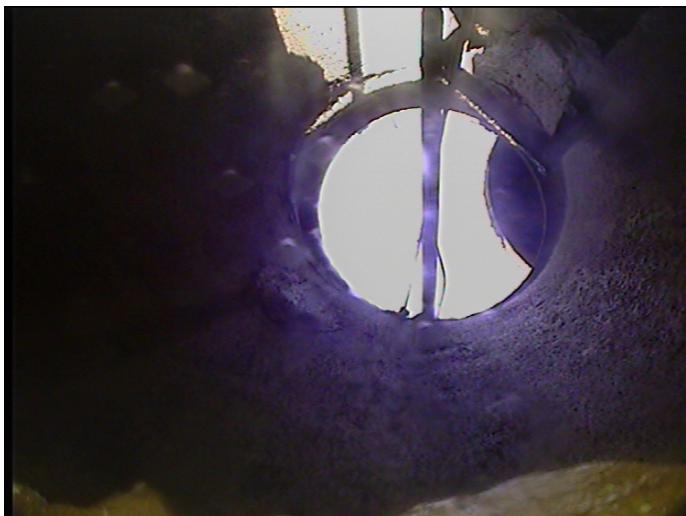
Code: **AMH**
Description: **Manhole**

Distance (ft): **.0**
Structural Grade: **0**
O&M Grade: **0**
Clock Start/From:
Clock To:
1st Value:
2nd Value:
Value Percent:
Continuous Index:
Within 8" of Joint: **NO**
Remarks: **M-303-004**
