Profile/Photo Observation Report

Date:	04/07/2018	Weather:		Coding:	PACP 6.0
Pipe Length (ft):		Owner:	City of Hobart	Pre Clean:	No Pre-Cleaning
P.O.#:	10-1	Surveyor:	M. Pielacha	PSR:	M-303-004-M-303-003
Customer:	City of Hobart	Clean Date:		Shape:	C

Street:	Ridgelawn Drive	Flow Control:	Not Controlled
City:	Hobart, IN	Year Renewed:	
Location:	Light Highway	Tape/Media #:	DEP 10
Purpose:	Routine Assessment	Dia/Height:	18"
Use:	Sanitary	Material:	VCP
Drain Area:		Lining:

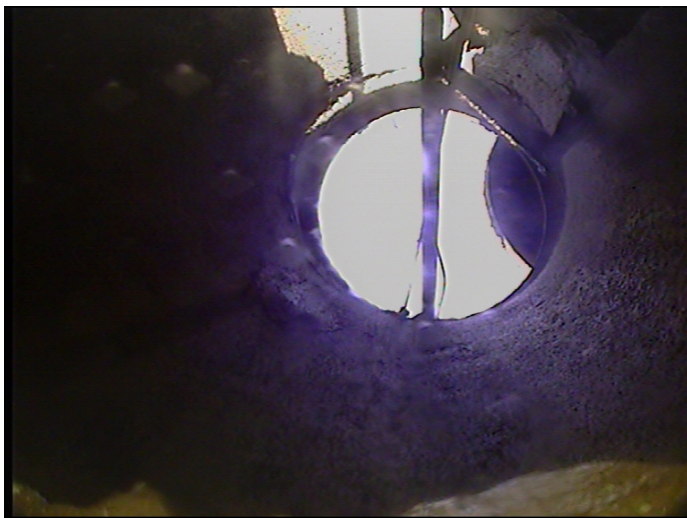
Code: **AMH**
Description: **Manhole**

Distance (ft): **.0**
Structural Grade: **0**
O&M Grade: **0**
Clock Start/From:
Clock To:
1st Value:
2nd Value:
Value Percent:
Continuous Index:
Within 8" of Joint: **NO**
Remarks: **M-303-004**

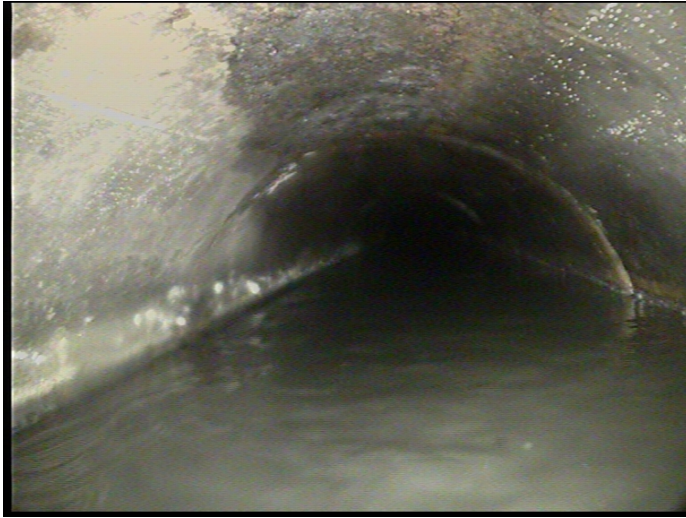
Code: **MWL**
Description: **Water Level**

Distance (ft): **.0**
Structural Grade: **0**
O&M Grade: **0**
Clock Start/From:
Clock To:
1st Value:
2nd Value:
Value Percent: **40.000**
Continuous Index:
Within 8" of Joint: **NO**
Remarks:

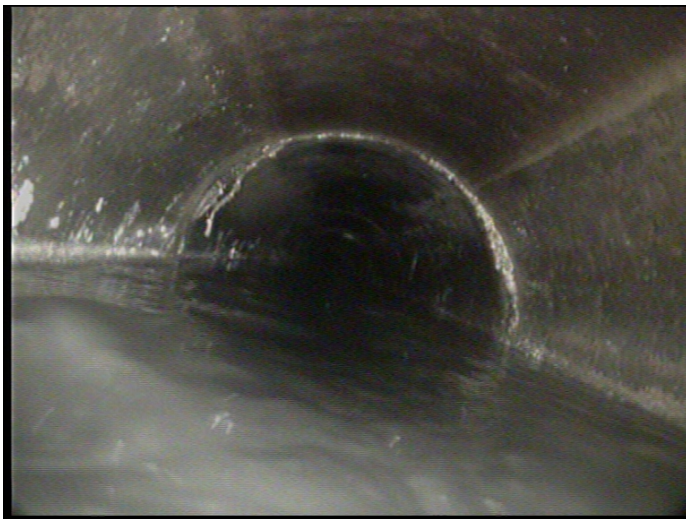
Code: **OBZ**
Description: **Obstacle Other**

Distance (ft): **42.8**
Structural Grade: **0**
O&M Grade: **3**
Clock Start/From: **5**
Clock To: **7**
1st Value:
2nd Value:
Value Percent: **15.000**
Continuous Index:
Within 8" of Joint: **NO**
Remarks: **Debris**

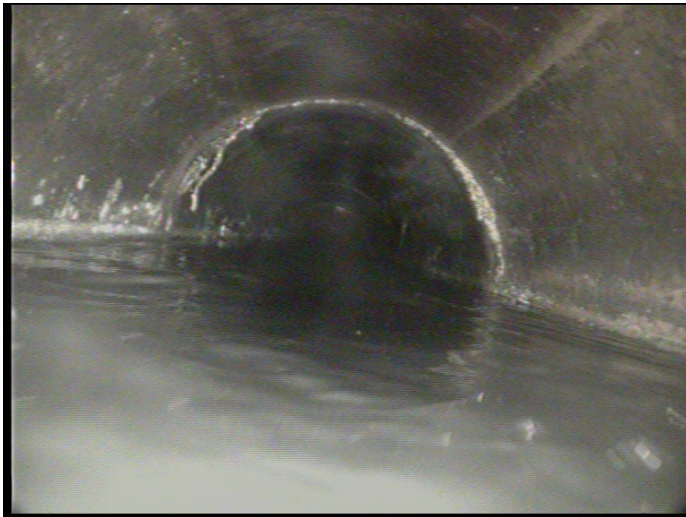
Code:	MSA
Description:	Abandoned Survey
Distance (ft):	42.9
Structural Grade:	0
O&M Grade:	0
Clock Start/From:	
Clock To:	
1st Value:	
2nd Value:	
Value Percent:	
Continuous Index:	
Within 8" of Joint:	NO
Remarks:	sediment/underwater debris
