## Profile/Photo Observation Report

Date:	<b>01/25/2025</b>	Weather:		Coding:	<b>PACP 7.0</b>
Pipe Length (ft):	<b>281.0</b>	Owner:	<b>City of Hobart</b>	Pre Clean:	<b>Heavy Cleaning</b>
P.O.#:	<b>YES502259</b>	Surveyor:	<b>Steven Bucklin</b>	PSR:	<b>P-303-004-003</b>
Customer:	<b>City of Hobart</b>	Clean Date:	<b>10/14/2024</b>	Shape:	<b>C</b>

Street:	<b>Ridgelawn Drive</b>	Flow Control:	<b>Not Controlled</b>
City:	<b>Hobart, IN</b>	Year Renewed:	
Location:	<b>Local rural streets with light traffic, t</b>	Tape/Media #:	
Purpose:	<b>Sewer System Evaluation Survey (SS</b>	Dia/Height:	<b>18"</b>
Use:	<b>Sanitary Sewage Pipe</b>	Material:	<b>VCP</b>
Drain Area:		Lining:	<b>None</b>
Category:	<b>NA</b>		
Comment:			
Location Details:	<b>GRAVEL DRIVEWAY APPROACH</b>	Direction of Survey:	<b>Downstream</b>
US MH:	<b>M-303-004</b>	DS MH:	<b>M-303-003</b>
		Total Length Surveyed (ft):	<b>293.7</b>

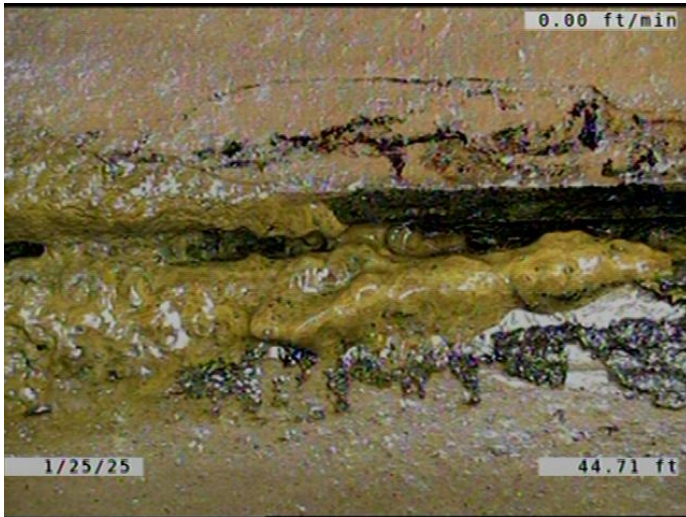
Code: **DAE**  
 Description: **Deposits Attached Encrustation**

Distance (ft): **44.7**  
 Structural Grade: **0**  
 O&M Grade: **2**  
 Clock Start/From: **8**  
 Clock To: **4**  
 1st Value:  
 2nd Value:  
 Value Percent: **5.000**  
 Continuous Index: **S01**  
 Within 8" of Joint: **YES**  
 Remarks:

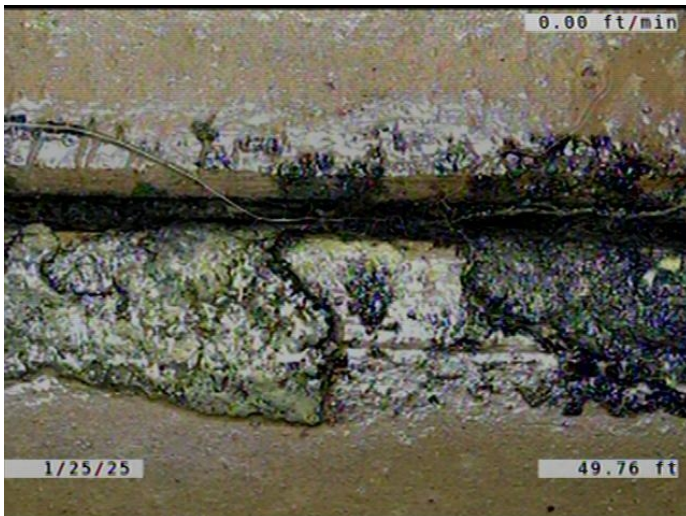
Code: **RFJ**  
 Description: **Roots Fine Joint**

Distance (ft): **49.8**  
 Structural Grade: **0**  
 O&M Grade: **1**  
 Clock Start/From: **8**  
 Clock To: **4**  
 1st Value:  
 2nd Value:  
 Value Percent:  
 Continuous Index: **S02**  
 Within 8" of Joint: **YES**  
 Remarks:

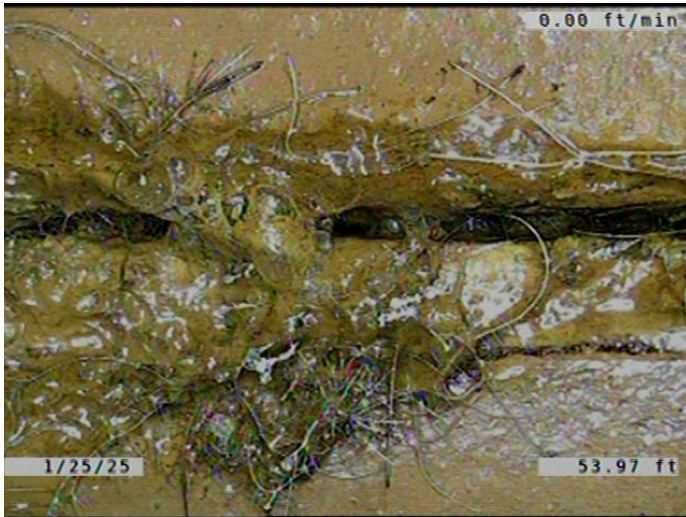
Code: **IDJ**  
 Description: **Infiltration Dripper Joint**

Distance (ft): **54.0**  
 Structural Grade: **0**  
 O&M Grade: **3**  
 Clock Start/From: **11**  
 Clock To:  
 1st Value:  
 2nd Value:  
 Value Percent:  
 Continuous Index:  
 Within 8" of Joint: **YES**  
 Remarks:

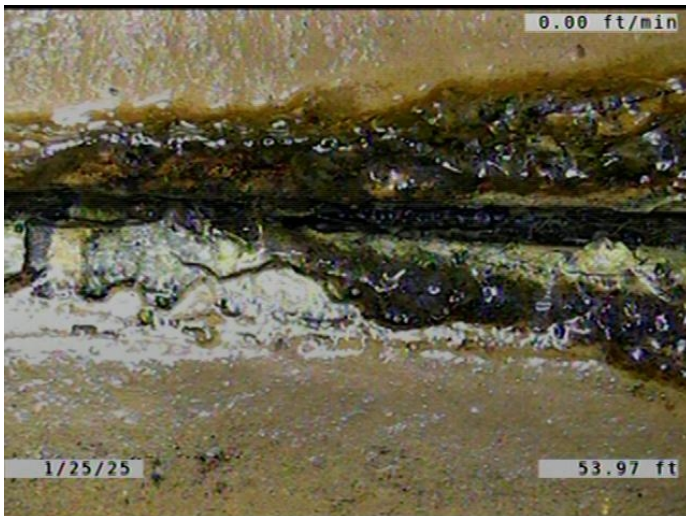
Code: **IWJ**  
 Description: **Infiltration Weeper Joint**

Distance (ft): **54.0**  
 Structural Grade: **0**  
 O&M Grade: **2**  
 Clock Start/From: **1**  
 Clock To:  
 1st Value:  
 2nd Value:  
 Value Percent:  
 Continuous Index:  
 Within 8" of Joint: **YES**  
 Remarks:

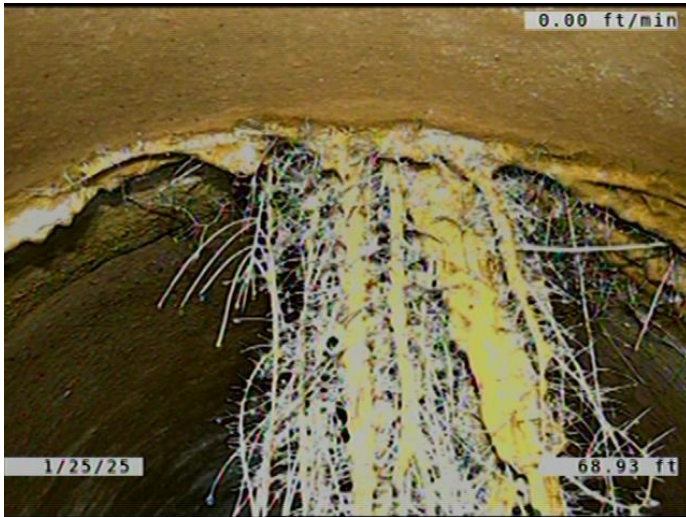
Code: **IRJ**  
 Description: **Infiltration Runner Joint**

Distance (ft): **68.9**  
 Structural Grade: **0**  
 O&M Grade: **4**  
 Clock Start/From: **12**  
 Clock To:  
 1st Value:  
 2nd Value:  
 Value Percent:  
 Continuous Index:  
 Within 8" of Joint: **YES**  
 Remarks:

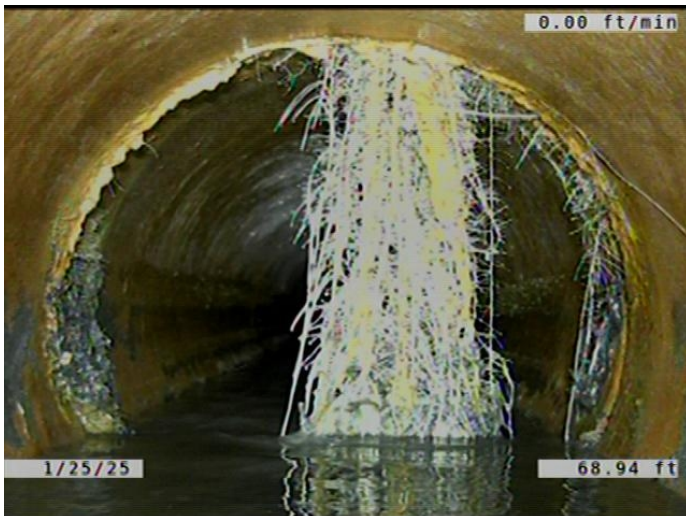
Code: **RMJ**  
 Description: **Roots Medium Joint**

Distance (ft): **68.9**  
 Structural Grade: **0**  
 O&M Grade: **3**  
 Clock Start/From: **8**  
 Clock To: **4**  
 1st Value:  
 2nd Value:  
 Value Percent: **20.000**  
 Continuous Index:  
 Within 8" of Joint: **YES**  
 Remarks:

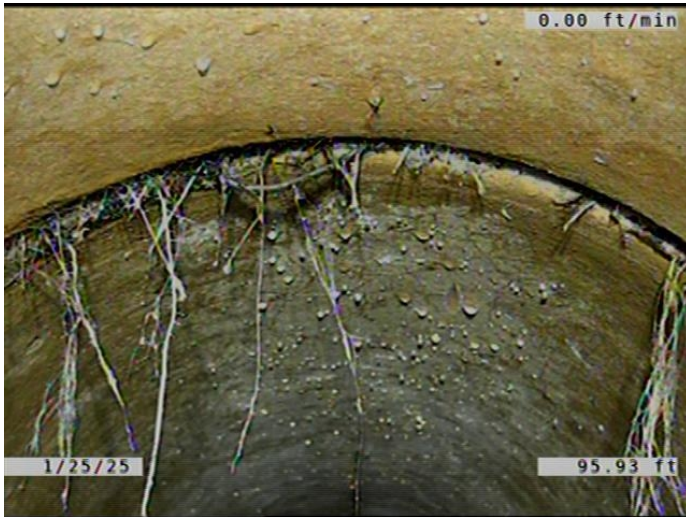
Code: **IRJ**  
Description: **Infiltration Runner Joint**

Distance (ft): **95.9**  
Structural Grade: **0**  
O&M Grade: **4**  
Clock Start/From: **11**  
Clock To: **1**  
1st Value:  
2nd Value:  
Value Percent:  
Continuous Index:  
Within 8" of Joint: **YES**  
Remarks:

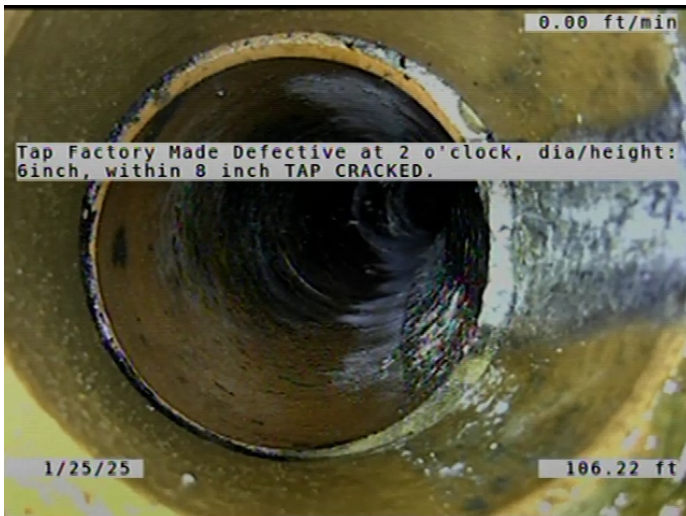
Code: **TFD**  
Description: **Tap Factory Defective**

Distance (ft): **106.2**  
Structural Grade: **0**  
O&M Grade: **3**  
Clock Start/From: **2**  
Clock To:  
1st Value: **6.000**  
2nd Value:  
Value Percent:  
Continuous Index:  
Within 8" of Joint:  
Remarks: **tap cracked**

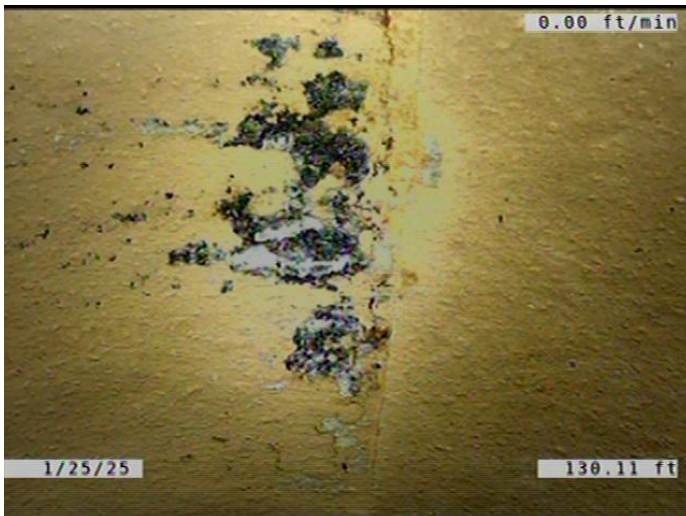
Code: **ISB**  
Description: **Infiltration Stain Barrel**

Distance (ft): **130.1**  
Structural Grade: **0**  
O&M Grade: **1**  
Clock Start/From: **10**  
Clock To: **12**  
1st Value:  
2nd Value:  
Value Percent:  
Continuous Index:  
Within 8" of Joint: **NO**  
Remarks:

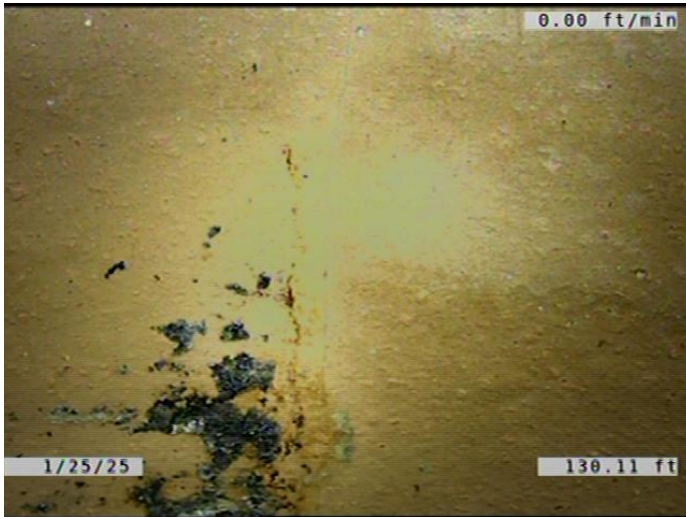
Code: **B**  
Description: **Broken**

Distance (ft): **130.1**  
Structural Grade: **4**  
O&M Grade: **0**  
Clock Start/From: **10**  
Clock To: **2**  
1st Value:  
2nd Value:  
Value Percent:  
Continuous Index: **S03**  
Within 8" of Joint: **YES**  
Remarks:

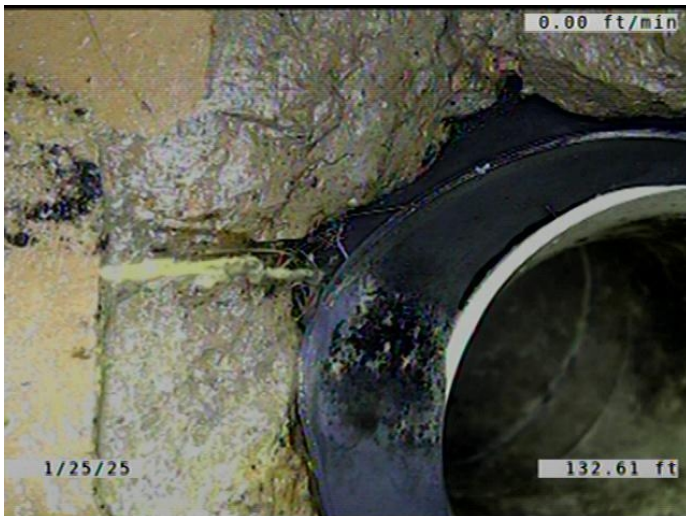
Code: **RFB**  
Description: **Roots Fine Barrel**

Distance (ft): **132.6**  
Structural Grade: **0**  
O&M Grade: **2**  
Clock Start/From: **11**  
Clock To: **1**  
1st Value:  
2nd Value:  
Value Percent:  
Continuous Index:  
Within 8" of Joint: **NO**  
Remarks:

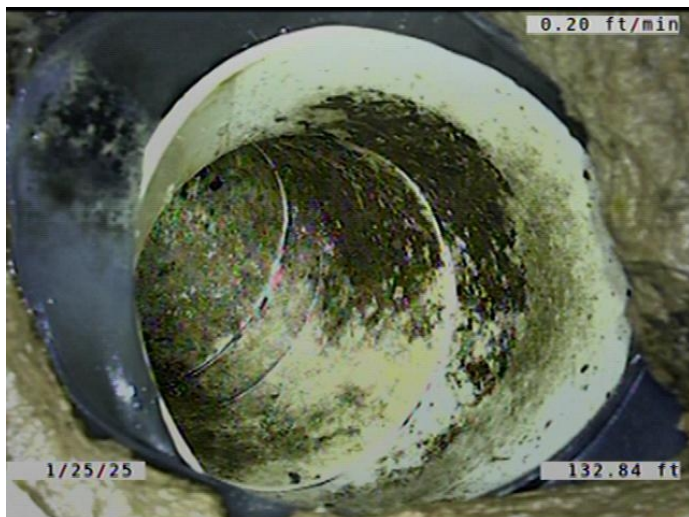
Code:	<b>TSD</b>
Description:	<b>Tap Saddle Defective</b>
Distance (ft):	<b>132.8</b>
Structural Grade:	<b>0</b>
O&M Grade:	<b>3</b>
Clock Start/From:	<b>12</b>
Clock To:	
1st Value:	<b>6.000</b>
2nd Value:	
Value Percent:	
Continuous Index:	
Within 8" of Joint:	<b>YES</b>
Remarks:	<b>SERVICE IS PVC AND COMES FROM THE LEFT (NORTH).</b>

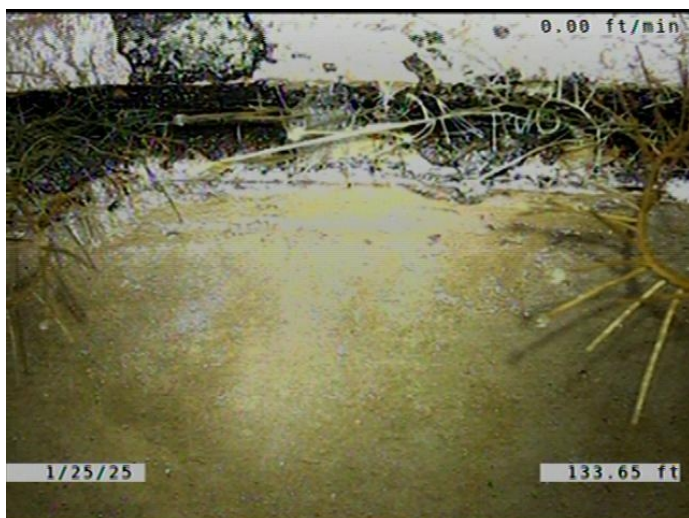
Code:	<b>B</b>
Description:	<b>Broken</b>
Distance (ft):	<b>133.6</b>
Structural Grade:	<b>4</b>
O&M Grade:	<b>0</b>
Clock Start/From:	<b>10</b>
Clock To:	<b>2</b>
1st Value:	
2nd Value:	
Value Percent:	
Continuous Index:	<b>F03</b>
Within 8" of Joint:	<b>YES</b>
Remarks:

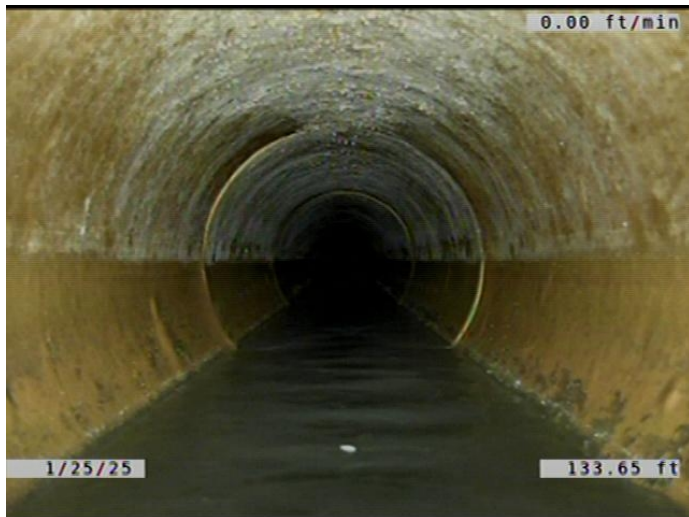
Code: **RFJ**  
 Description: **Roots Fine Joint**

Distance (ft): **133.6**  
 Structural Grade: **0**  
 O&M Grade: **1**  
 Clock Start/From: **8**  
 Clock To: **4**  
 1st Value:  
 2nd Value:  
 Value Percent:  
 Continuous Index: **F02**  
 Within 8" of Joint: **YES**  
 Remarks:

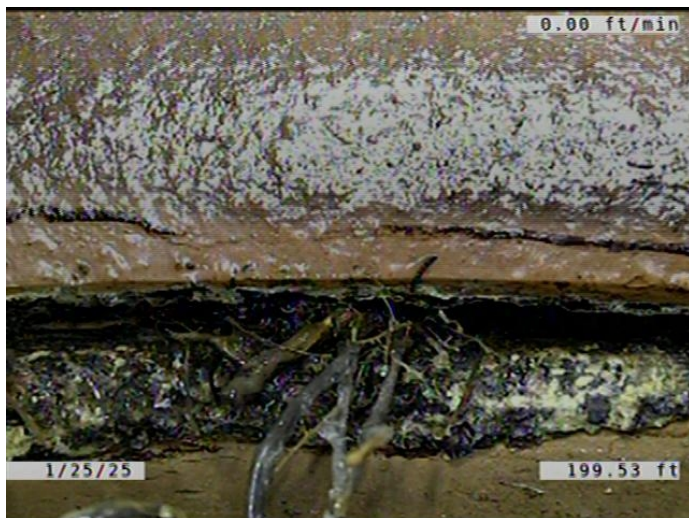
Code: **IRJ**  
 Description: **Infiltration Runner Joint**

Distance (ft): **199.5**  
 Structural Grade: **0**  
 O&M Grade: **4**  
 Clock Start/From: **11**  
 Clock To: **1**  
 1st Value:  
 2nd Value:  
 Value Percent:  
 Continuous Index:  
 Within 8" of Joint: **YES**  
 Remarks:

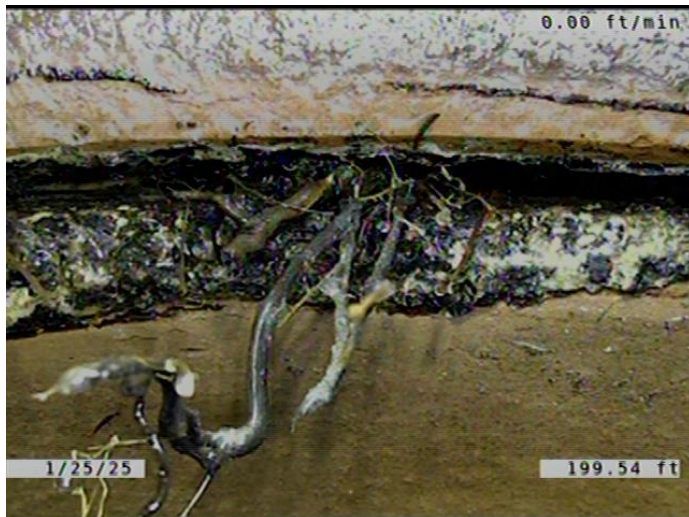
Code: **RFJ**  
 Description: **Roots Fine Joint**

Distance (ft): **199.5**  
 Structural Grade: **0**  
 O&M Grade: **1**  
 Clock Start/From: **8**  
 Clock To: **4**  
 1st Value:  
 2nd Value:  
 Value Percent:  
 Continuous Index:  
 Within 8" of Joint: **YES**  
 Remarks:

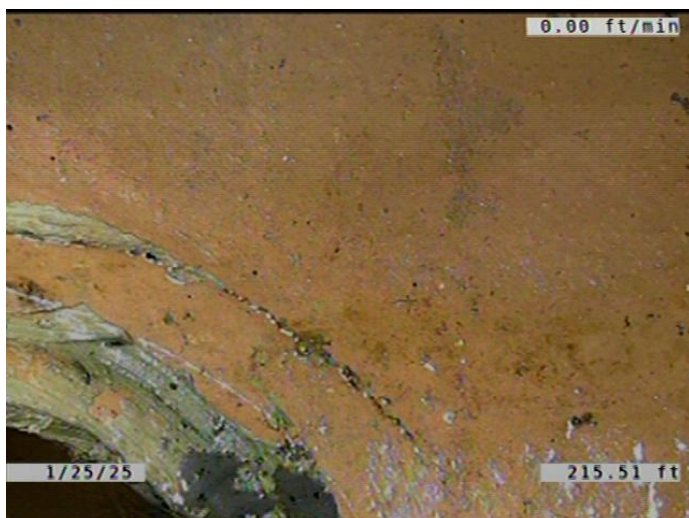
Code: **CS**  
 Description: **Crack Spiral**

Distance (ft): **215.5**  
 Structural Grade: **2**  
 O&M Grade: **0**  
 Clock Start/From: **1**  
 Clock To: **4**  
 1st Value:  
 2nd Value:  
 Value Percent:  
 Continuous Index:  
 Within 8" of Joint: **NO**  
 Remarks:

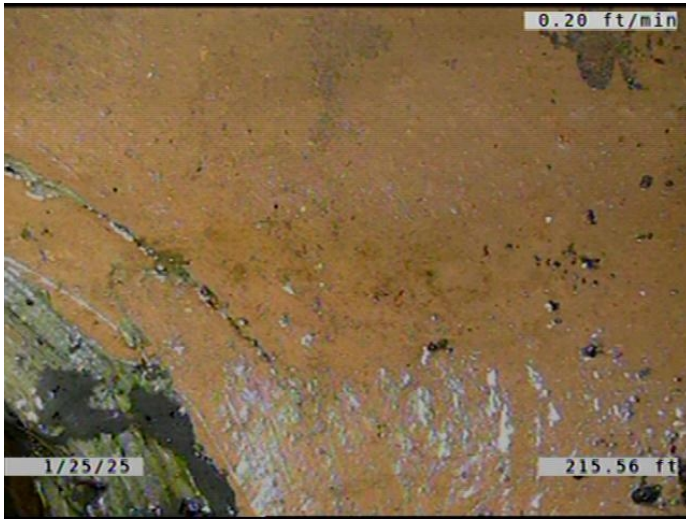
Code: **ISB**  
Description: **Infiltration Stain Barrel**

Distance (ft): **215.5**  
Structural Grade: **0**  
O&M Grade: **1**  
Clock Start/From: **3**  
Clock To: **4**  
1st Value:  
2nd Value:  
Value Percent:  
Continuous Index:  
Within 8" of Joint: **NO**  
Remarks:

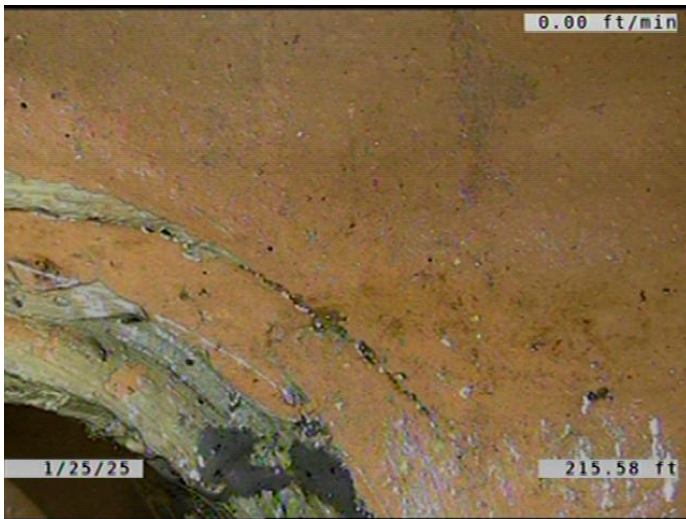
Code: **IWB**  
Description: **Infiltration Weeper Barrel**

Distance (ft): **215.6**  
Structural Grade: **0**  
O&M Grade: **2**  
Clock Start/From: **3**  
Clock To:  
1st Value:  
2nd Value:  
Value Percent:  
Continuous Index:  
Within 8" of Joint: **NO**  
Remarks:

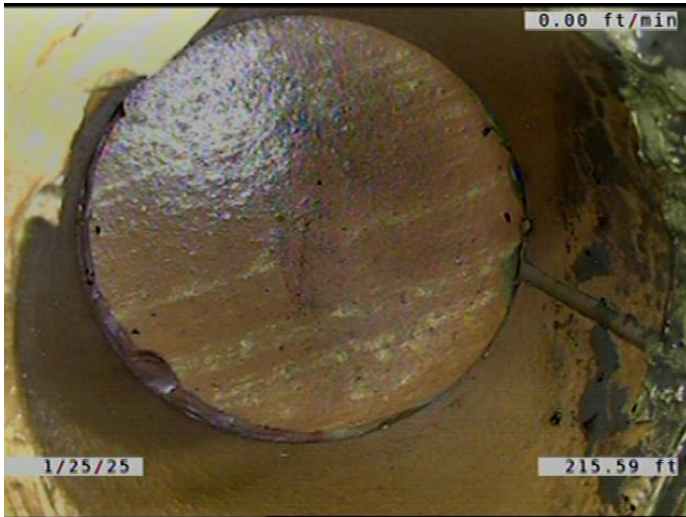
Code: **TFI**  
Description: **Tap Factory Intruding**

Distance (ft): **215.6**  
Structural Grade: **0**  
O&M Grade: **2**  
Clock Start/From: **2**  
Clock To:  
1st Value: **6.000**  
2nd Value: **1.000**  
Value Percent:  
Continuous Index:  
Within 8" of Joint: **YES**  
Remarks: **CAPPED. TAP CRACKED.**

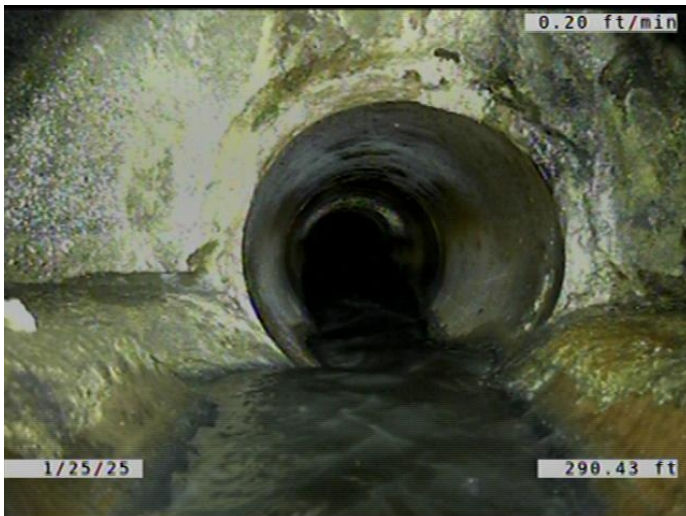
Code: **DAE**  
Description: **Deposits Attached Encrustation**

Distance (ft): **290.4**  
Structural Grade: **0**  
O&M Grade: **2**  
Clock Start/From: **8**  
Clock To: **4**  
1st Value:  
2nd Value:  
Value Percent: **5.000**  
Continuous Index: **F01**  
Within 8" of Joint: **YES**  
Remarks:
