Profile/Photo Observation Report

Date:	04/07/2018	Weather:		Coding:	PACP 6.0
Pipe Length (ft):		Owner:	City of Hobart	Pre Clean:	No Pre-Cleaning
P.O.#:	8-1	Surveyor:	M. Pielacha	PSR:	M-303-004-M-303-073
Customer:	City of Hobart	Clean Date:		Shape:	C

Street:	Ridgelawn Drive	Flow Control:	Not Controlled
City:	Hobart, IN	Year Renewed:	
Location:	Light Highway	Tape/Media #:	DEP 8
Purpose:	Routine Assessment	Dia/Height:	18"
Use:	Sanitary	Material:	VCP
Drain Area:		Lining:	
Category:	NA		
Comment:			
Location Details:		Direction of Survey:	Downstream
US MH:	M-303-004	DS MH:	M-303-073
		Total Length Surveyed (ft):	5.2

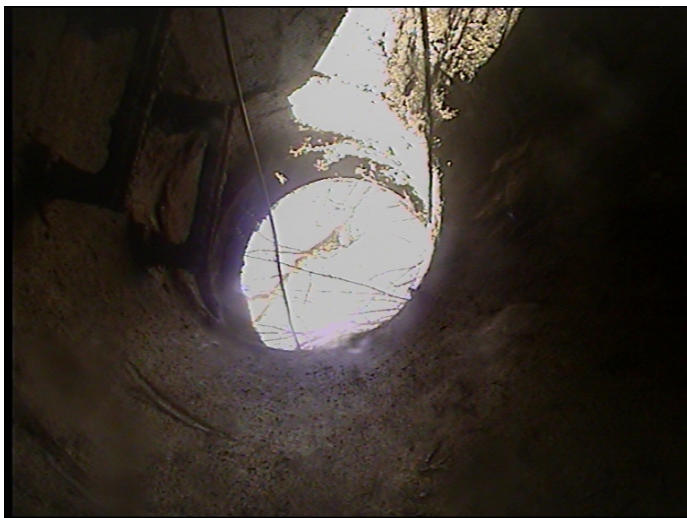
Code: **AMH**
Description: **Manhole**

Distance (ft): **.0**
Structural Grade: **0**
O&M Grade: **0**
Clock Start/From:
Clock To:
1st Value:
2nd Value:
Value Percent:
Continuous Index:
Within 8" of Joint: **NO**
Remarks: **M-303-004**

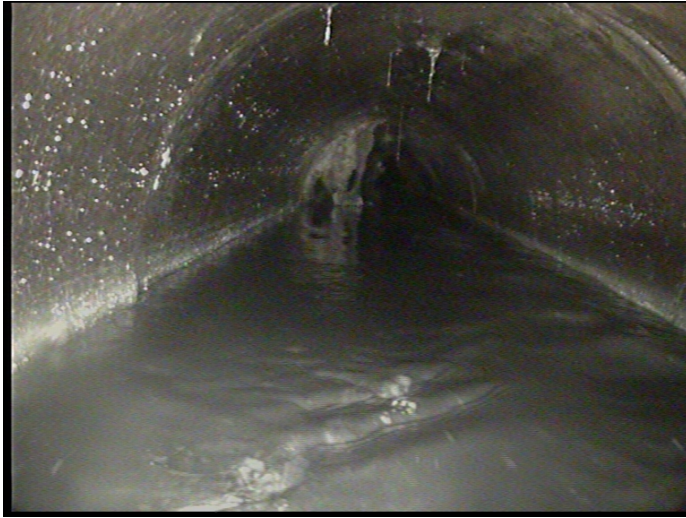
Code: **MWL**
Description: **Water Level**

Distance (ft): **.0**
Structural Grade: **0**
O&M Grade: **0**
Clock Start/From:
Clock To:
1st Value:
2nd Value:
Value Percent: **15.000**
Continuous Index:
Within 8" of Joint: **NO**
Remarks:

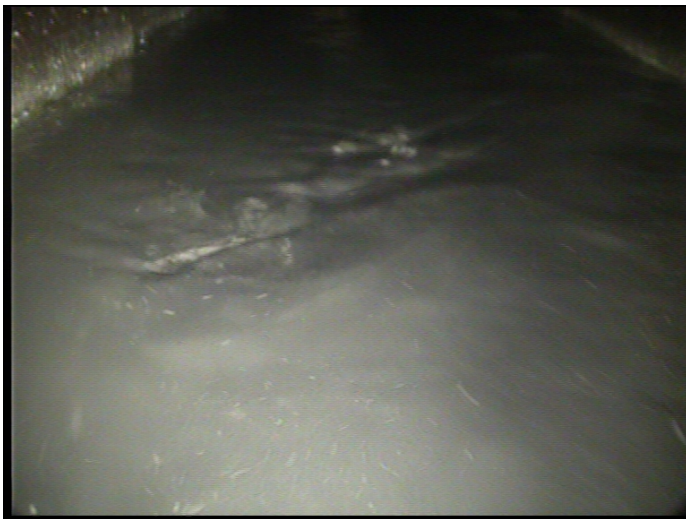
Code: **DSF**
Description: **Deposits Settled Fine**

Distance (ft): **.0**
Structural Grade: **0**
O&M Grade: **3**
Clock Start/From: **5**
Clock To: **7**
1st Value:
2nd Value:
Value Percent: **15.000**
Continuous Index: **S01**
Within 8" of Joint: **YES**
Remarks:

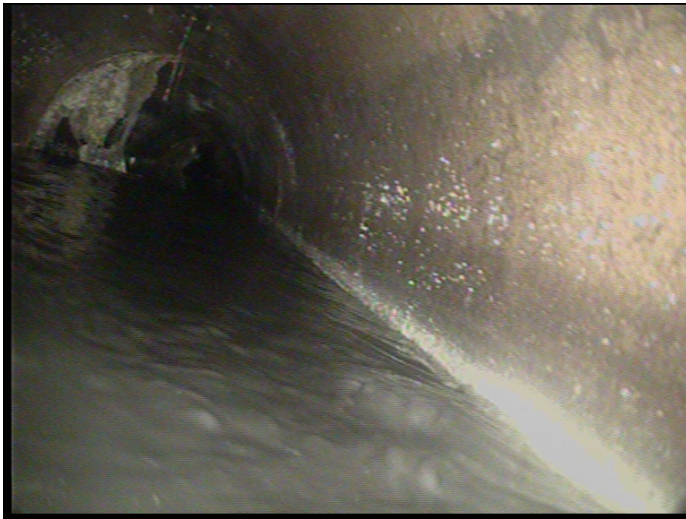
Code: **DSF**
Description: **Deposits Settled Fine**

Distance (ft): **5.2**
Structural Grade: **0**
O&M Grade: **3**
Clock Start/From: **5**
Clock To: **7**
1st Value:
2nd Value:
Value Percent: **20.000**
Continuous Index: **F01**
Within 8" of Joint: **NO**
Remarks:

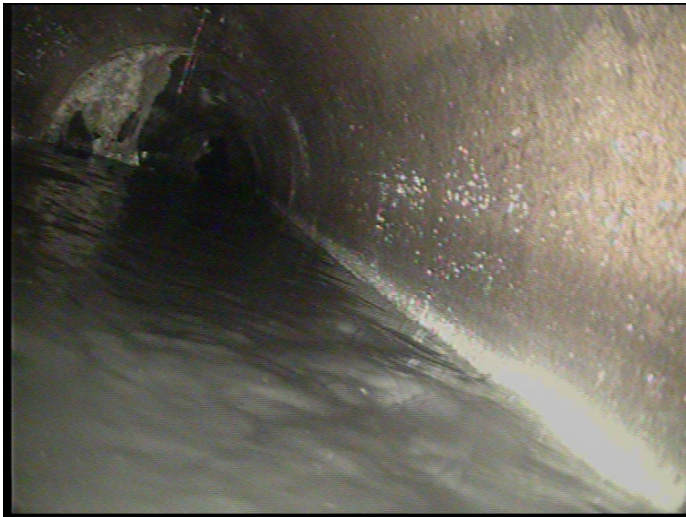
Code: **MSA**
Description: **Abandoned Survey**

Distance (ft): **5.2**
Structural Grade: **0**
O&M Grade: **0**
Clock Start/From:
Clock To:
1st Value:
2nd Value:
Value Percent:
Continuous Index:
Within 8" of Joint: **NO**
Remarks: **deep sediment**
