Profile/Photo Observation Report

Date:	04/07/2018	Weather:		Coding:	PACP 6.0
Pipe Length (ft):		Owner:	City of Hobart	Pre Clean:	No Pre-Cleaning
P.O.#:	9-1	Surveyor:	M. Pielacha	PSR:	M-303-004-M-303-073
Customer:	City of Hobart	Clean Date:		Shape:	C

Street:	Ridgelawn Drive	Flow Control:	Not Controlled
City:	Hobart, IN	Year Renewed:	
Location:	Light Highway	Tape/Media #:	DEP 9
Purpose:	Routine Assessment	Dia/Height:	18"
Use:	Sanitary	Material:	VCP
Drain Area:		Lining:	
Category:	NA		
Comment:			
Location Details:		Direction of Survey:	Upstream
US MH:	M-303-004	DS MH:	M-303-073
		Total Length Surveyed (ft):	1.9

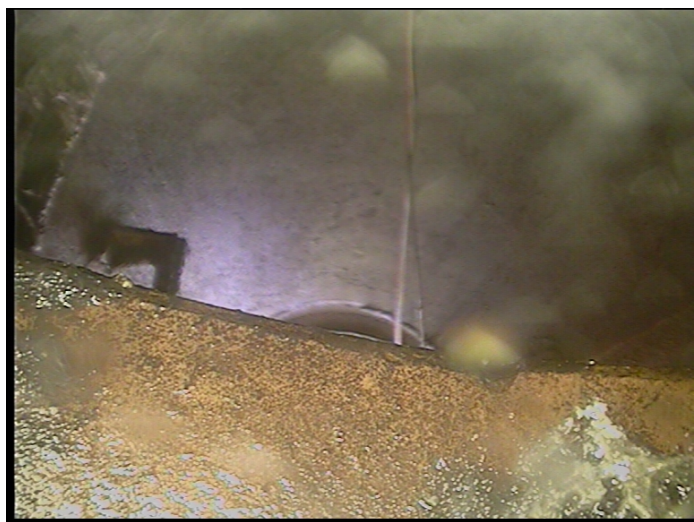
Code: **AMH**
Description: **Manhole**

Distance (ft): **.0**
Structural Grade: **0**
O&M Grade: **0**
Clock Start/From:
Clock To:
1st Value:
2nd Value:
Value Percent:
Continuous Index:
Within 8" of Joint: **NO**
Remarks: **M-303-073**

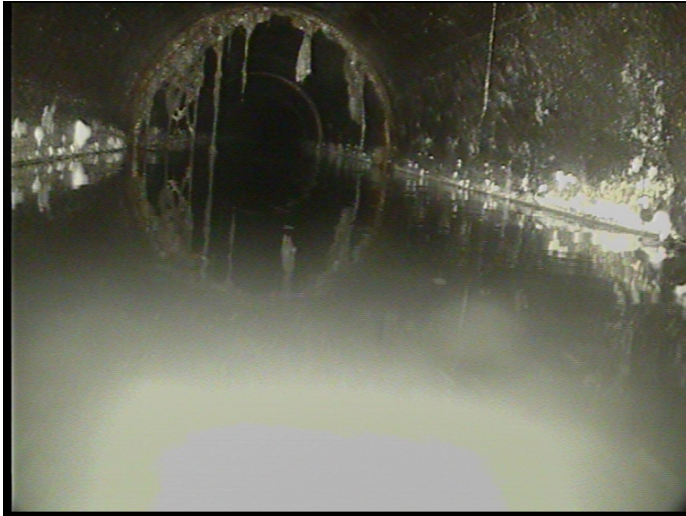
Code: **MWL**
Description: **Water Level**

Distance (ft): **.0**
Structural Grade: **0**
O&M Grade: **0**
Clock Start/From:
Clock To:
1st Value:
2nd Value:
Value Percent: **20.000**
Continuous Index:
Within 8" of Joint: **NO**
Remarks:

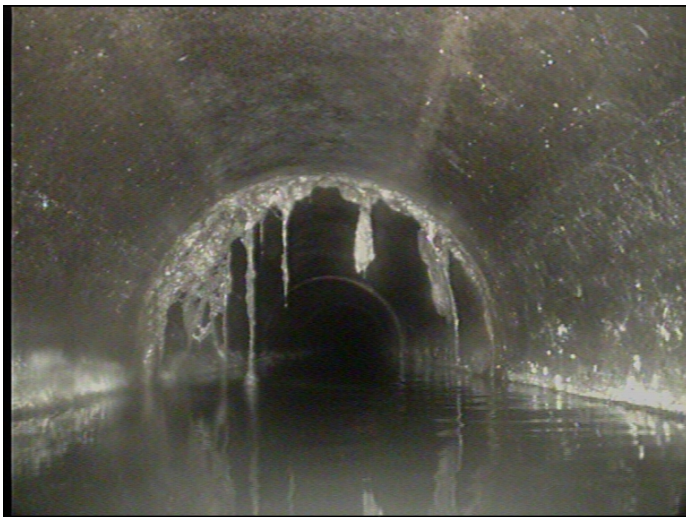
Code: **OBZ**
Description: **Obstacle Other**

Distance (ft): **1.8**
Structural Grade: **0**
O&M Grade: **3**
Clock Start/From: **5**
Clock To: **7**
1st Value:
2nd Value:
Value Percent: **15.000**
Continuous Index:
Within 8" of Joint: **NO**
Remarks: **Debris**

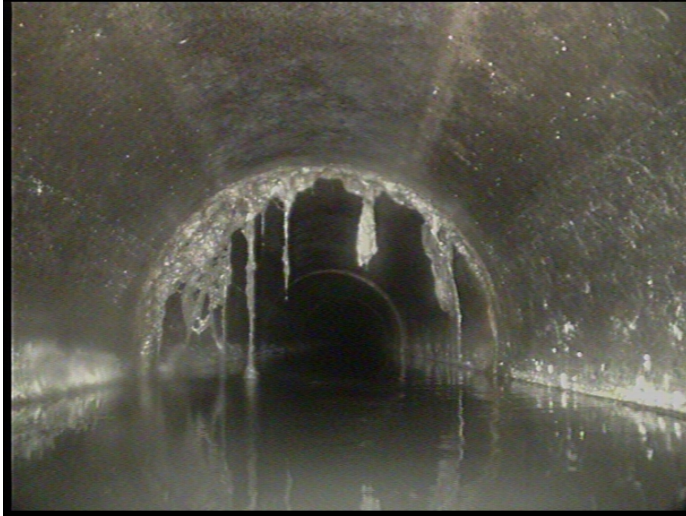
Code:	MSA
Description:	Abandoned Survey
Distance (ft):	1.8
Structural Grade:	0
O&M Grade:	0
Clock Start/From:	
Clock To:	
1st Value:	
2nd Value:	
Value Percent:	
Continuous Index:	
Within 8" of Joint:	NO
Remarks:	sediment/ underwater debris
