## Profile/Photo Observation Report

Date:	<b>01/25/2025</b>	Weather:		Coding:	<b>PACP 7.0</b>
Pipe Length (ft):	<b>367.0</b>	Owner:	<b>City of Hobart</b>	Pre Clean:	<b>Heavy Cleaning</b>
P.O.#:	<b>YES502259</b>	Surveyor:	<b>Steven Bucklin</b>	PSR:	<b>P-303-073-004</b>
Customer:	<b>City of Hobart</b>	Clean Date:	<b>10/13/2024</b>	Shape:	<b>C</b>

Street:	<b>Ridgelawn Drive</b>	Flow Control:	<b>Not Controlled</b>
City:	<b>Hobart, IN</b>	Year Renewed:	
Location:	<b>Easement/Right of Way</b>	Tape/Media #:	
Purpose:	<b>Sewer System Evaluation Survey (SS</b>	Dia/Height:	<b>18"</b>
Use:	<b>Sanitary Sewage Pipe</b>	Material:	<b>VCP</b>
Drain Area:		Lining:	<b>None</b>

US MH: **M-303-073** DS MH: **M-303-004** Total Length Surveyed (ft): **363.5**

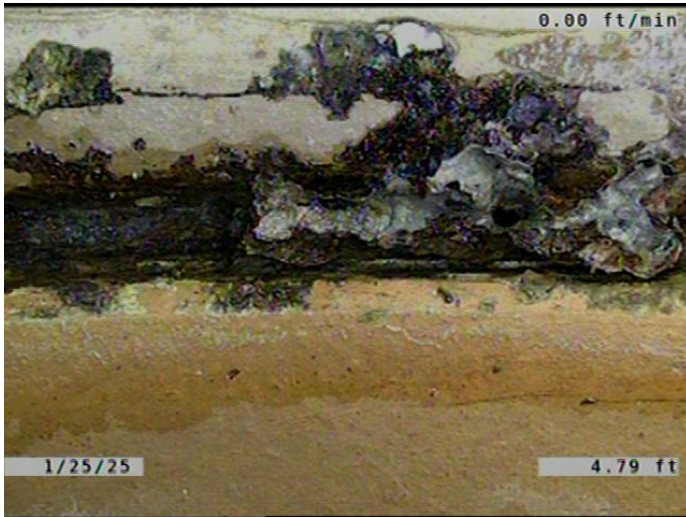
Code: **DAE**  
Description: **Deposits Attached Encrustation**

Distance (ft): **4.8**  
Structural Grade: **0**  
O&M Grade: **2**  
Clock Start/From: **9**  
Clock To: **3**  
1st Value:  
2nd Value:  
Value Percent: **5.000**  
Continuous Index: **S01**  
Within 8" of Joint: **YES**  
Remarks:

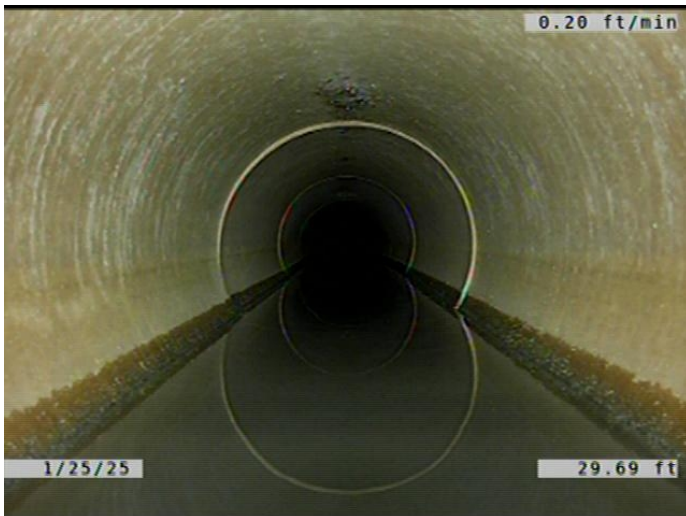
Code: **DAE**  
Description: **Deposits Attached Encrustation**

Distance (ft): **29.7**  
Structural Grade: **0**  
O&M Grade: **2**  
Clock Start/From: **9**  
Clock To: **3**  
1st Value:  
2nd Value:  
Value Percent: **5.000**  
Continuous Index: **F01**  
Within 8" of Joint: **YES**  
Remarks:

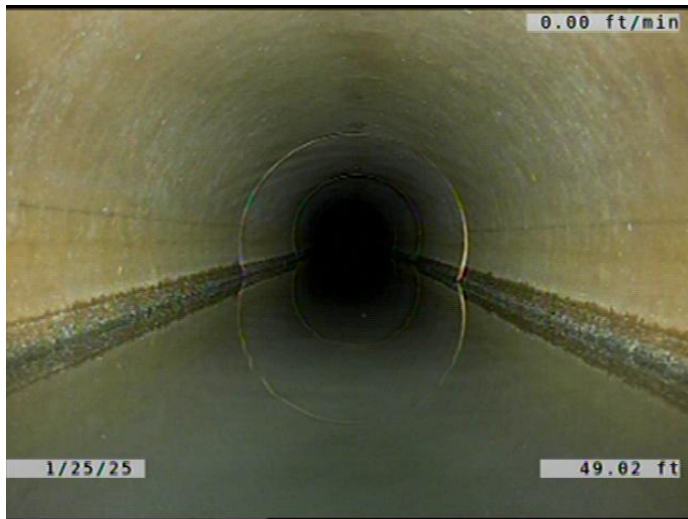
Code: **MWL**  
Description: **Miscellaneous Water Level**

Distance (ft): **49.0**  
Structural Grade: **0**  
O&M Grade: **0**  
Clock Start/From:  
Clock To:  
1st Value:  
2nd Value:  
Value Percent: **30.000**  
Continuous Index:  
Within 8" of Joint: **NO**  
Remarks:

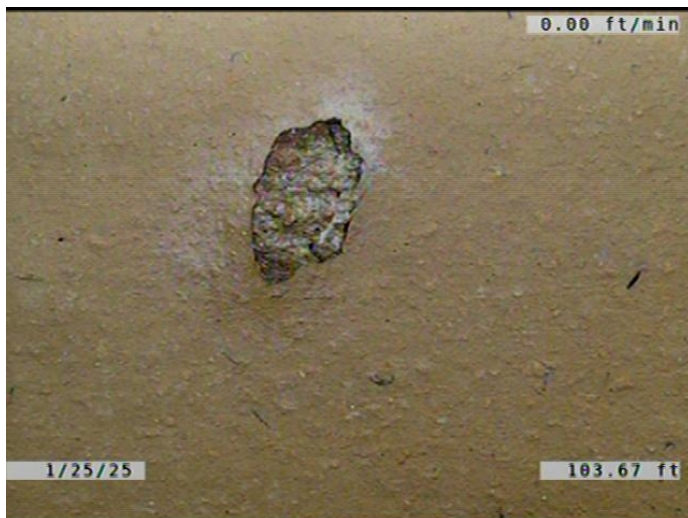
Code: **SSC**  
Description: **Surface Spalling of Damage Coating**

Distance (ft): **103.7**  
Structural Grade: **1**  
O&M Grade: **0**  
Clock Start/From: **11**  
Clock To: **12**  
1st Value:  
2nd Value:  
Value Percent:  
Continuous Index:  
Within 8" of Joint: **NO**  
Remarks:

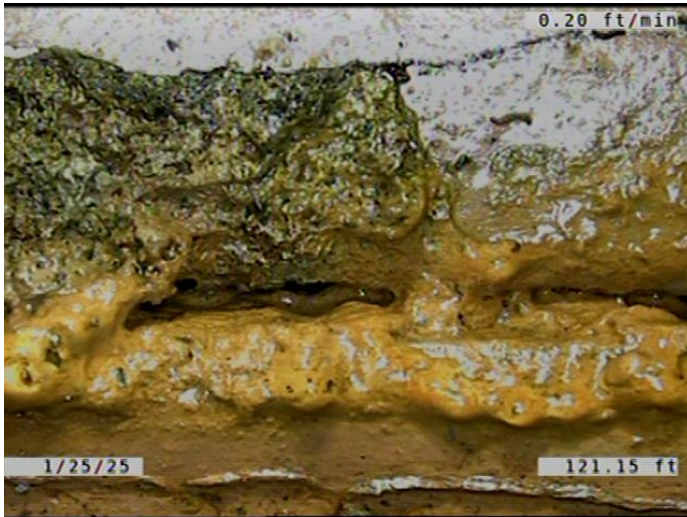
Code: **DAE**  
 Description: **Deposits Attached Encrustation**

Distance (ft): **121.1**  
 Structural Grade: **0**  
 O&M Grade: **2**  
 Clock Start/From: **8**  
 Clock To: **4**  
 1st Value:  
 2nd Value:  
 Value Percent: **5.000**  
 Continuous Index:  
 Within 8" of Joint: **YES**  
 Remarks:

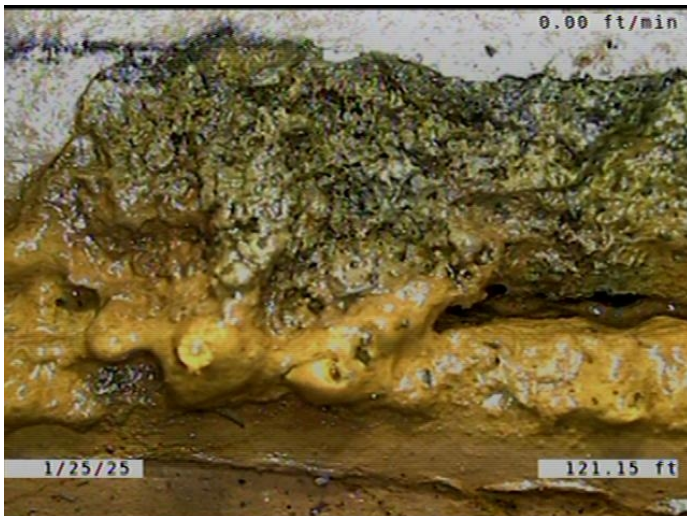
Code: **IRJ**  
 Description: **Infiltration Runner Joint**

Distance (ft): **121.2**  
 Structural Grade: **0**  
 O&M Grade: **4**  
 Clock Start/From: **11**  
 Clock To: **1**  
 1st Value:  
 2nd Value:  
 Value Percent:  
 Continuous Index:  
 Within 8" of Joint: **YES**  
 Remarks:

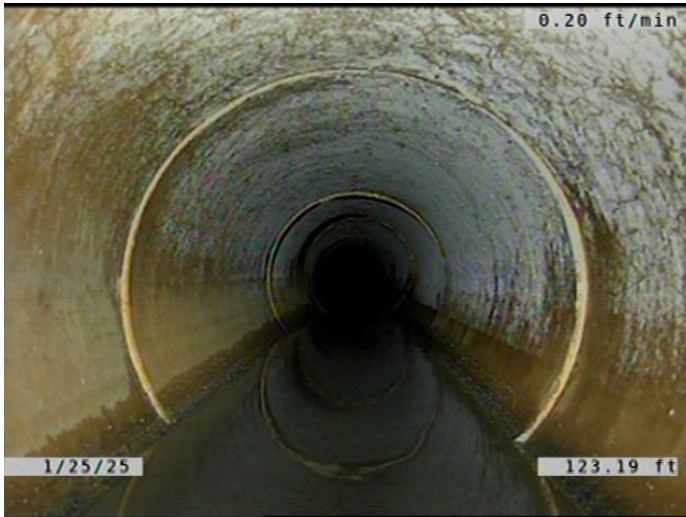
Code: **MWL**  
 Description: **Miscellaneous Water Level**

Distance (ft): **123.2**  
 Structural Grade: **0**  
 O&M Grade: **0**  
 Clock Start/From:  
 Clock To:  
 1st Value:  
 2nd Value:  
 Value Percent: **20.000**  
 Continuous Index:  
 Within 8" of Joint: **NO**  
 Remarks:

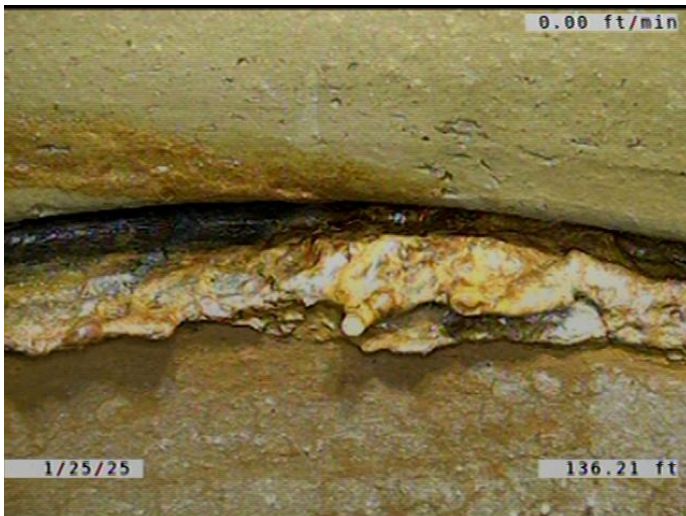
Code: **DAE**  
 Description: **Deposits Attached Encrustation**

Distance (ft): **136.2**  
 Structural Grade: **0**  
 O&M Grade: **2**  
 Clock Start/From: **8**  
 Clock To: **4**  
 1st Value:  
 2nd Value:  
 Value Percent: **5.000**  
 Continuous Index:  
 Within 8" of Joint: **YES**  
 Remarks:

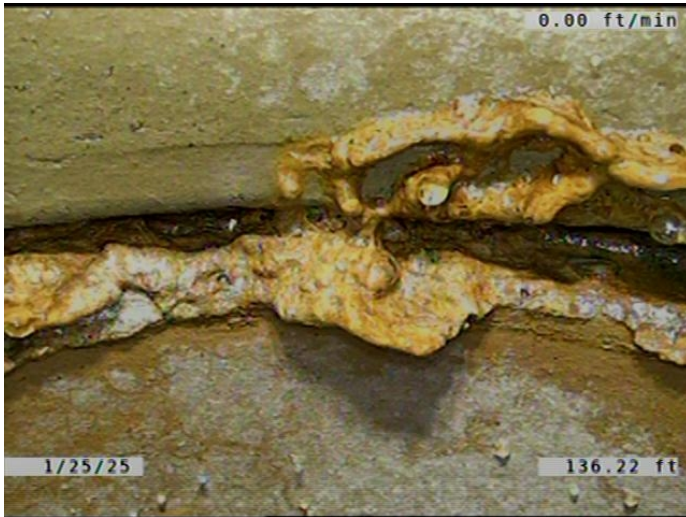
Code: **IDJ**  
Description: **Infiltration Dripper Joint**

Distance (ft): **136.2**  
Structural Grade: **0**  
O&M Grade: **3**  
Clock Start/From: **11**  
Clock To: **1**  
1st Value:  
2nd Value:  
Value Percent:  
Continuous Index:  
Within 8" of Joint: **YES**  
Remarks:

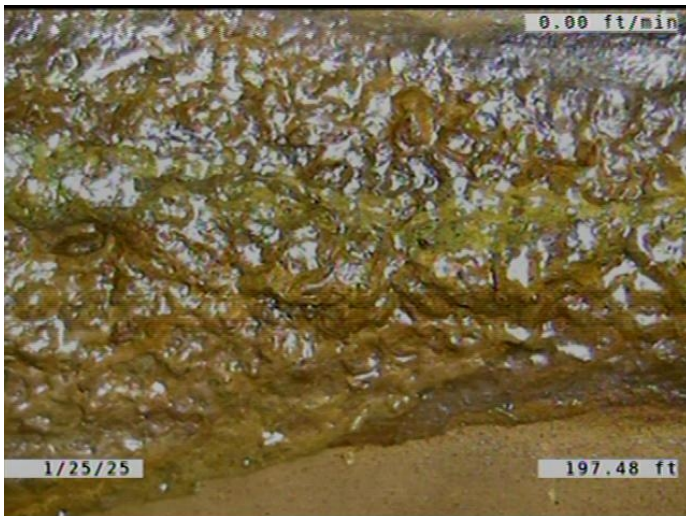
Code: **DAE**  
Description: **Deposits Attached Encrustation**

Distance (ft): **197.5**  
Structural Grade: **0**  
O&M Grade: **2**  
Clock Start/From: **8**  
Clock To: **4**  
1st Value:  
2nd Value:  
Value Percent: **5.000**  
Continuous Index:  
Within 8" of Joint: **YES**  
Remarks:

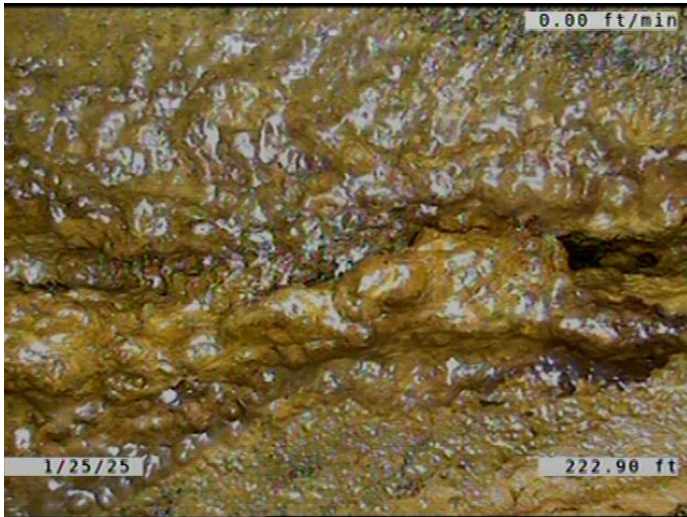
Code: **DAE**  
 Description: **Deposits Attached Encrustation**

Distance (ft): **222.9**  
 Structural Grade: **0**  
 O&M Grade: **2**  
 Clock Start/From: **8**  
 Clock To: **4**  
 1st Value:  
 2nd Value:  
 Value Percent: **5.000**  
 Continuous Index: **S02**  
 Within 8" of Joint: **YES**  
 Remarks:

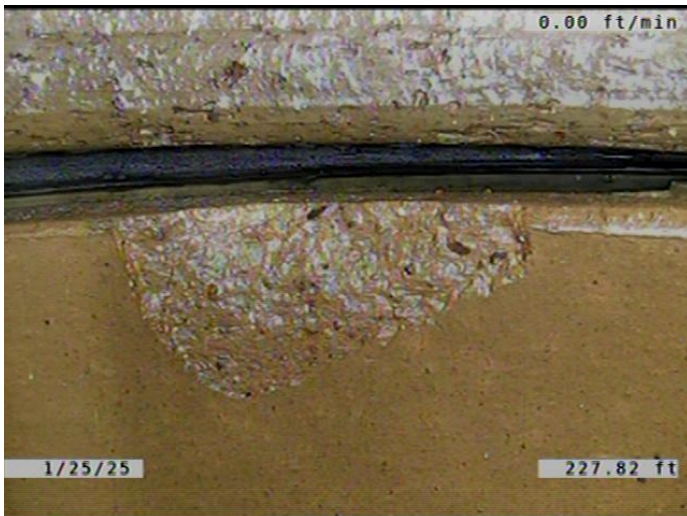
Code: **SSS**  
 Description: **Surface Damage Surface Spalling**

Distance (ft): **227.8**  
 Structural Grade: **2**  
 O&M Grade: **0**  
 Clock Start/From: **9**  
 Clock To: **10**  
 1st Value:  
 2nd Value:  
 Value Percent:  
 Continuous Index:  
 Within 8" of Joint: **YES**  
 Remarks:

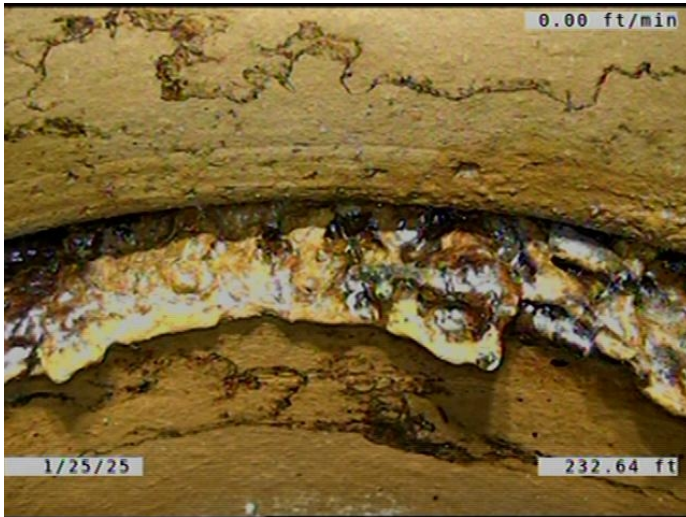
Code: **IDJ**  
 Description: **Infiltration Dripper Joint**

Distance (ft): **232.6**  
 Structural Grade: **0**  
 O&M Grade: **3**  
 Clock Start/From: **10**  
 Clock To: **2**  
 1st Value:  
 2nd Value:  
 Value Percent:  
 Continuous Index:  
 Within 8" of Joint: **YES**  
 Remarks:

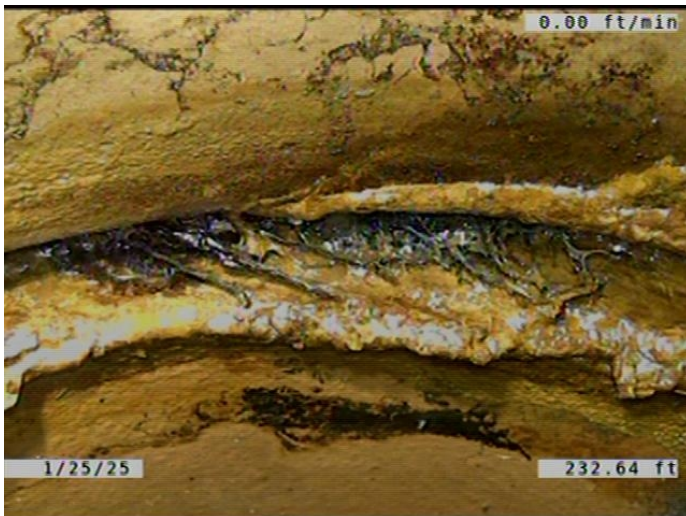
Code: **RFJ**  
 Description: **Roots Fine Joint**

Distance (ft): **232.6**  
 Structural Grade: **0**  
 O&M Grade: **1**  
 Clock Start/From: **2**  
 Clock To: **4**  
 1st Value:  
 2nd Value:  
 Value Percent:  
 Continuous Index:  
 Within 8" of Joint: **YES**  
 Remarks:

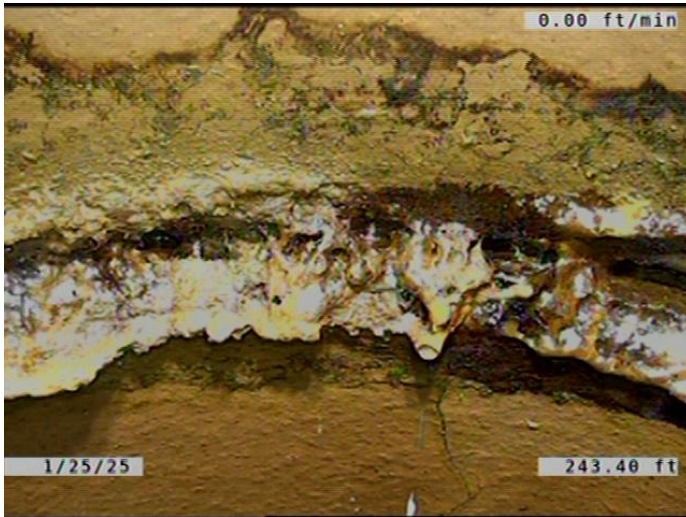
Code: **IDJ**  
Description: **Infiltration Dripper Joint**

Distance (ft): **243.4**  
Structural Grade: **0**  
O&M Grade: **3**  
Clock Start/From: **12**  
Clock To:  
1st Value:  
2nd Value:  
Value Percent:  
Continuous Index:  
Within 8" of Joint: **YES**  
Remarks:

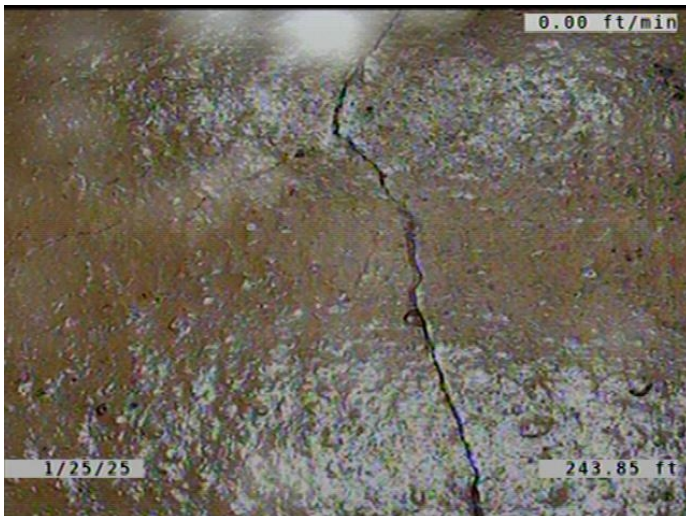
Code: **CM**  
Description: **Crack Multiple**

Distance (ft): **243.8**  
Structural Grade: **3**  
O&M Grade: **0**  
Clock Start/From: **10**  
Clock To: **2**  
1st Value:  
2nd Value:  
Value Percent:  
Continuous Index:  
Within 8" of Joint: **YES**  
Remarks:

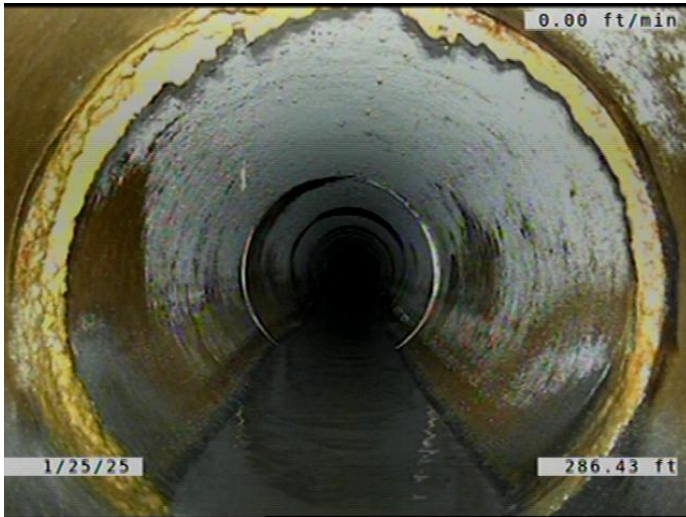
Code: **MWL**  
 Description: **Miscellaneous Water Level**

Distance (ft): **286.4**  
 Structural Grade: **0**  
 O&M Grade: **0**  
 Clock Start/From:  
 Clock To:  
 1st Value:  
 2nd Value:  
 Value Percent: **10.000**  
 Continuous Index:  
 Within 8" of Joint: **NO**  
 Remarks:

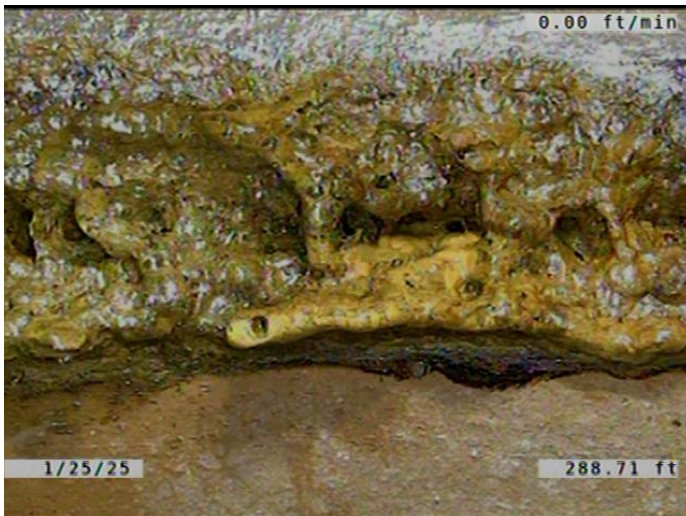
Code: **IDJ**  
 Description: **Infiltration Dripper Joint**

Distance (ft): **288.7**  
 Structural Grade: **0**  
 O&M Grade: **3**  
 Clock Start/From: **11**  
 Clock To: **12**  
 1st Value:  
 2nd Value:  
 Value Percent:  
 Continuous Index:  
 Within 8" of Joint: **YES**  
 Remarks:

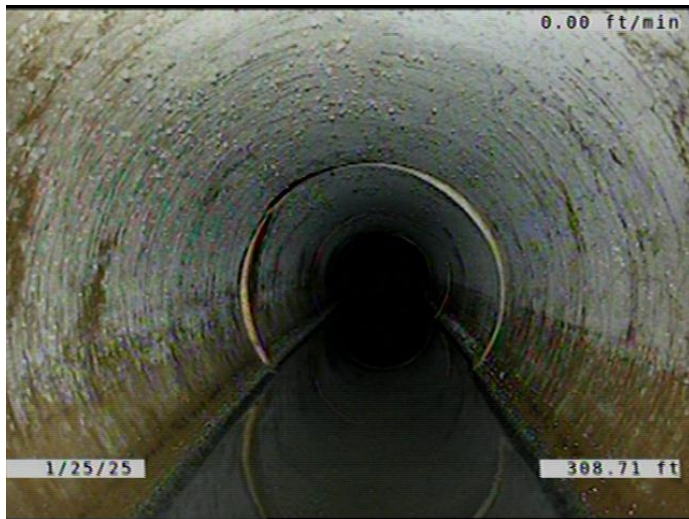
Code: **LR**  
 Description: **Line Right**

Distance (ft): **308.7**  
 Structural Grade: **0**  
 O&M Grade: **1**  
 Clock Start/From:  
 Clock To:  
 1st Value:  
 2nd Value:  
 Value Percent: **5.000**  
 Continuous Index:  
 Within 8" of Joint: **NO**  
 Remarks:

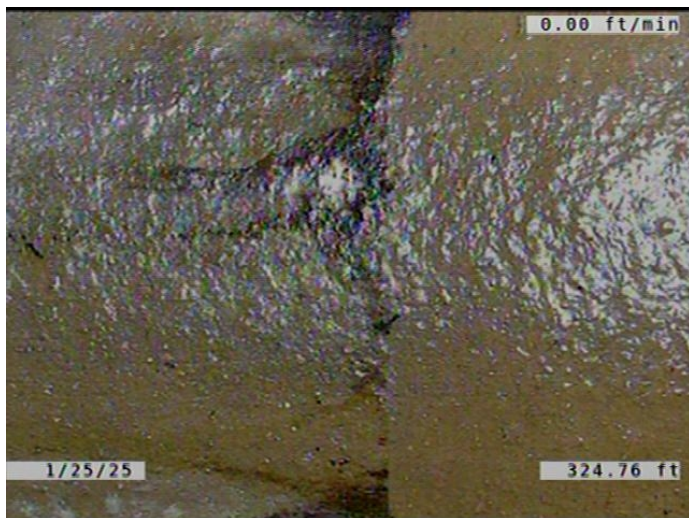
Code: **CL**  
 Description: **Crack Longitudinal**

Distance (ft): **324.8**  
 Structural Grade: **2**  
 O&M Grade: **0**  
 Clock Start/From: **10**  
 Clock To:  
 1st Value:  
 2nd Value:  
 Value Percent:  
 Continuous Index:  
 Within 8" of Joint: **YES**  
 Remarks:

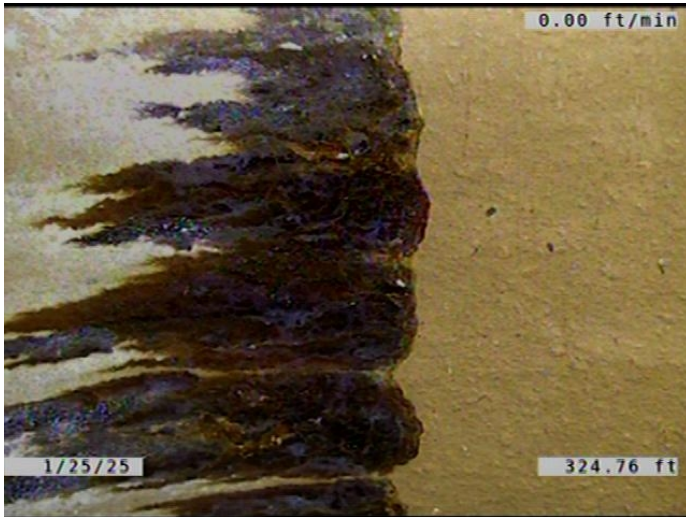
Code: **ISB**  
Description: **Infiltration Stain Barrel**

Distance (ft): **324.8**  
Structural Grade: **0**  
O&M Grade: **1**  
Clock Start/From: **8**  
Clock To: **10**  
1st Value:  
2nd Value:  
Value Percent:  
Continuous Index:  
Within 8" of Joint: **YES**  
Remarks:

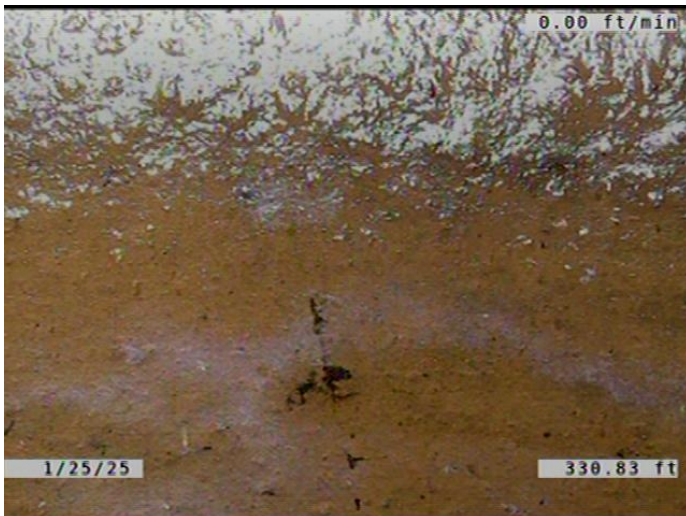
Code: **CS**  
Description: **Crack Spiral**

Distance (ft): **330.8**  
Structural Grade: **2**  
O&M Grade: **0**  
Clock Start/From: **1**  
Clock To: **2**  
1st Value:  
2nd Value:  
Value Percent:  
Continuous Index:  
Within 8" of Joint: **YES**  
Remarks:

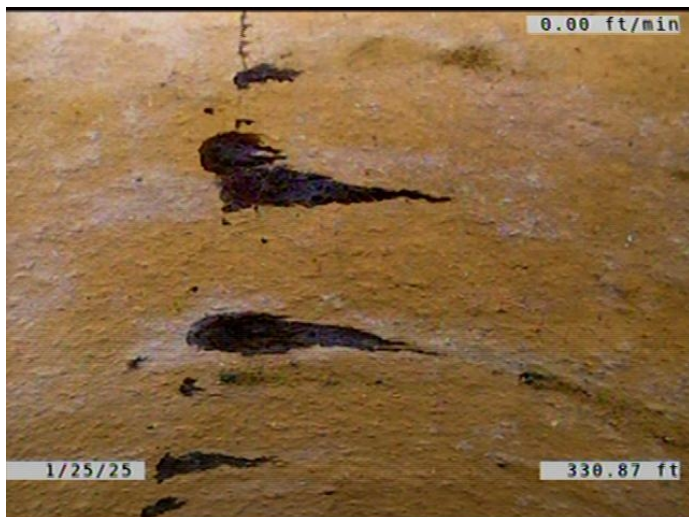
Code: **ISB**  
 Description: **Infiltration Stain Barrel**

Distance (ft): **330.8**  
 Structural Grade: **0**  
 O&M Grade: **1**  
 Clock Start/From: **1**  
 Clock To: **3**  
 1st Value:  
 2nd Value:  
 Value Percent:  
 Continuous Index:  
 Within 8" of Joint: **YES**  
 Remarks:

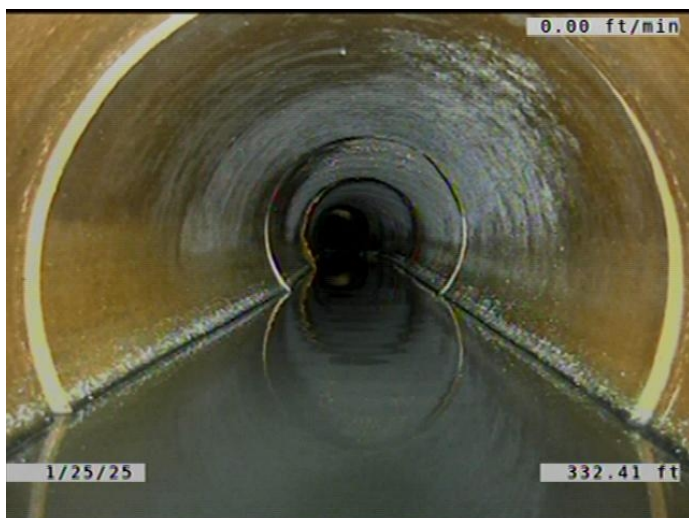
Code: **MWL**  
 Description: **Miscellaneous Water Level**

Distance (ft): **332.4**  
 Structural Grade: **0**  
 O&M Grade: **0**  
 Clock Start/From:  
 Clock To:  
 1st Value:  
 2nd Value:  
 Value Percent: **20.000**  
 Continuous Index:  
 Within 8" of Joint: **NO**  
 Remarks:

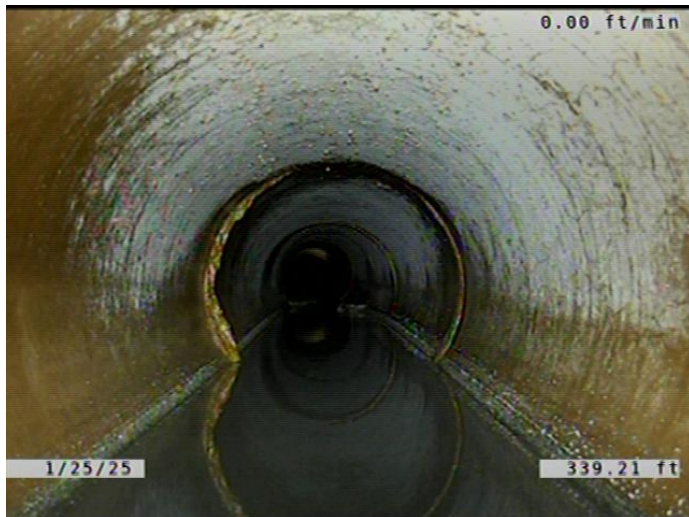
Code: **LL**  
 Description: **Line Left**

Distance (ft): **339.2**  
 Structural Grade: **0**  
 O&M Grade: **1**  
 Clock Start/From:  
 Clock To:  
 1st Value:  
 2nd Value:  
 Value Percent: **5.000**  
 Continuous Index:  
 Within 8" of Joint: **NO**  
 Remarks:

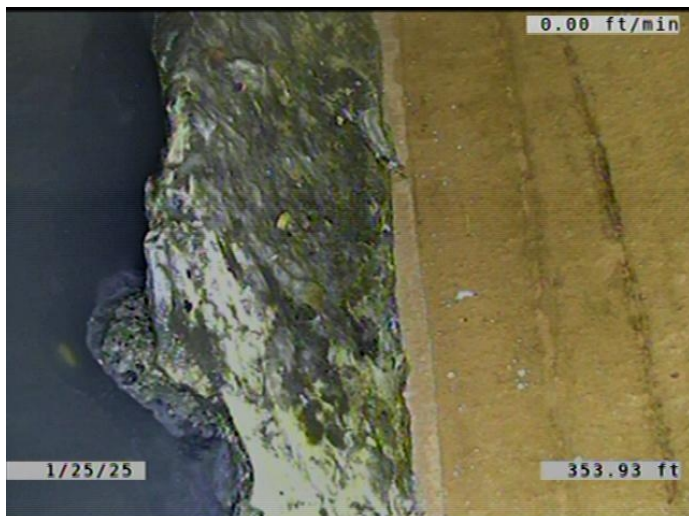
Code: **DAE**  
 Description: **Deposits Attached Encrustation**

Distance (ft): **353.9**  
 Structural Grade: **0**  
 O&M Grade: **2**  
 Clock Start/From: **4**  
 Clock To: **8**  
 1st Value:  
 2nd Value:  
 Value Percent: **5.000**  
 Continuous Index: **S03**  
 Within 8" of Joint: **YES**  
 Remarks:

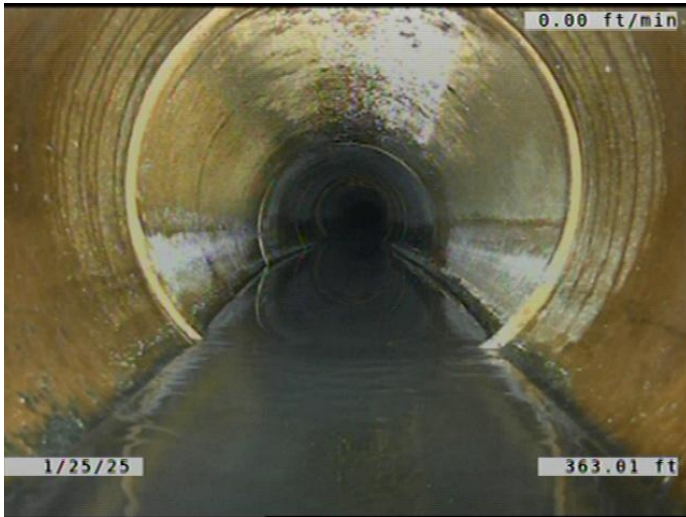
Code: **DAE**  
Description: **Deposits Attached Encrustation**

Distance (ft): **363.0**  
Structural Grade: **0**  
O&M Grade: **2**  
Clock Start/From: **8**  
Clock To: **4**  
1st Value:  
2nd Value:  
Value Percent: **5.000**  
Continuous Index: **F02**  
Within 8" of Joint: **YES**  
Remarks:

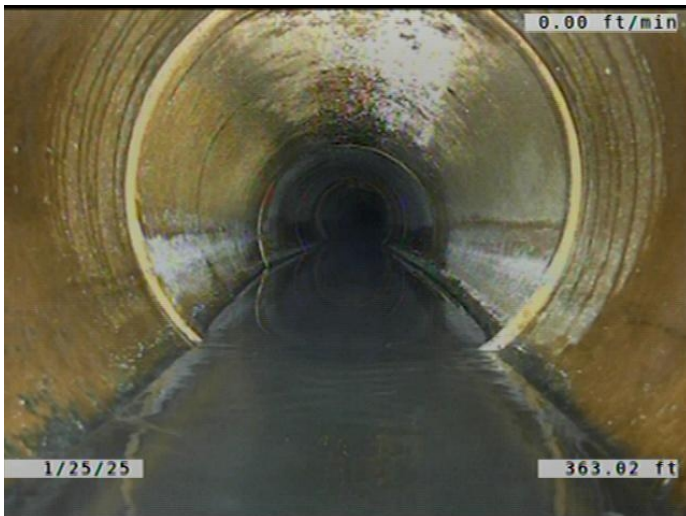
Code: **DAE**  
Description: **Deposits Attached Encrustation**

Distance (ft): **363.0**  
Structural Grade: **0**  
O&M Grade: **2**  
Clock Start/From: **4**  
Clock To: **8**  
1st Value:  
2nd Value:  
Value Percent: **5.000**  
Continuous Index: **F03**  
Within 8" of Joint: **YES**  
Remarks:
