Profile/Photo Observation Report

Date:	04/07/2018	Weather:		Coding:	PACP 6.0
Pipe Length (ft):		Owner:	City of Hobart	Pre Clean:	No Pre-Cleaning
P.O.#:	11-1	Surveyor:	M. Pielacha	PSR:	M-303-005-M-303-004
Customer:	City of Hobart	Clean Date:		Shape:	C

Street:	Ridgelawn Drive	Flow Control:	Not Controlled
City:	Hobart, IN	Year Renewed:	
Location:	Light Highway	Tape/Media #:	DEP 11
Purpose:	Routine Assessment	Dia/Height:	15"
Use:	Sanitary	Material:	VCP
Drain Area:		Lining:	
Category:	NA		
Comment:			
Location Details:		Direction of Survey:	Upstream
US MH:	M-303-005	DS MH:	M-303-004
		Total Length Surveyed (ft):	203.7

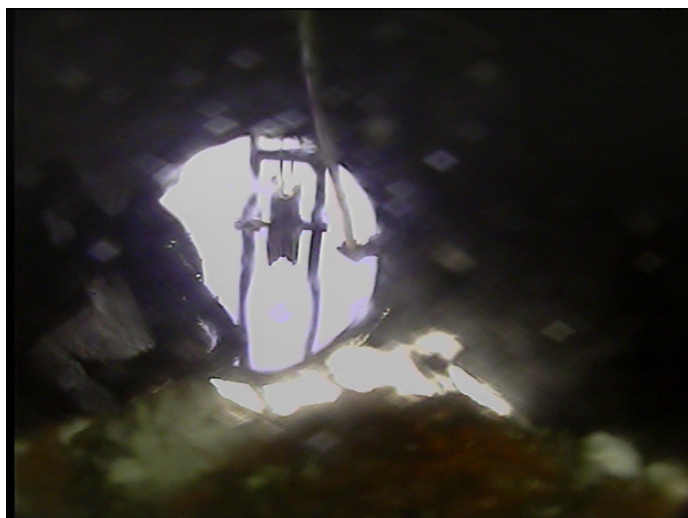
Code: **AMH**
 Description: **Manhole**

Distance (ft): **.0**
 Structural Grade: **0**
 O&M Grade: **0**
 Clock Start/From:
 Clock To:
 1st Value:
 2nd Value:
 Value Percent:
 Continuous Index:
 Within 8" of Joint: **NO**
 Remarks: **M-303-004**

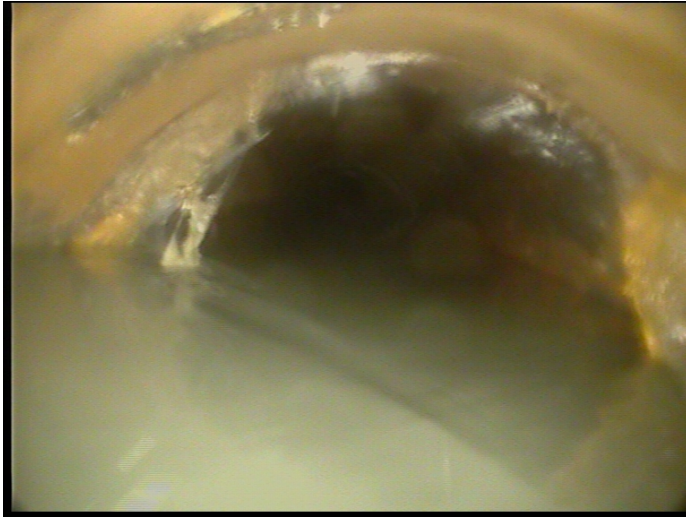
Code:	MWL
Description:	Water Level
Distance (ft):	.0
Structural Grade:	0
O&M Grade:	0
Clock Start/From:	
Clock To:	
1st Value:	
2nd Value:	
Value Percent:	35.000
Continuous Index:	
Within 8" of Joint:	NO
Remarks:

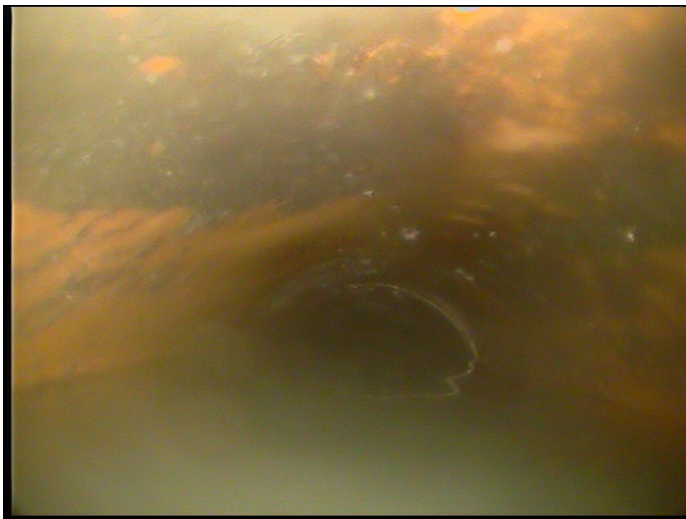
Code:	MWL
Description:	Water Level
Distance (ft):	2.9
Structural Grade:	0
O&M Grade:	0
Clock Start/From:	
Clock To:	
1st Value:	
2nd Value:	
Value Percent:	75.000
Continuous Index:	
Within 8" of Joint:	NO
Remarks:

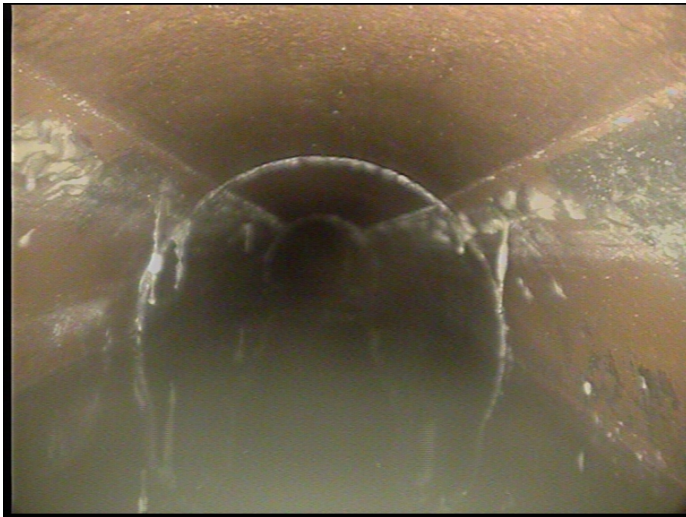
Code: **MWL**
Description: **Water Level**

Distance (ft): **56.4**
Structural Grade: **0**
O&M Grade: **0**
Clock Start/From:
Clock To:
1st Value:
2nd Value:
Value Percent: **40.000**
Continuous Index:
Within 8" of Joint: **NO**
Remarks:

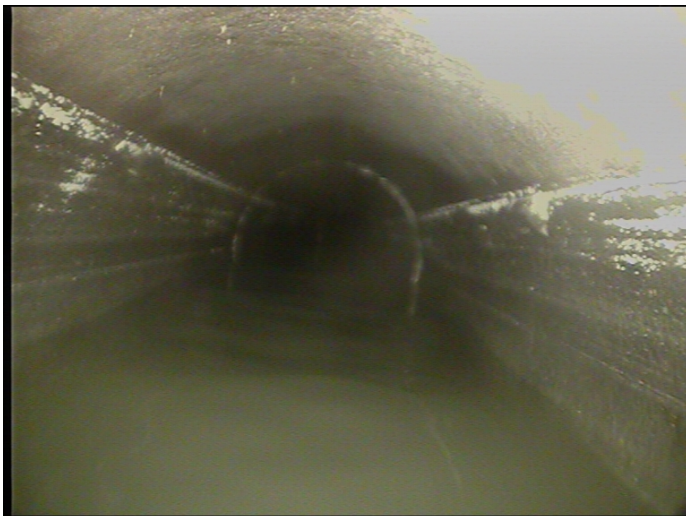
Code: **MWL**
Description: **Water Level**

Distance (ft): **64.1**
Structural Grade: **0**
O&M Grade: **0**
Clock Start/From:
Clock To:
1st Value:
2nd Value:
Value Percent: **25.000**
Continuous Index:
Within 8" of Joint: **NO**
Remarks:

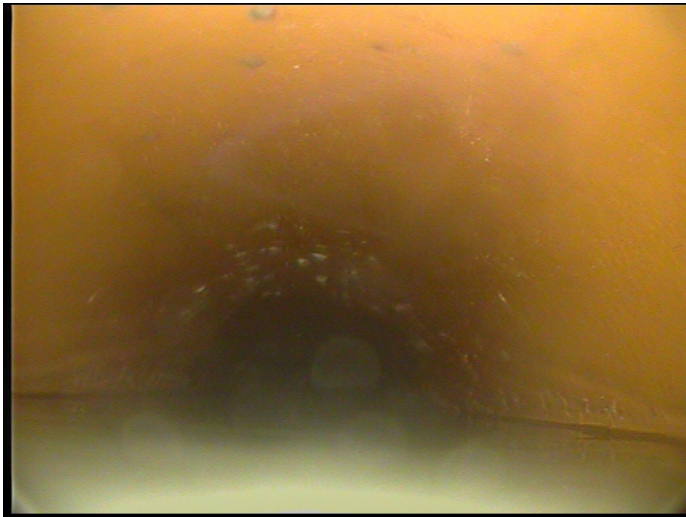
Code: **MWL**
Description: **Water Level**

Distance (ft): **93.6**
Structural Grade: **0**
O&M Grade: **0**
Clock Start/From:
Clock To:
1st Value:
2nd Value:
Value Percent: **50.000**
Continuous Index:
Within 8" of Joint: **NO**
Remarks:

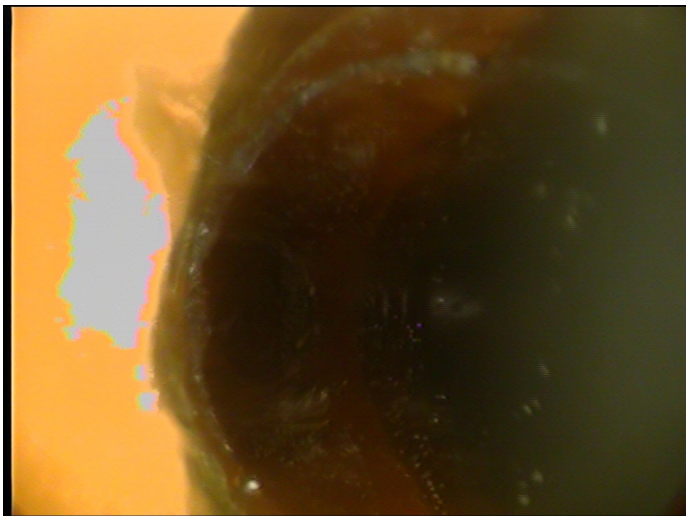
Code: **TF**
Description: **Tap Factory**

Distance (ft): **109.5**
Structural Grade: **0**
O&M Grade: **0**
Clock Start/From: **3**
Clock To:
1st Value: **4.000**
2nd Value:
Value Percent:
Continuous Index:
Within 8" of Joint: **NO**
Remarks:

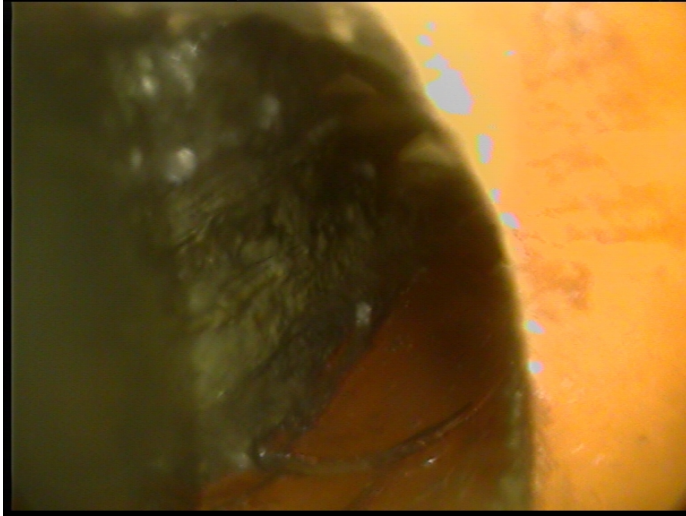
Code: **TF**
Description: **Tap Factory**

Distance (ft): **111.3**
Structural Grade: **0**
O&M Grade: **0**
Clock Start/From: **9**
Clock To:
1st Value: **4.000**
2nd Value:
Value Percent:
Continuous Index:
Within 8" of Joint: **NO**
Remarks:

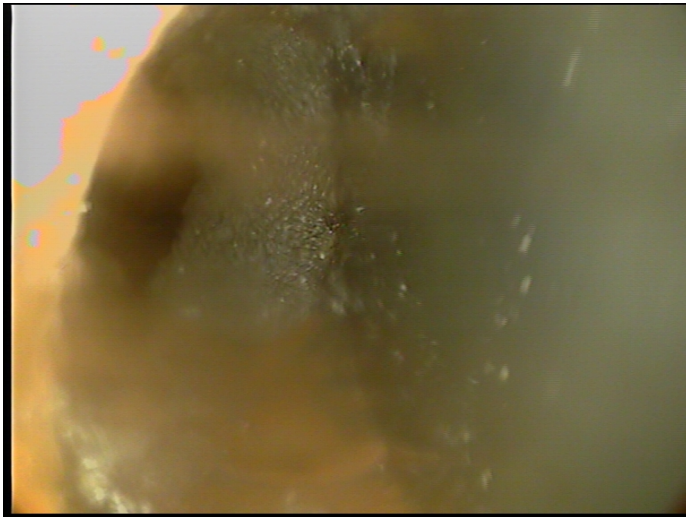
Code: **TF**
Description: **Tap Factory**

Distance (ft): **188.2**
Structural Grade: **0**
O&M Grade: **0**
Clock Start/From: **3**
Clock To:
1st Value: **4.000**
2nd Value:
Value Percent:
Continuous Index:
Within 8" of Joint: **NO**
Remarks:

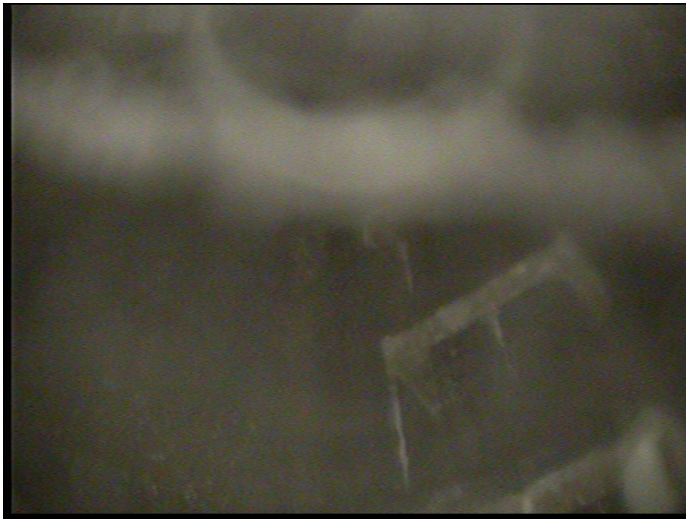
Code:	AMH
Description:	Manhole
Distance (ft):	203.7
Structural Grade:	0
O&M Grade:	0
Clock Start/From:	
Clock To:	
1st Value:	
2nd Value:	
Value Percent:	
Continuous Index:	
Within 8" of Joint:	NO
Remarks:	M-303-005
