Profile/Photo Observation Report

Date:	04/07/2018	Weather:		Coding:	PACP 6.0
Pipe Length (ft):		Owner:	City of Hobart	Pre Clean:	No Pre-Cleaning
P.O.#:	11-1	Surveyor:	M. Pielacha	PSR:	M-303-005-M-303-004
Customer:	City of Hobart	Clean Date:		Shape:	C

Street:	Ridgelawn Drive	Flow Control:	Not Controlled
City:	Hobart, IN	Year Renewed:	
Location:	Light Highway	Tape/Media #:	DEP 11
Purpose:	Routine Assessment	Dia/Height:	15"
Use:	Sanitary	Material:	VCP
Drain Area:		Lining:	
Category:	NA		
Comment:			
Location Details:		Direction of Survey:	Upstream
US MH:	M-303-005	DS MH:	M-303-004
		Total Length Surveyed (ft):	203.7

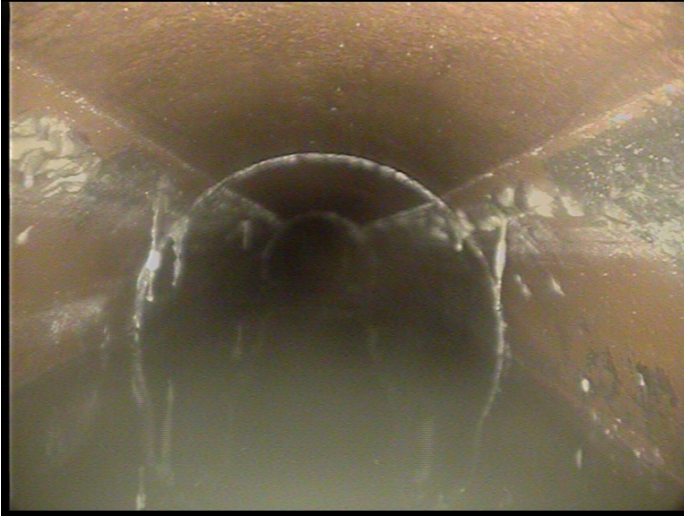
Code:	MWL
Description:	Water Level
Distance (ft):	2.9
Structural Grade:	0
O&M Grade:	0
Clock Start/From:	
Clock To:	
1st Value:	
2nd Value:	
Value Percent:	75.000
Continuous Index:	
Within 8" of Joint:	NO
Remarks:

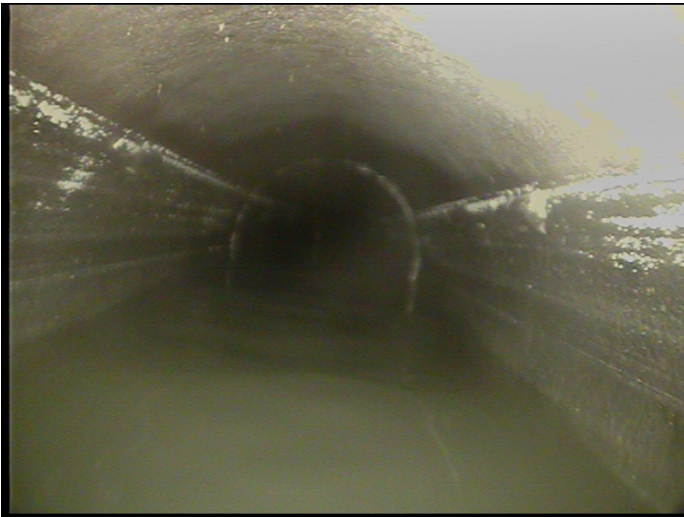
Code: **MWL**
Description: **Water Level**

Distance (ft): **56.4**
Structural Grade: **0**
O&M Grade: **0**
Clock Start/From:
Clock To:
1st Value:
2nd Value:
Value Percent: **40.000**
Continuous Index:
Within 8" of Joint: **NO**
Remarks:

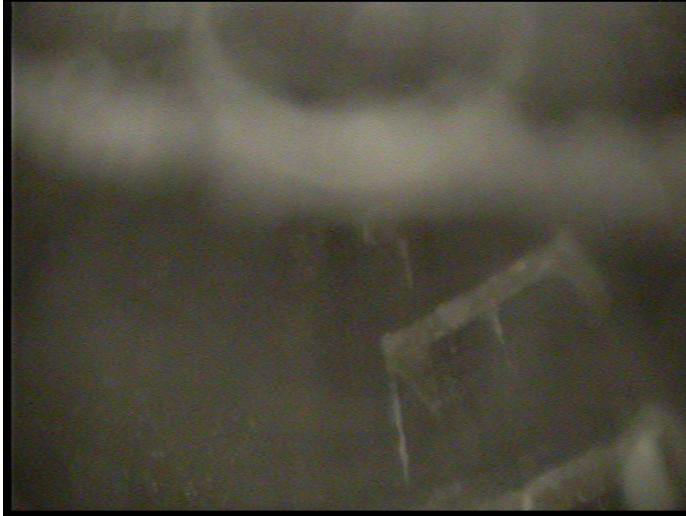
Code:	TF
Description:	Tap Factory
Distance (ft):	188.2
Structural Grade:	0
O&M Grade:	0
Clock Start/From:	3
Clock To:	
1st Value:	4.000
2nd Value:	
Value Percent:	
Continuous Index:	
Within 8" of Joint:	NO
Remarks:
