## Profile/Photo Observation Report

| Street: | <b>W OLD RIDGE RD</b> | Flow Control: | <b>Not Controlled</b> |
| City: | <b>Hobart, IN</b> | Year Renewed: | |

| US MH: | <b>M-303-006</b> | DS MH: | <b>M-303-005</b> |

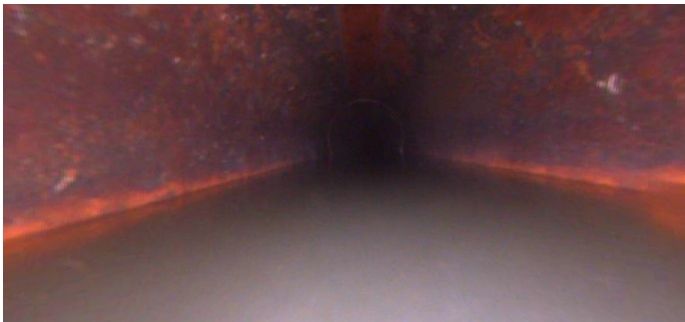
Code: **AMH**  
Description: **Manhole**

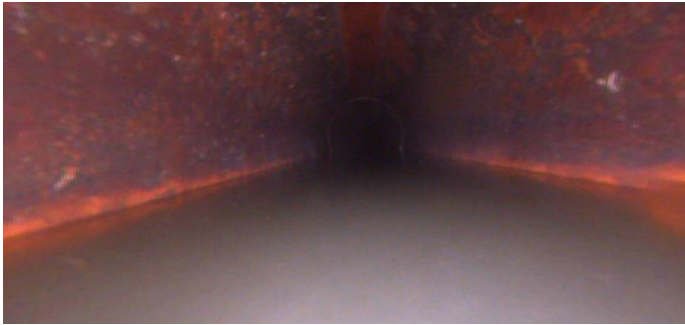
| Code: | <b>MWL</b> |
| Description: | <b>Water Level</b> |

| Distance (ft): | <b>.0</b> |
| Value Percent: | <b>5.000</b> |

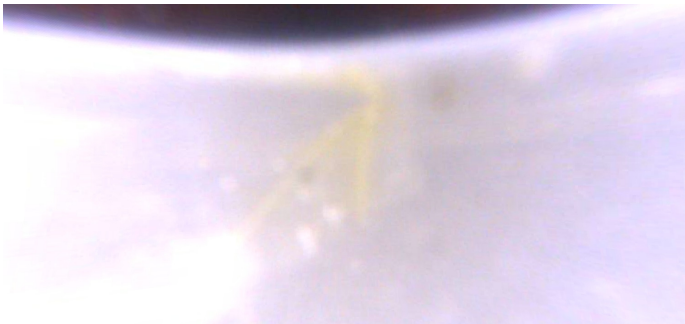
| Position | Code | Observation | Video (sec) | Grade |
|---|---|---|---|---|
| 18.9 | MWLS | Water Level Sag | 70 | S 2 |

| Code: | <b>MWLS</b> |
| Description: | <b>Water Level Sag</b> |

| Distance (ft): | <b>18.9</b> |
| Structural Grade: | <b>2</b> |
| O&M Grade: | <b>3</b> |
| Value Percent: | <b>20.000</b> |

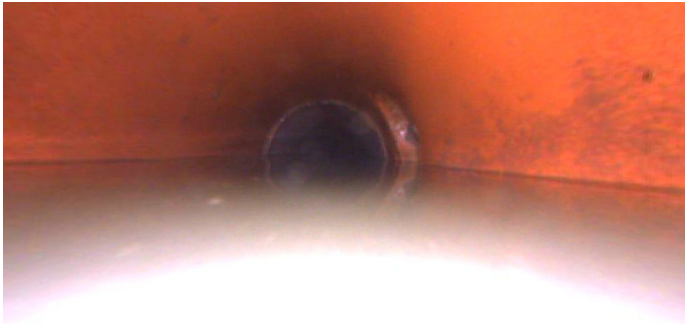
| Position | Code | Observation | Video (sec) | Grade |
|---|---|---|---|---|
| 19.6 | TF | Tap Factory | 83 | NA |

Code: **TF**  
Description: **Tap Factory**

Distance (ft): **19.6**  
Structural Grade: **0**  
O&M Grade: **0**  
Clock Start/From: **3**  
Clock To:  
1st Value: **4.000**  
2nd Value:  
Value Percent:  
Continuous Index:  
Within 8" of Joint:  
Remarks:

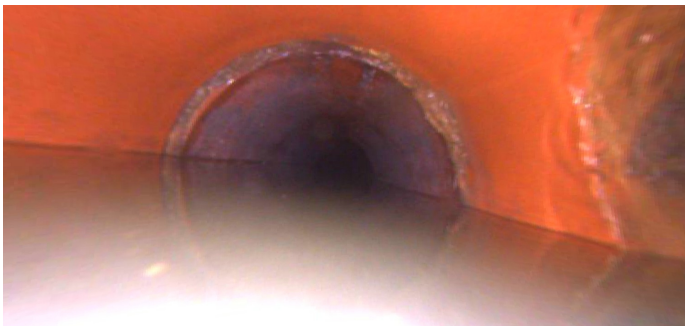
| Position | Code | Observation | Video (sec) | Grade |
|---|---|---|---|---|
| 20.9 | DAE | Deposits Attached Encrustation | 97 | M 2 |

Code: **DAE**  
Description: **Deposits Attached Encrustation**

Distance (ft): **20.9**  
Structural Grade: **0**  
O&M Grade: **2**  
Clock Start/From: **9**  
Clock To: **3**  
1st Value:  
2nd Value:  
Value Percent: **10.000**  
Continuous Index:  
Within 8" of Joint: **YES**  
Remarks:

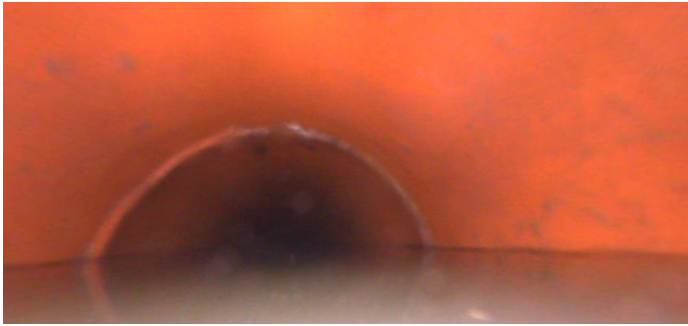
| Code: | <b>MSA</b> |
| Description: | <b>Abandoned Survey</b> |
| Distance (ft): | <b>36.1</b> |
| Remarks: | <b>camera stopped</b> |
