## Profile/Photo Observation Report

Street:	<b>39th. Ave.</b>	Flow Control:	<b>Not Controlled</b>
City:	<b>Hobart, IN</b>	Year Renewed:	
Location:	<b>Light Highway</b>	Tape/Media #:	
Purpose:	<b>Routine Assessment</b>	Dia/Height:	<b>12"</b>
Use:	<b>Sanitary</b>	Material:	<b>VCP</b>
Drain Area:	<b>NA</b>	Lining:	
Category:	<b>NA</b>		
Comment:

Location Details:		Direction of Survey:	<b>Upstream</b>
US MH:	<b>M-303-006</b>	DS MH:	<b>M-303-005</b>
		Total Length Surveyed (ft):	<b>36.1</b>

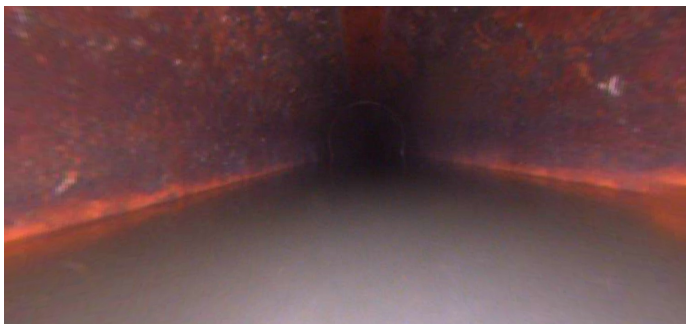
Code: **AMH**  
Description: **Manhole**

Distance (ft): **.0**  
Structural Grade: **0**  
O&M Grade: **0**  
Clock Start/From:  
Clock To:  
1st Value:  
2nd Value:  
Value Percent:  
Continuous Index:  
Within 8" of Joint: **NO**  
Remarks: **M-303-005**

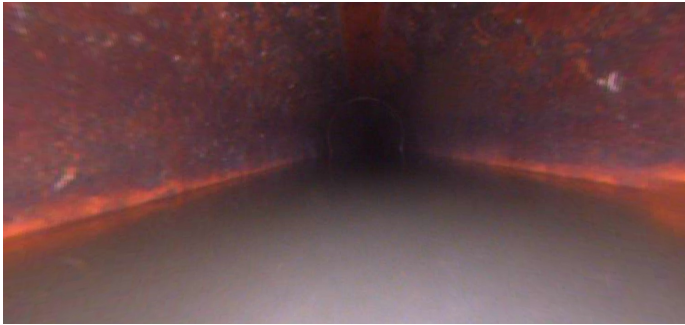
Code:	<b>MWL</b>
Description:	<b>Water Level</b>

Distance (ft):	<b>.0</b>
Structural Grade:	<b>0</b>
O&M Grade:	<b>0</b>
Clock Start/From:	
Clock To:	
1st Value:	
2nd Value:	
Value Percent:	<b>5.000</b>
Continuous Index:	
Within 8" of Joint:	<b>NO</b>
Remarks:

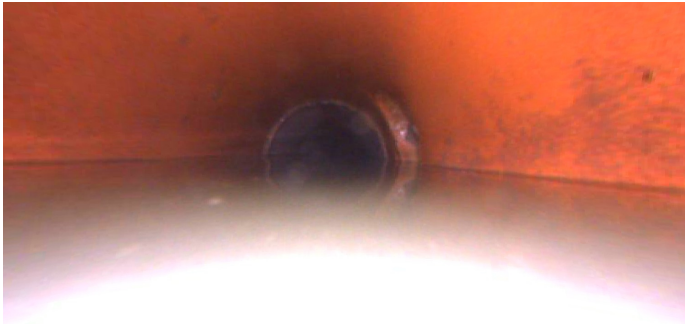
Code: **TF**  
Description: **Tap Factory**

Distance (ft): **19.6**  
Structural Grade: **0**  
O&M Grade: **0**  
Clock Start/From: **3**  
Clock To:  
1st Value: **4.000**  
2nd Value:  
Value Percent:  
Continuous Index:  
Within 8" of Joint:  
Remarks:

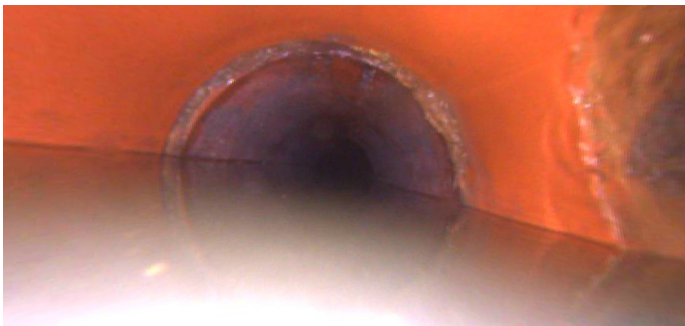
Code: **DAE**  
Description: **Deposits Attached Encrustation**

Distance (ft): **20.9**  
Structural Grade: **0**  
O&M Grade: **2**  
Clock Start/From: **9**  
Clock To: **3**  
1st Value:  
2nd Value:  
Value Percent: **10.000**  
Continuous Index:  
Within 8" of Joint: **YES**  
Remarks:

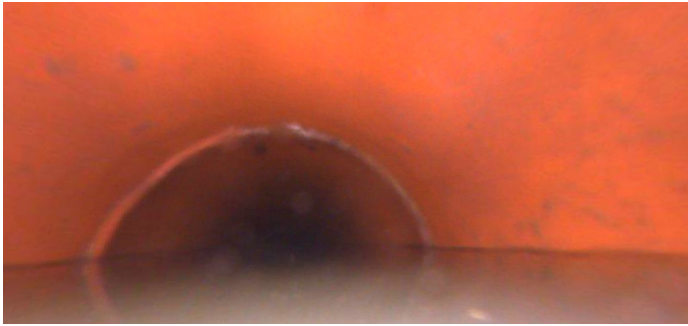
Code:	<b>MSA</b>
Description:	<b>Abandoned Survey</b>
Distance (ft):	<b>36.1</b>
Structural Grade:	<b>0</b>
O&M Grade:	<b>0</b>
Clock Start/From:	
Clock To:	
1st Value:	
2nd Value:	
Value Percent:	
Continuous Index:	
Within 8" of Joint:	<b>NO</b>
Remarks:	<b>camera stopped</b>
