Profile/Photo Observation Report

Date:	10/23/2021	Weather:		Coding:	PACP 6.0
Pipe Length (ft):		Owner:	Hobart, IN	Pre Clean:	Not Known
P.O.#:	994_1	Surveyor:	M. Pielacha	PSR:	P-303-007-006
Customer:	Hobart, IN	Clean Date:		Shape:	C

Street:	Off Old Ridge Road	Flow Control:	
City:	Hobart, IN	Year Renewed:	
Location:	Sidewalk	Tape/Media #:	994
Purpose:	Routine Assessment	Dia/Height:	12"
Use:	Sanitary	Material:	VCP
Drain Area:		Lining:

US MH: **M-303-7** DS MH: **M-303-6** Total Length Surveyed (ft): **62.9**

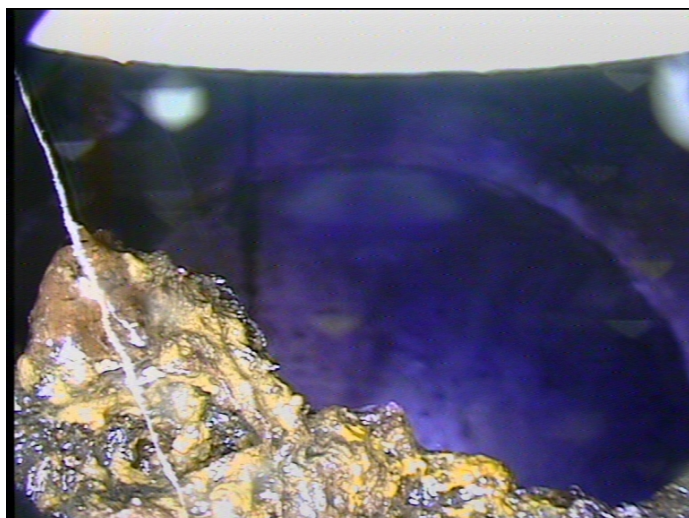
Code: **AMH**
Description: **Manhole**

Distance (ft): **.0**
Structural Grade: **0**
O&M Grade: **0**
Clock Start/From:
Clock To:
1st Value:
2nd Value:
Value Percent:
Continuous Index:
Within 8" of Joint: **NO**
Remarks: **M-303-6**

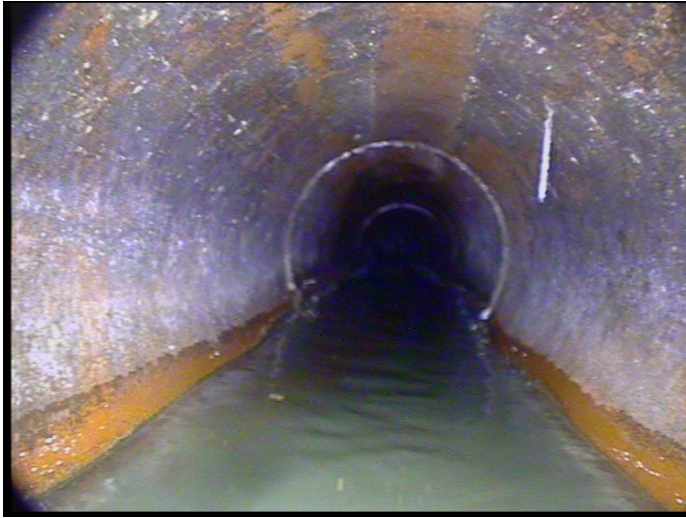
Code: **MWL**
Description: **Water Level**

Distance (ft): **.0**
Structural Grade: **0**
O&M Grade: **0**
Clock Start/From:
Clock To:
1st Value:
2nd Value:
Value Percent: **10.000**
Continuous Index:
Within 8" of Joint: **NO**
Remarks:

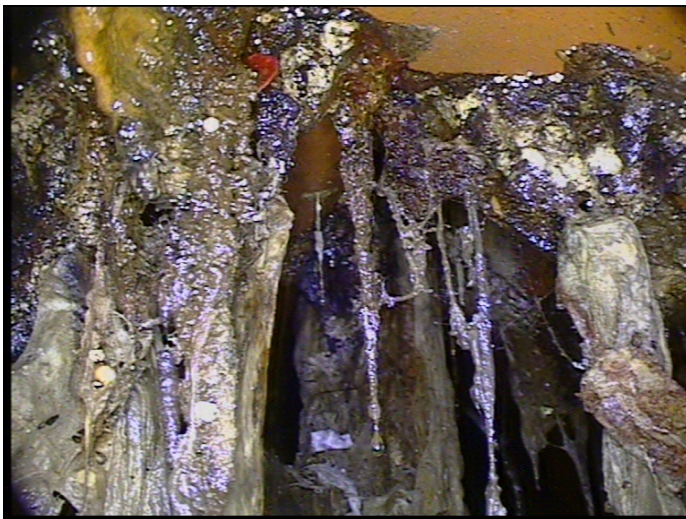
Code: **RMJ**
Description: **Roots Medium Joint**

Distance (ft): **21.9**
Structural Grade: **0**
O&M Grade: **3**
Clock Start/From: **8**
Clock To: **4**
1st Value:
2nd Value:
Value Percent: **10.000**
Continuous Index:
Within 8" of Joint: **YES**
Remarks:

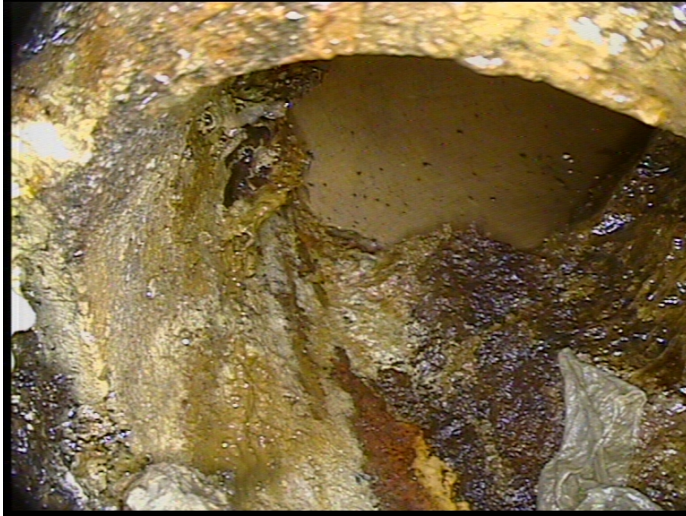
Code: **TF**
Description: **Tap Factory**

Distance (ft): **23.0**
Structural Grade: **0**
O&M Grade: **0**
Clock Start/From: **2**
Clock To:
1st Value: **4.000**
2nd Value:
Value Percent:
Continuous Index:
Within 8" of Joint: **NO**
Remarks:

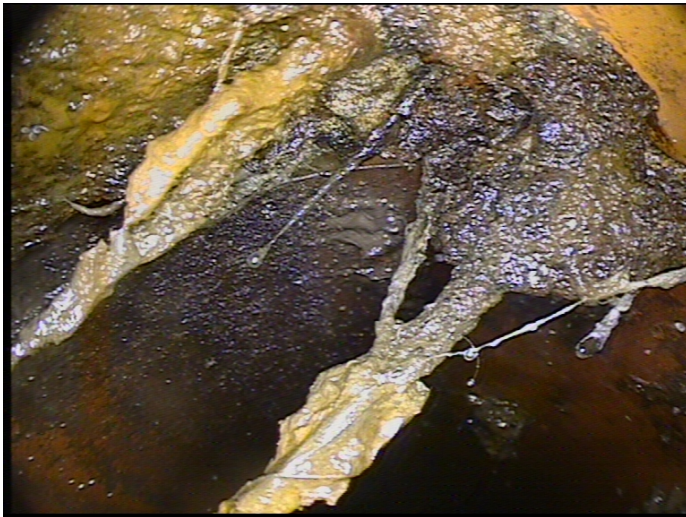
Code: **RMJ**
Description: **Roots Medium Joint**

Distance (ft): **23.9**
Structural Grade: **0**
O&M Grade: **3**
Clock Start/From: **10**
Clock To: **12**
1st Value:
2nd Value:
Value Percent: **5.000**
Continuous Index:
Within 8" of Joint: **YES**
Remarks:

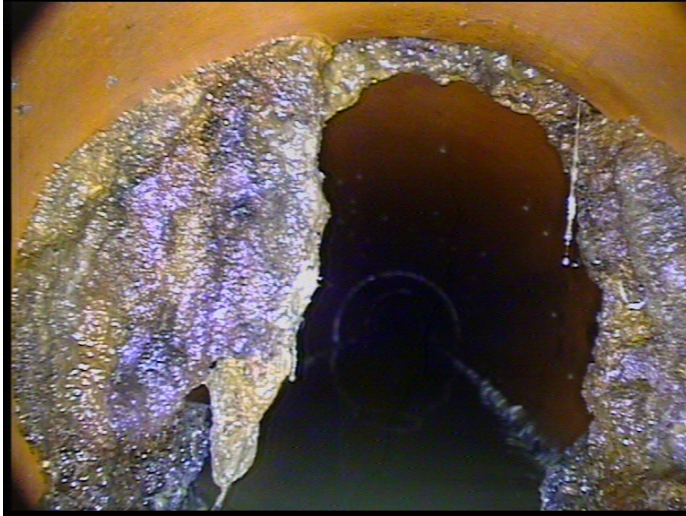
Code:	DAE
Description:	Deposits Attached Encrustation
Distance (ft):	43.6
Structural Grade:	0
O&M Grade:	2
Clock Start/From:	7
Clock To:	5
1st Value:	
2nd Value:	
Value Percent:	10.000
Continuous Index:	
Within 8" of Joint:	YES
Remarks:

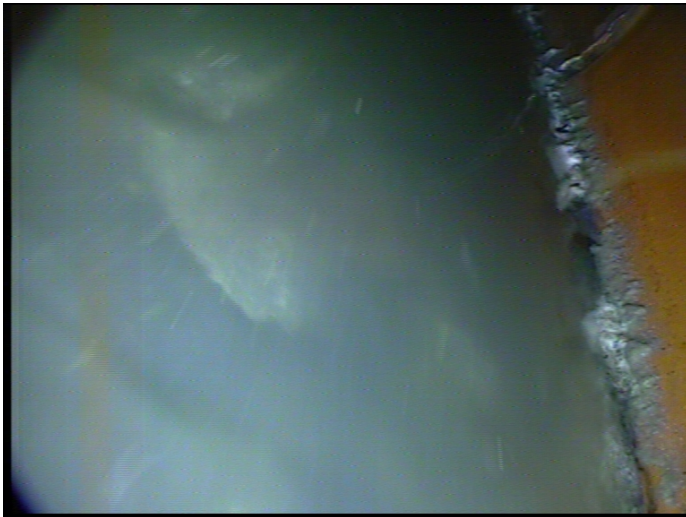
Code:	OBZ
Description:	Obstacle Other
Distance (ft):	62.9
Structural Grade:	0
O&M Grade:	2
Clock Start/From:	4
Clock To:	8
1st Value:	
2nd Value:	
Value Percent:	10.000
Continuous Index:	
Within 8" of Joint:	NO
Remarks:	under water debris

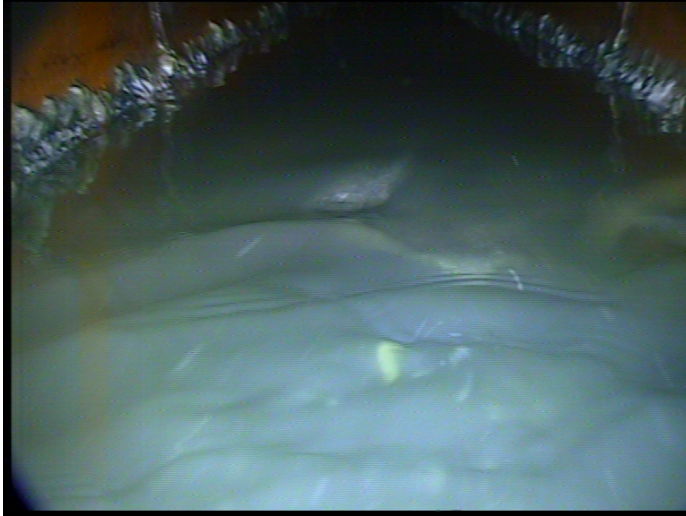
Code:	MSA
Description:	Abandoned Survey
Distance (ft):	62.9
Structural Grade:	0
O&M Grade:	0
Clock Start/From:	
Clock To:	
1st Value:	
2nd Value:	
Value Percent:	
Continuous Index:	
Within 8" of Joint:	NO
Remarks:	under water debris
