Profile/Ph	oto Observation	Report			RedZone
Date:	09/29/2018	Weather:		Coding:	PACP 6.0
Pipe Length (ft	): <b>18.4</b>	Owner:	NA	Pre Clean:	Not Known
P.O.#:		Surveyor:	Selasie Honu	PSR:	P-303-010-009
Customer:		Clean Date:	01/01/1900	Shape:	С
Street:	39th. Ave.		Flow Control:	Not Controlled	
City:	Hobart, IN		Year Renewed:		
Location:	Light Highway		Tape/Media #:		
Purpose:	Routine Assessment	t	Dia/Height:	12"	
Use:	Sanitary		Material:	VCP	
Drain Area:	NA		Lining:		
Category:	NA				
Comment:					
Location Detail	s:		Direction of Surve	ey: Downstream	
US MH:	M-303-010	DS MH:	M-303-009	Total Length Surveyed (ft):	9.7
O&M Index:	3.00	O&M Quick:	3100	O&M Rating:	3.00
Structural Index:	4.00	 Structural Qu	ick: 4100	Structural Rating:	4.00
Overall Index:	3.50	Overall Quick	4131	Overall Rating:	7.00

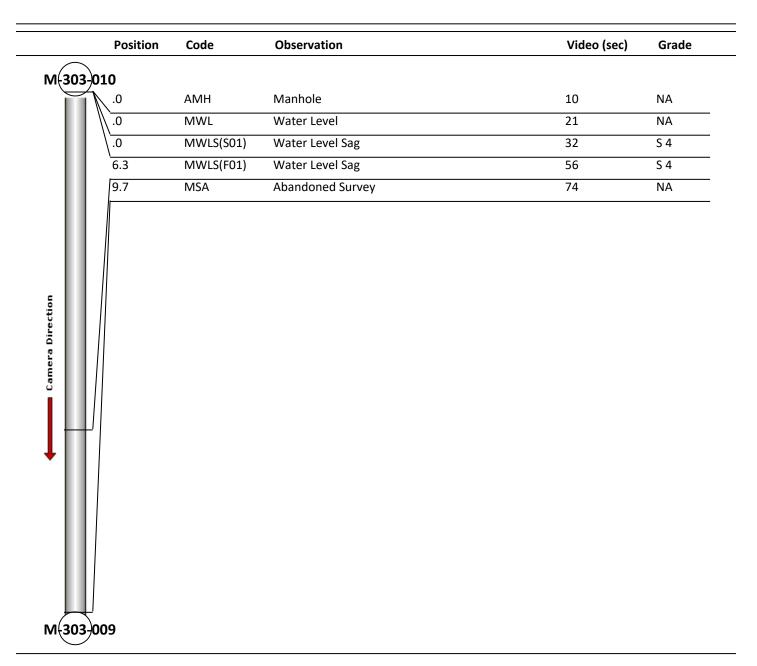
Code:	MWLS
Description:	Water Level Sag

Distance (ft):	.0
Structural Grade:	4
O&M Grade:	3
Clock Start/From:	
Clock To:	
1st Value:	
2nd Value:	
Value Percent:	60.000
Continuous Index:	S01
Within 8" of Joint:	NO
Remarks:

Code:MWLSDescription:Water Level Sag

Distance (ft):	6.3
Structural Grade:	4
O&M Grade:	3
Clock Start/From:	
Clock To:	
1st Value:	
2nd Value:	
Value Percent:	60.000
Continuous Index:	F01
Within 8" of Joint:	NO
Remarks:
