## Profile/Photo Observation Report

Street:	<b>39th. Ave.</b>	Flow Control:	<b>Not Controlled</b>
City:	<b>Hobart, IN</b>	Year Renewed:	
Location:	<b>Light Highway</b>	Tape/Media #:	
Purpose:	<b>Routine Assessment</b>	Dia/Height:	<b>10"</b>
Use:	<b>Sanitary</b>	Material:	<b>VCP</b>
Drain Area:	<b>NA</b>	Lining:	
Category:	<b>NA</b>		
Comment:

Location Details:		Direction of Survey:	<b>Upstream</b>
US MH:	<b>M-303-015</b>	DS MH:	<b>M-303-016</b>
		Total Length Surveyed (ft):	<b>11.8</b>

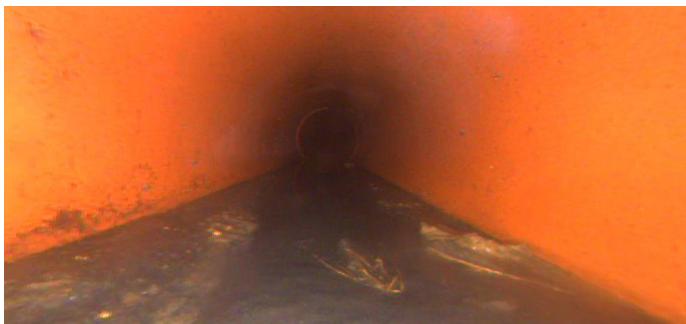
Code: **AMH**  
Description: **Manhole**

Distance (ft): **.0**  
Structural Grade: **0**  
O&M Grade: **0**  
Clock Start/From:  
Clock To:  
1st Value:  
2nd Value:  
Value Percent:  
Continuous Index:  
Within 8" of Joint: **NO**  
Remarks: **M-303-016**

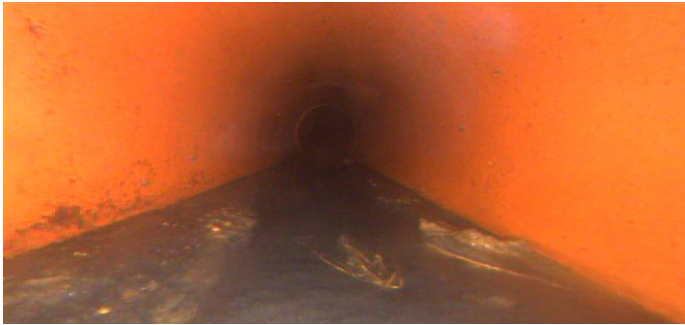
Code:	<b>MWL</b>
Description:	<b>Water Level</b>

Distance (ft):	<b>.0</b>
Structural Grade:	<b>0</b>
O&M Grade:	<b>0</b>
Clock Start/From:	
Clock To:	
1st Value:	
2nd Value:	
Value Percent:	<b>5.000</b>
Continuous Index:	
Within 8" of Joint:	<b>NO</b>
Remarks:

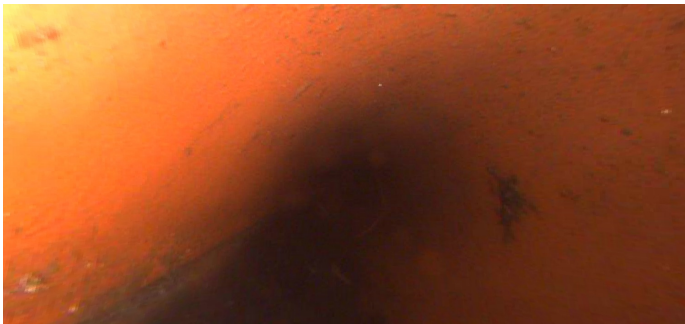
Code:	<b>MSA</b>
Description:	<b>Abandoned Survey</b>

Distance (ft):	<b>11.8</b>
Structural Grade:	<b>0</b>
O&M Grade:	<b>0</b>
Clock Start/From:	
Clock To:	
1st Value:	
2nd Value:	
Value Percent:	
Continuous Index:	
Within 8" of Joint:	<b>NO</b>
Remarks:	<b>camera stopped</b>
