## Profile/Photo Observation Report

Street:	<b>W OLD RIDGE RD</b>	Flow Control:	<b>Not Controlled</b>
City:	<b>Hobart, IN</b>	Year Renewed:	
Location:	<b>Light Highway</b>	Tape/Media #:	
Purpose:	<b>Routine Assessment</b>	Dia/Height:	<b>10"</b>
Use:	<b>Sanitary</b>	Material:	<b>VCP</b>
Drain Area:	<b>NA</b>	Lining:	
Category:	<b>NA</b>		
Comment:

Location Details:		Direction of Survey:	<b>Downstream</b>
US MH:	<b>M-303-015</b>	DS MH:	<b>M-303-016</b>
		Total Length Surveyed (ft):	<b>3.5</b>

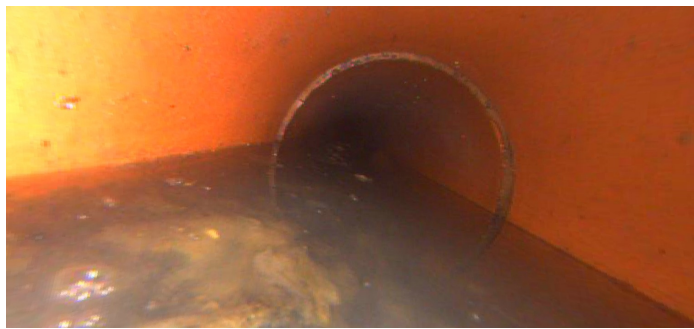
Code: **AMH**  
Description: **Manhole**

Distance (ft): **.0**  
Structural Grade: **0**  
O&M Grade: **0**  
Clock Start/From:  
Clock To:  
1st Value:  
2nd Value:  
Value Percent:  
Continuous Index:  
Within 8" of Joint: **NO**  
Remarks: **M-303-015**

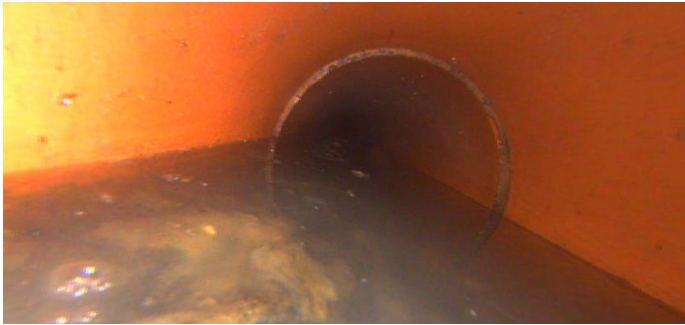
Code:	<b>MWL</b>
Description:	<b>Water Level</b>

Distance (ft):	<b>.0</b>
Structural Grade:	<b>0</b>
O&M Grade:	<b>0</b>
Clock Start/From:	
Clock To:	
1st Value:	
2nd Value:	
Value Percent:	<b>5.000</b>
Continuous Index:	
Within 8" of Joint:	<b>NO</b>
Remarks:
