## Profile/Photo Observation Report

Street:	<b>39th. Ave.</b>	Flow Control:	<b>Not Controlled</b>
City:	<b>Hobart, IN</b>	Year Renewed:	
Location:	<b>Light Highway</b>	Tape/Media #:	
Purpose:	<b>Routine Assessment</b>	Dia/Height:	<b>10"</b>
Use:	<b>Sanitary</b>	Material:	<b>VCP</b>
Drain Area:	<b>NA</b>	Lining:	
Category:	<b>NA</b>		
Comment:

Location Details:		Direction of Survey:	<b>Downstream</b>
US MH:	<b>M-303-015</b>	DS MH:	<b>M-303-016</b>
		Total Length Surveyed (ft):	<b>3.5</b>

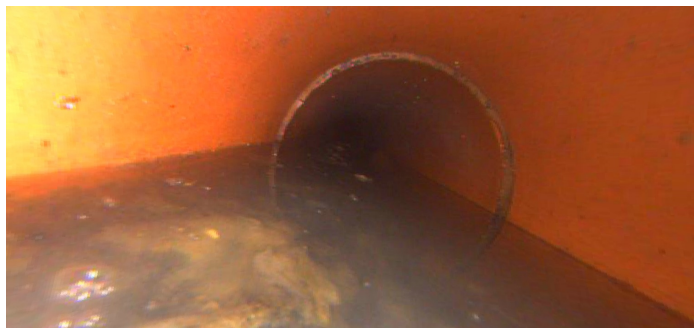
Code: **AMH**  
 Description: **Manhole**  
 Distance (ft): **.0**  
 Structural Grade: **0**  
 O&M Grade: **0**  
 Clock Start/From:  
 Clock To:  
 1st Value:  
 2nd Value:  
 Value Percent:  
 Continuous Index:  
 Within 8" of Joint: **NO**  
 Remarks: **M-303-015**

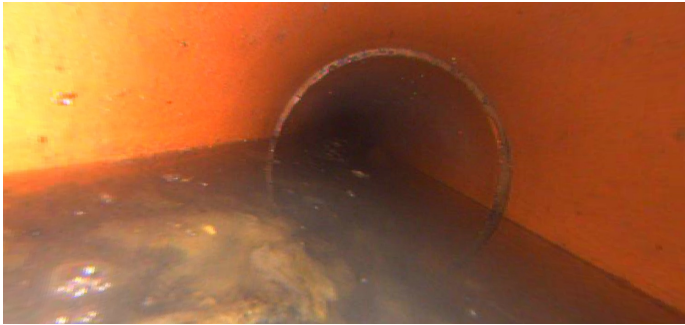
Code:	<b>MWL</b>
Description:	<b>Water Level</b>

Distance (ft):	<b>.0</b>
Structural Grade:	<b>0</b>
O&M Grade:	<b>0</b>
Clock Start/From:	
Clock To:	
1st Value:	
2nd Value:	
Value Percent:	<b>5.000</b>
Continuous Index:	
Within 8" of Joint:	<b>NO</b>
Remarks:
