## Profile/Photo Observation Report

Street:	<b>W OLD RIDGE RD</b>	Flow Control:	<b>Not Controlled</b>
City:	<b>Hobart, IN</b>	Year Renewed:	
Location:	<b>Light Highway</b>	Tape/Media #:	
Purpose:	<b>Routine Assessment</b>	Dia/Height:	<b>10"</b>
Use:	<b>Sanitary</b>	Material:	<b>VCP</b>
Drain Area:	<b>NA</b>	Lining:	
Category:	<b>NA</b>		
Comment:

Location Details:		Direction of Survey:	<b>Downstream</b>
US MH:	<b>M-303-016</b>	DS MH:	<b>M-303-017</b>
		Total Length Surveyed (ft):	<b>7.7</b>

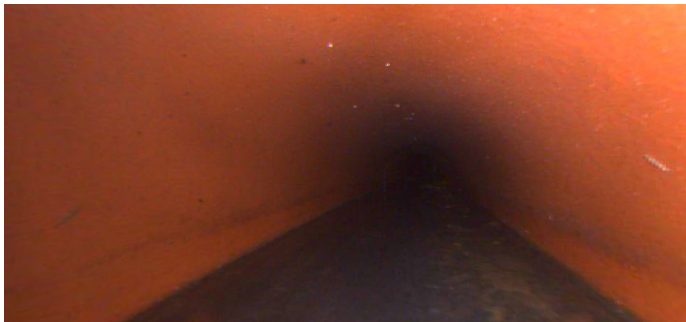
Code: **AMH**  
Description: **Manhole**

Distance (ft): **.0**  
Structural Grade: **0**  
O&M Grade: **0**  
Clock Start/From:  
Clock To:  
1st Value:  
2nd Value:  
Value Percent:  
Continuous Index:  
Within 8" of Joint: **NO**  
Remarks: **M-303-016**

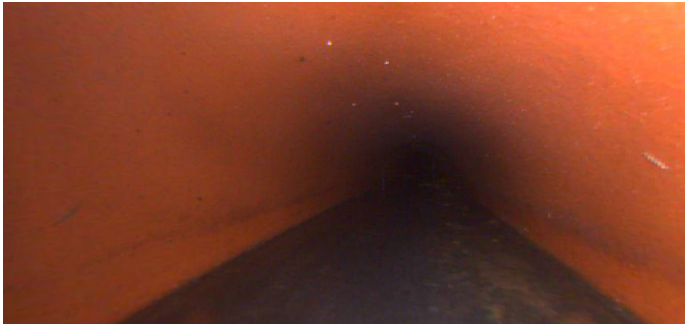
Code:	<b>MWL</b>
Description:	<b>Water Level</b>

Distance (ft):	<b>.0</b>
Structural Grade:	<b>0</b>
O&M Grade:	<b>0</b>
Clock Start/From:	
Clock To:	
1st Value:	
2nd Value:	
Value Percent:	<b>5.000</b>
Continuous Index:	
Within 8" of Joint:	<b>NO</b>
Remarks:

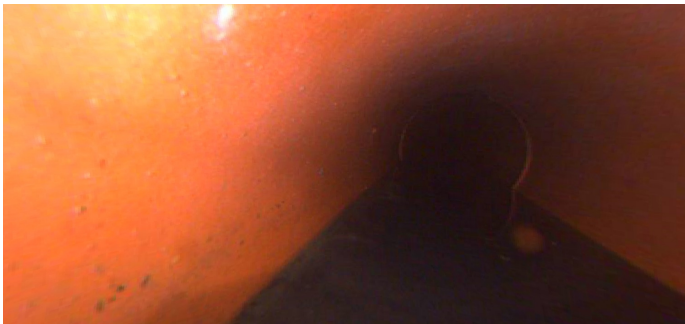
Code:	<b>MSA</b>
Description:	<b>Abandoned Survey</b>

Distance (ft):	<b>7.7</b>
Structural Grade:	<b>0</b>
O&M Grade:	<b>0</b>
Clock Start/From:	
Clock To:	
1st Value:	
2nd Value:	
Value Percent:	
Continuous Index:	
Within 8" of Joint:	<b>NO</b>
Remarks:	<b>camera stoppped</b>
