Profile/Photo Observation Report

Street:	39th. Ave.	Flow Control:	Not Controlled
City:	Hobart, IN	Year Renewed:	
Location:	Light Highway	Tape/Media #:	
Purpose:	Routine Assessment	Dia/Height:	10"
Use:	Sanitary	Material:	VCP
Drain Area:	NA	Lining:	
Category:	NA		
Comment:

Location Details:		Direction of Survey:	Downstream
US MH:	M-303-016	DS MH:	M-303-017
		Total Length Surveyed (ft):	7.7

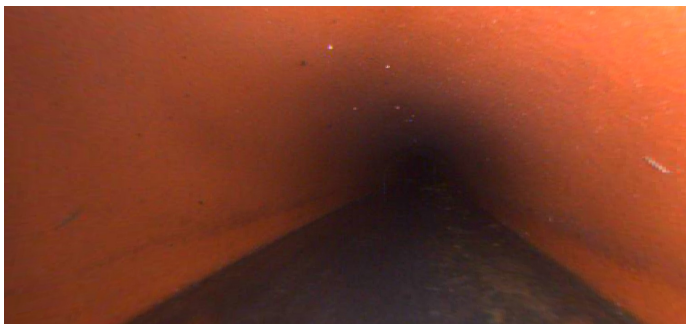
Code: **AMH**
Description: **Manhole**

Distance (ft): **.0**
Structural Grade: **0**
O&M Grade: **0**
Clock Start/From:
Clock To:
1st Value:
2nd Value:
Value Percent:
Continuous Index:
Within 8" of Joint: **NO**
Remarks: **M-303-016**

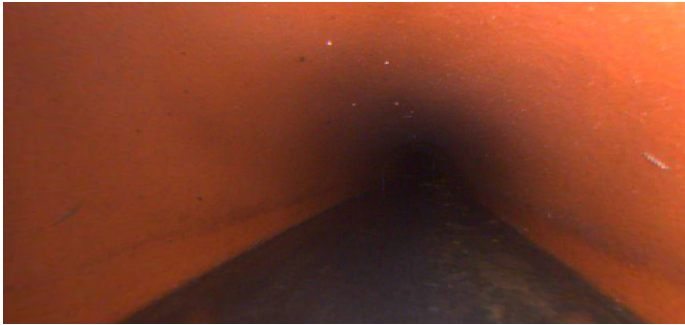
Code:	MWL
Description:	Water Level

Distance (ft):	.0
Structural Grade:	0
O&M Grade:	0
Clock Start/From:	
Clock To:	
1st Value:	
2nd Value:	
Value Percent:	5.000
Continuous Index:	
Within 8" of Joint:	NO
Remarks:

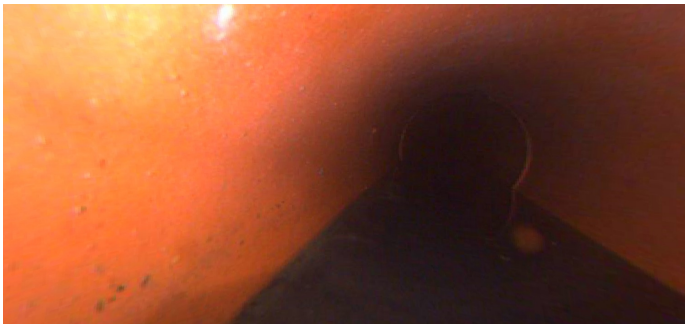
Code:	MSA
Description:	Abandoned Survey

Distance (ft):	7.7
Structural Grade:	0
O&M Grade:	0
Clock Start/From:	
Clock To:	
1st Value:	
2nd Value:	
Value Percent:	
Continuous Index:	
Within 8" of Joint:	NO
Remarks:	camera stoppped
