Profile/Photo Observation Report

Date:	04/12/2018	Weather:		Coding:	PACP 6.0
Pipe Length (ft):		Owner:	City of Hobart	Pre Clean:	No Pre-Cleaning
P.O.#:	33-1	Surveyor:	M. Pielacha	PSR:	M-303-020-M-303-071
Customer:	City of Hobart	Clean Date:		Shape:	C

Street:	Off 40th Place	Flow Control:	Not Controlled
City:	Hobart, IN	Year Renewed:	
Location:	Light Highway	Tape/Media #:	DEP 33
Purpose:	Routine Assessment	Dia/Height:	6"
Use:	Sanitary	Material:	PVC
Drain Area:		Lining:	
Category:	NA		
Comment:			
Location Details:		Direction of Survey:	Upstream
US MH:	M-303-020	DS MH:	M-303-071
		Total Length Surveyed (ft):	104.8

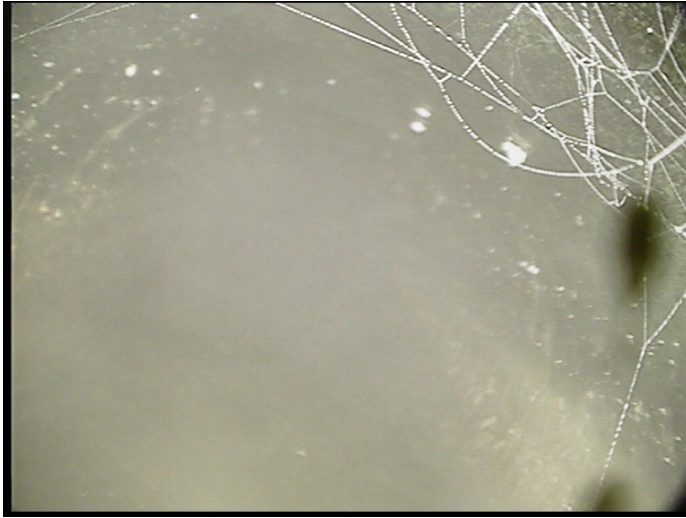
Code: **MWL**
Description: **Water Level**

Distance (ft): **.0**
Structural Grade: **0**
O&M Grade: **0**
Clock Start/From:
Clock To:
1st Value:
2nd Value:
Value Percent: **5.000**
Continuous Index:
Within 8" of Joint: **NO**
Remarks:

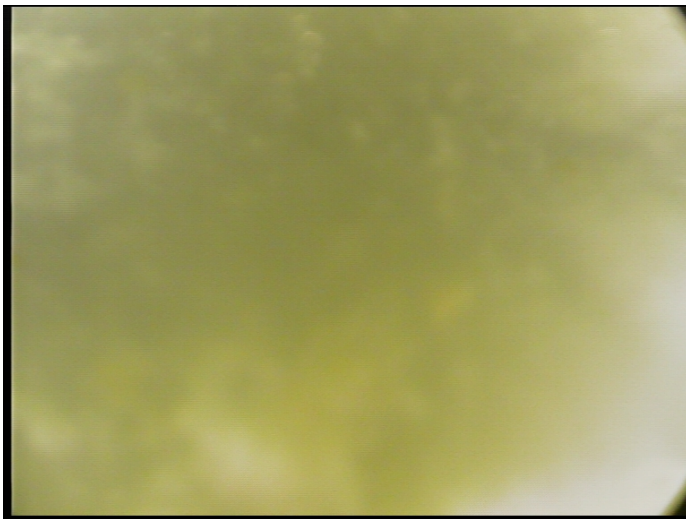
Code: **MCU**
Description: **Camera Underwater**

Distance (ft): **3.4**
Structural Grade: **0**
O&M Grade: **4**
Clock Start/From:
Clock To:
1st Value:
2nd Value:
Value Percent:
Continuous Index: **S01**
Within 8" of Joint: **NO**
Remarks:

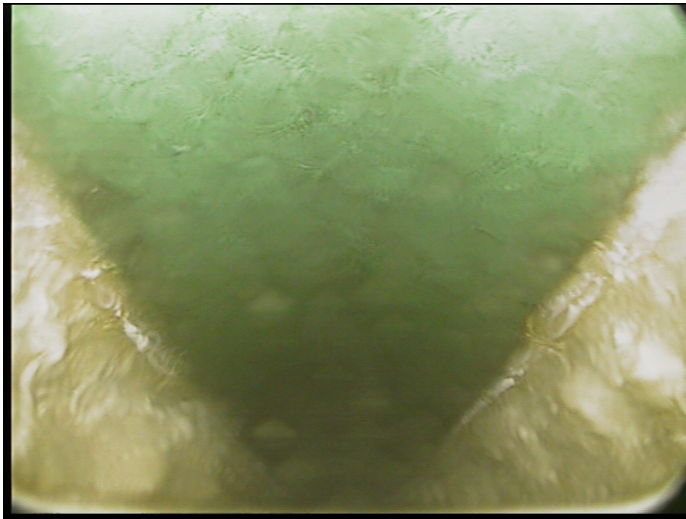
Code: **MCU**
Description: **Camera Underwater**

Distance (ft): **11.0**
Structural Grade: **0**
O&M Grade: **4**
Clock Start/From:
Clock To:
1st Value:
2nd Value:
Value Percent:
Continuous Index: **F01**
Within 8" of Joint: **NO**
Remarks:

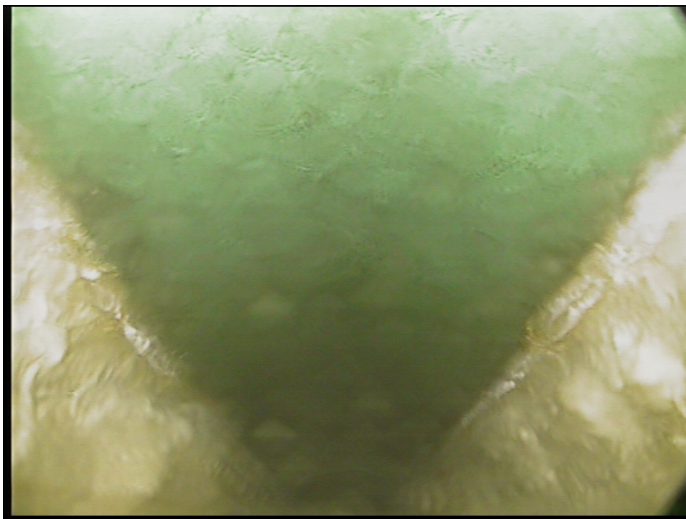
Code: **DAE**
Description: **Deposits Attached Encrustation**

Distance (ft): **11.0**
Structural Grade: **0**
O&M Grade: **2**
Clock Start/From: **8**
Clock To: **4**
1st Value:
2nd Value:
Value Percent: **10.000**
Continuous Index: **S02**
Within 8" of Joint: **YES**
Remarks:

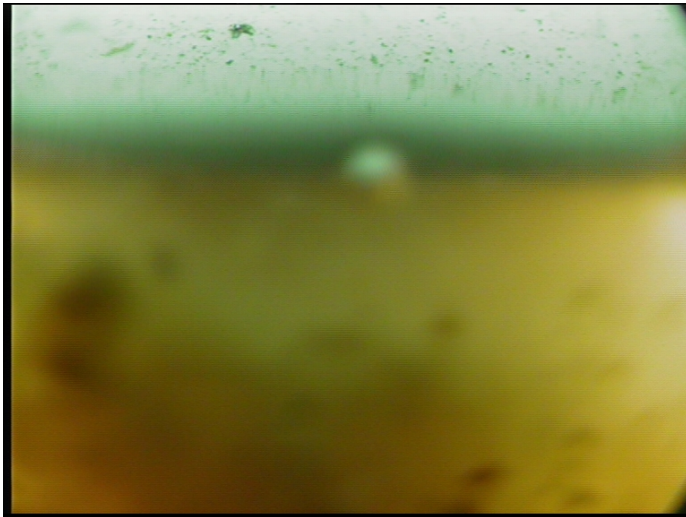
Code:	DAE
Description:	Deposits Attached Encrustation
Distance (ft):	24.8
Structural Grade:	0
O&M Grade:	2
Clock Start/From:	8
Clock To:	4
1st Value:	
2nd Value:	
Value Percent:	10.000
Continuous Index:	F02
Within 8" of Joint:	NO
Remarks:

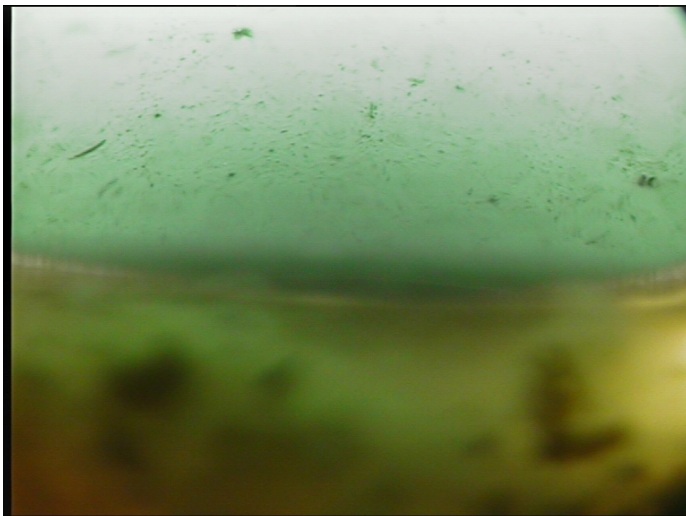
Code:	MWL
Description:	Water Level
Distance (ft):	24.8
Structural Grade:	0
O&M Grade:	0
Clock Start/From:	
Clock To:	
1st Value:	
2nd Value:	
Value Percent:	40.000
Continuous Index:	
Within 8" of Joint:	NO
Remarks:
