# Profile/Photo Observation Report

Date:	<b>04/12/2018</b>	Weather:		Coding:	<b>PACP 6.0</b>
Pipe Length (ft):		Owner:	<b>City of Hobart</b>	Pre Clean:	<b>No Pre-Cleaning</b>
P.O.#:	<b>33-1</b>	Surveyor:	<b>M. Pielacha</b>	PSR:	<b>M-303-020-M-303-071</b>
Customer:	<b>City of Hobart</b>	Clean Date:		Shape:	<b>C</b>

Street:	<b>Off 40th Place</b>	Flow Control:	<b>Not Controlled</b>
City:	<b>Hobart, IN</b>	Year Renewed:	
Location:	<b>Light Highway</b>	Tape/Media #:	<b>DEP 33</b>
Purpose:	<b>Routine Assessment</b>	Dia/Height:	<b>6"</b>
Use:	<b>Sanitary</b>	Material:	<b>PVC</b>
Drain Area:		Lining:	
Category:	<b>NA</b>		
Comment:			
Location Details:		Direction of Survey:	<b>Upstream</b>
US MH:	<b>M-303-020</b>	DS MH:	<b>M-303-071</b>
		Total Length Surveyed (ft):	<b>104.8</b>

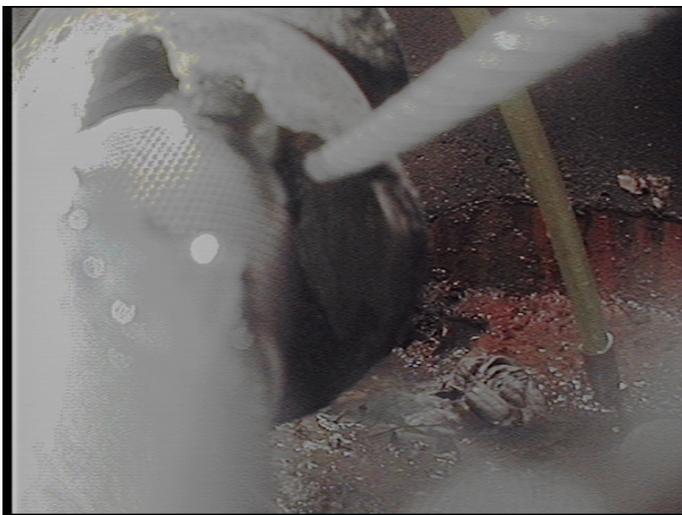
Code: **AMH**  
Description: **Manhole**

Distance (ft): **.0**  
Structural Grade: **0**  
O&M Grade: **0**  
Clock Start/From:  
Clock To:  
1st Value:  
2nd Value:  
Value Percent:  
Continuous Index:  
Within 8" of Joint: **NO**  
Remarks: **M-303-071**

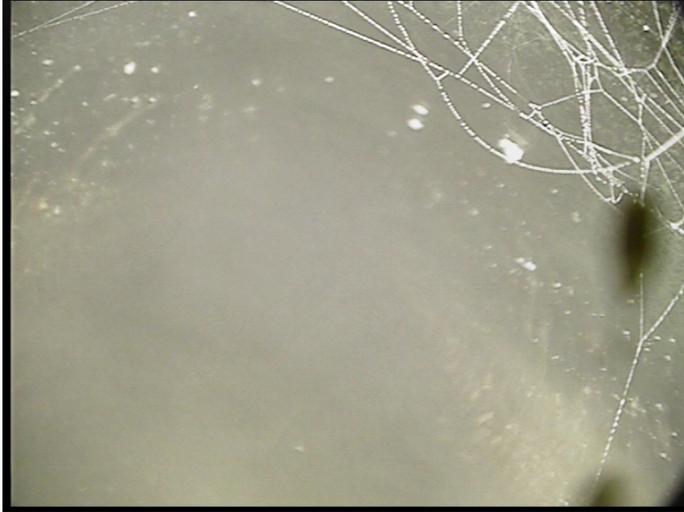
Code: **MWL**  
Description: **Water Level**

Distance (ft): **.0**  
Structural Grade: **0**  
O&M Grade: **0**  
Clock Start/From:  
Clock To:  
1st Value:  
2nd Value:  
Value Percent: **5.000**  
Continuous Index:  
Within 8" of Joint: **NO**  
Remarks:

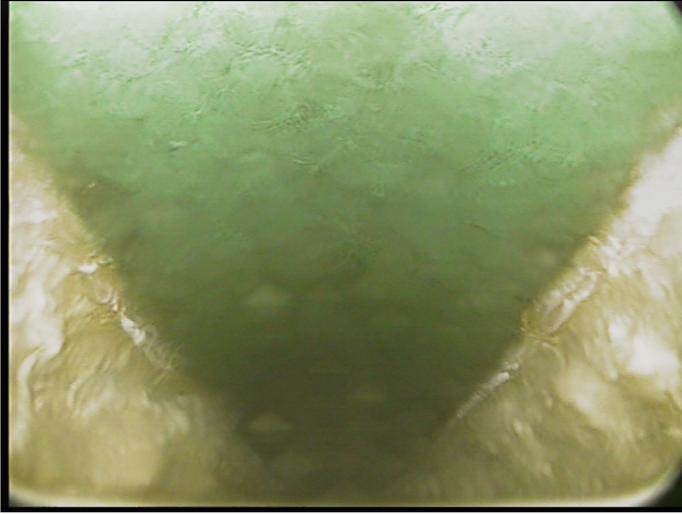
Code: **MCU**  
Description: **Camera Underwater**

Distance (ft): **11.0**  
Structural Grade: **0**  
O&M Grade: **4**  
Clock Start/From:  
Clock To:  
1st Value:  
2nd Value:  
Value Percent:  
Continuous Index: **F01**  
Within 8" of Joint: **NO**  
Remarks:

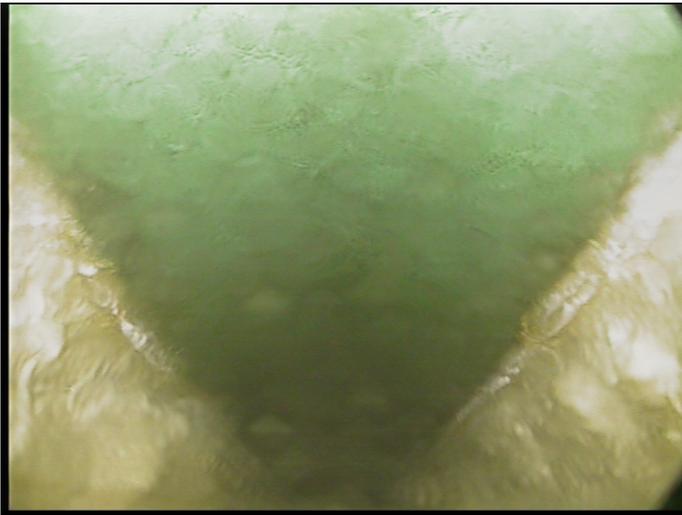
Code: **DAE**  
Description: **Deposits Attached Encrustation**

Distance (ft): **11.0**  
Structural Grade: **0**  
O&M Grade: **2**  
Clock Start/From: **8**  
Clock To: **4**  
1st Value:  
2nd Value:  
Value Percent: **10.000**  
Continuous Index: **S02**  
Within 8" of Joint: **YES**  
Remarks:

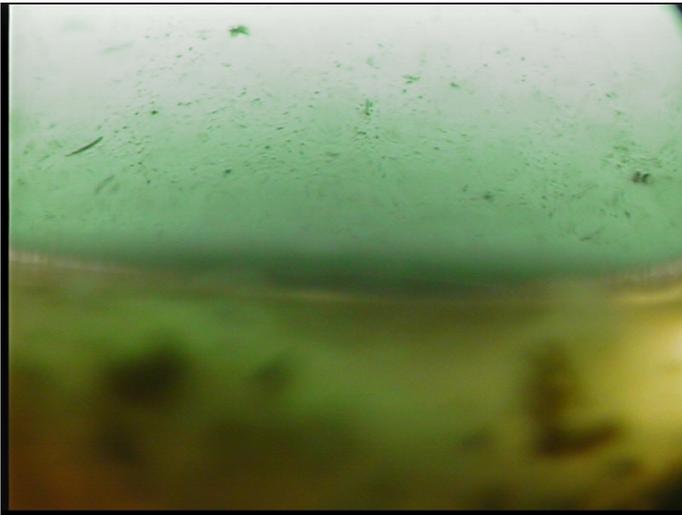
Code: **MWL**  
Description: **Water Level**

Distance (ft): **24.8**  
Structural Grade: **0**  
O&M Grade: **0**  
Clock Start/From:  
Clock To:  
1st Value:  
2nd Value:  
Value Percent: **40.000**  
Continuous Index:  
Within 8" of Joint: **NO**  
Remarks:

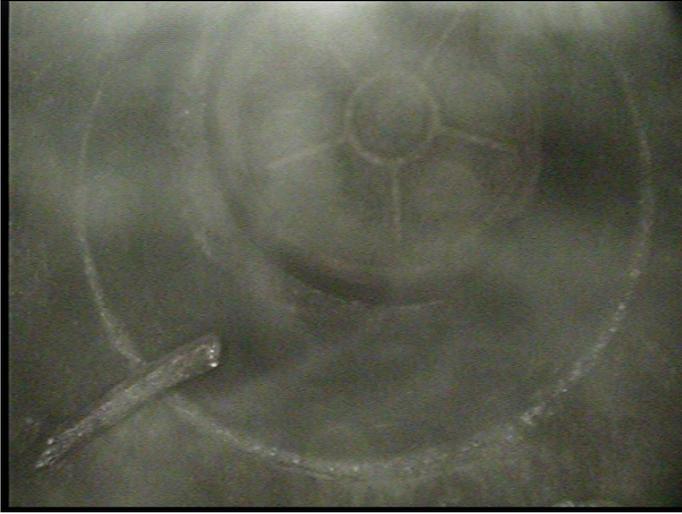
Code: **AMH**  
Description: **Manhole**

Distance (ft): **104.8**  
Structural Grade: **0**  
O&M Grade: **0**  
Clock Start/From:  
Clock To:  
1st Value:  
2nd Value:  
Value Percent:  
Continuous Index:  
Within 8" of Joint: **NO**  
Remarks: **M-303-020**
