## Profile/Photo Observation Report

Street:	<b>RIDGELAWN DR</b>	Flow Control:	<b>Not Controlled</b>
City:	<b>Hobart, IN</b>	Year Renewed:	
Location:	<b>Light Highway</b>	Tape/Media #:	
Purpose:	<b>Routine Assessment</b>	Dia/Height:	<b>8"</b>
Use:	<b>Sanitary</b>	Material:	<b>VCP</b>
Drain Area:	<b>NA</b>	Lining:	
Category:	<b>NA</b>		
Comment:

Location Details:		Direction of Survey:	<b>Downstream</b>
US MH:	<b>M-303-020</b>	DS MH:	<b>M-303-073</b>
		Total Length Surveyed (ft):	<b>25.3</b>

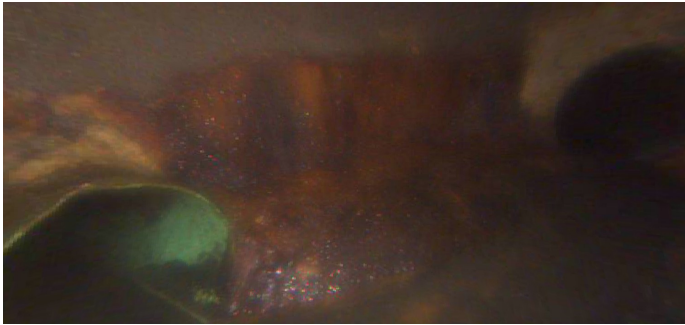
Code:	<b>MWL</b>
Description:	<b>Water Level</b>

Distance (ft):	<b>.0</b>
Structural Grade:	<b>0</b>
O&M Grade:	<b>0</b>
Clock Start/From:	
Clock To:	
1st Value:	
2nd Value:	
Value Percent:	<b>5.000</b>
Continuous Index:	
Within 8" of Joint:	<b>NO</b>
Remarks:
