Profile/Photo Observation Report

Street:	RIDGELAWN DR	Flow Control:	Not Controlled
City:	Hobart, IN	Year Renewed:	
Location:	Other	Tape/Media #:	
Purpose:	Not Known	Dia/Height:	10"
Use:	Sanitary	Material:	VCP
Drain Area:	NA	Lining:	
Category:	NA		
Comment:

Location Details:		Direction of Survey:	Upstream
US MH:	M-303-021	DS MH:	M-303-022
		Total Length Surveyed (ft):	151.3

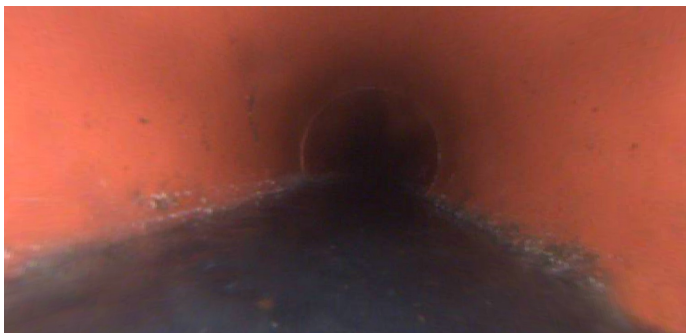
Code: **AMH**
Description: **Manhole**

Distance (ft): **.0**
Structural Grade: **0**
O&M Grade: **0**
Clock Start/From:
Clock To:
1st Value:
2nd Value:
Value Percent:
Continuous Index:
Within 8" of Joint: **NO**
Remarks: **M-303-022**

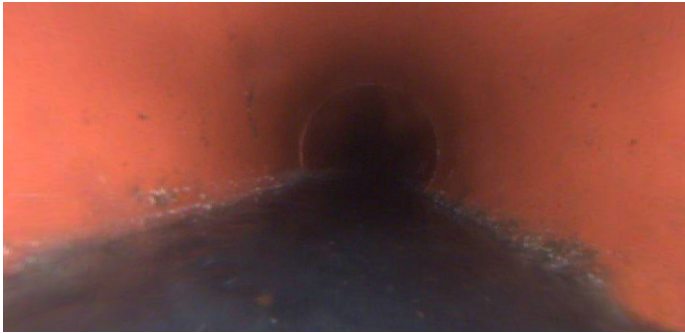
Code:	MWL
Description:	Water Level

Distance (ft):	.0
Structural Grade:	0
O&M Grade:	0
Clock Start/From:	
Clock To:	
1st Value:	
2nd Value:	
Value Percent:	5.000
Continuous Index:	
Within 8" of Joint:	NO
Remarks:

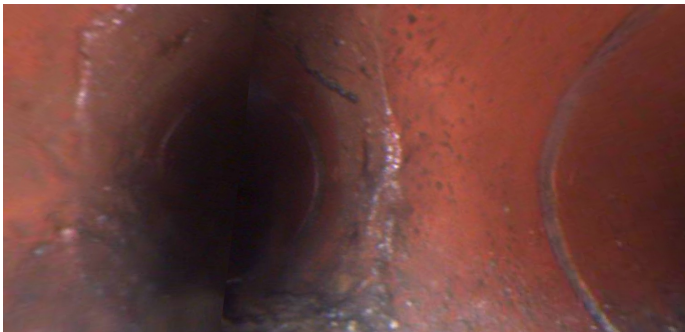
Code:	TF
Description:	Tap Factory

Distance (ft):	8.3
Structural Grade:	0
O&M Grade:	0
Clock Start/From:	3
Clock To:	
1st Value:	4.000
2nd Value:	
Value Percent:	
Continuous Index:	
Within 8" of Joint:	
Remarks:

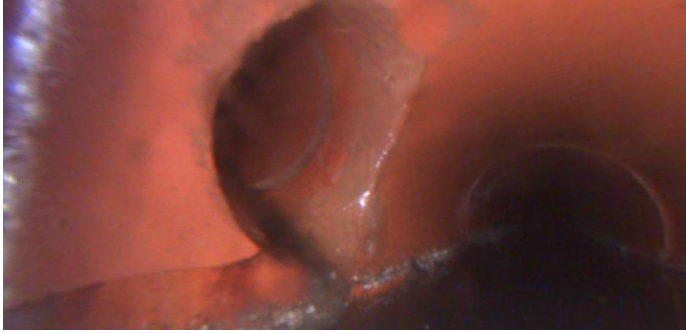
Code: **FL**
Description: **Fracture Longitudinal**

Distance (ft): **9.8**
Structural Grade: **3**
O&M Grade: **0**
Clock Start/From: **8**
Clock To:
1st Value:
2nd Value:
Value Percent:
Continuous Index:
Within 8" of Joint: **YES**
Remarks:

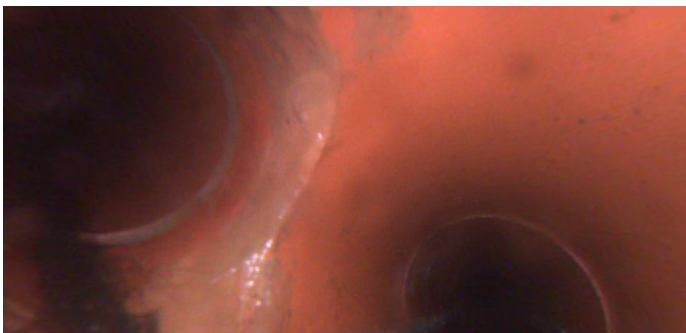
Code: **TFA**
Description: **Tap Factory Active**

Distance (ft): **10.0**
Structural Grade: **0**
O&M Grade: **0**
Clock Start/From: **9**
Clock To:
1st Value: **4.000**
2nd Value:
Value Percent:
Continuous Index:
Within 8" of Joint:
Remarks:

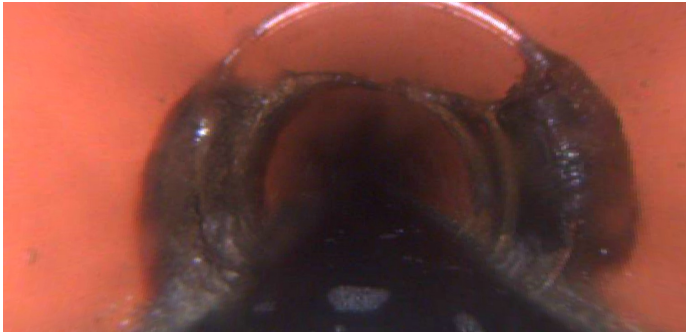
Code: **IW**
Description: **Infil Weeper**

Distance (ft): **41.2**
Structural Grade: **0**
O&M Grade: **2**
Clock Start/From: **7**
Clock To: **5**
1st Value:
2nd Value:
Value Percent:
Continuous Index:
Within 8" of Joint: **YES**
Remarks:

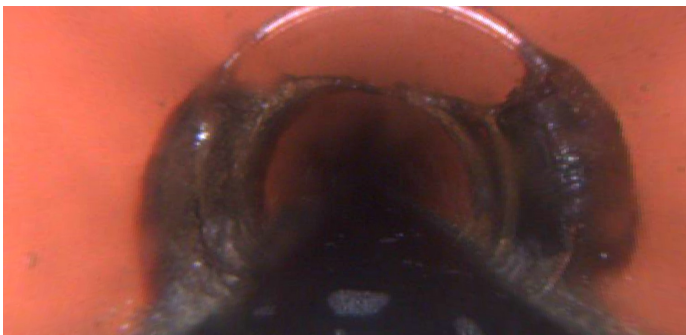
Code: **FC**
Description: **Fracture Circumferential**

Distance (ft): **41.2**
Structural Grade: **2**
O&M Grade: **0**
Clock Start/From: **7**
Clock To: **5**
1st Value:
2nd Value:
Value Percent:
Continuous Index:
Within 8" of Joint: **YES**
Remarks:

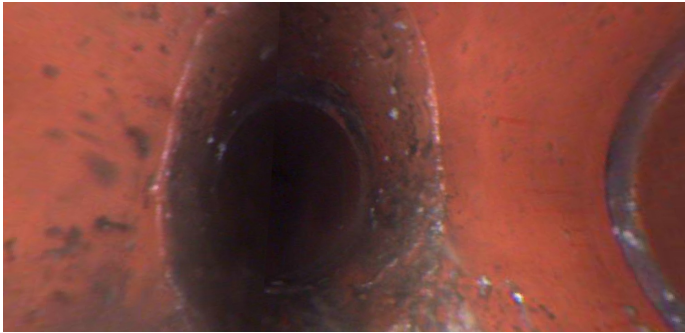
Code: **TF**
Description: **Tap Factory**

Distance (ft): **82.9**
Structural Grade: **0**
O&M Grade: **0**
Clock Start/From: **3**
Clock To:
1st Value: **4.000**
2nd Value:
Value Percent:
Continuous Index:
Within 8" of Joint:
Remarks:

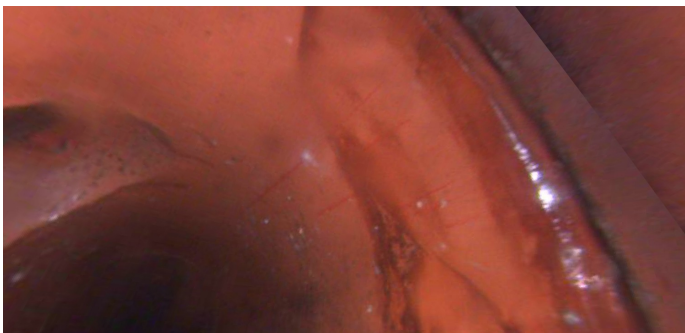
Code: **IW**
Description: **Infil Weeper**

Distance (ft): **84.1**
Structural Grade: **0**
O&M Grade: **2**
Clock Start/From: **1**
Clock To: **4**
1st Value:
2nd Value:
Value Percent:
Continuous Index:
Within 8" of Joint: **YES**
Remarks:

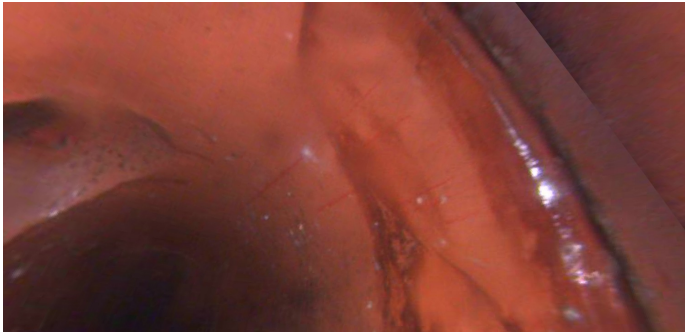
Code: **FM**
Description: **Fracture Multiple**

Distance (ft): **84.1**
Structural Grade: **4**
O&M Grade: **0**
Clock Start/From: **1**
Clock To: **4**
1st Value:
2nd Value:
Value Percent:
Continuous Index:
Within 8" of Joint: **YES**
Remarks:

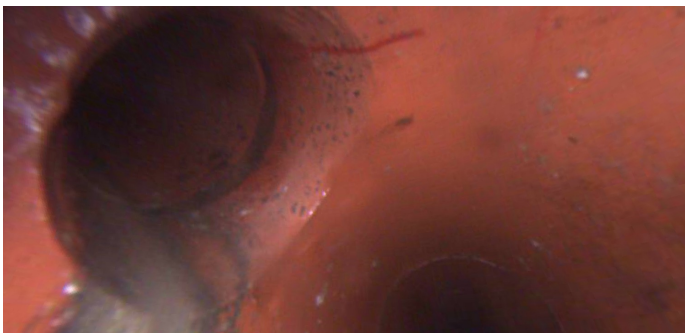
Code: **TF**
Description: **Tap Factory**

Distance (ft): **84.7**
Structural Grade: **0**
O&M Grade: **0**
Clock Start/From: **10**
Clock To:
1st Value: **4.000**
2nd Value:
Value Percent:
Continuous Index:
Within 8" of Joint:
Remarks:

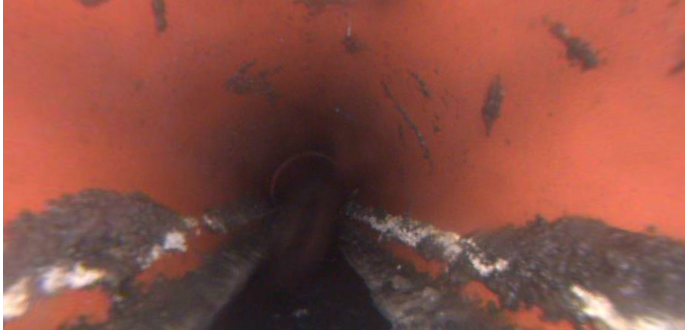
Code: **DAZ**
Description: **Deposits Attached Other**

Distance (ft): **143.5**
Structural Grade: **0**
O&M Grade: **2**
Clock Start/From: **8**
Clock To: **4**
1st Value:
2nd Value:
Value Percent: **5.000**
Continuous Index:
Within 8" of Joint: **NO**
Remarks:

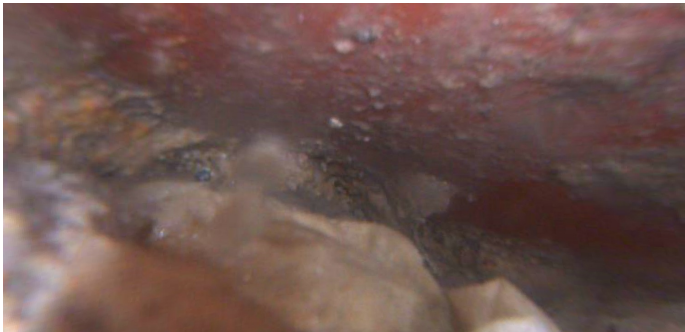
Code: **DAGS**
Description: **Deposits Attached Grease**

Distance (ft): **151.3**
Structural Grade: **0**
O&M Grade: **2**
Clock Start/From: **8**
Clock To: **4**
1st Value:
2nd Value:
Value Percent: **10.000**
Continuous Index:
Within 8" of Joint: **NO**
Remarks:

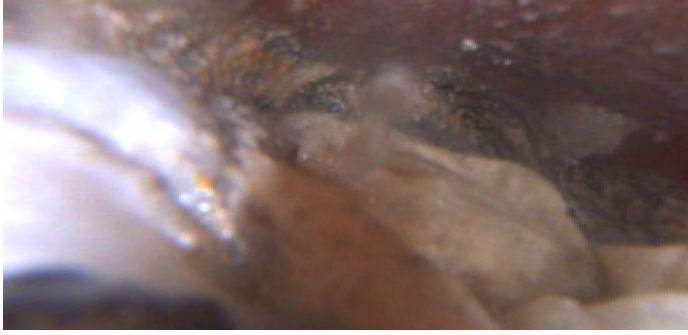
Code:	MSA
Description:	Abandoned Survey
Distance (ft):	151.3
Structural Grade:	0
O&M Grade:	0
Clock Start/From:	
Clock To:	
1st Value:	
2nd Value:	
Value Percent:	
Continuous Index:	
Within 8" of Joint:	NO
Remarks:	CAMERA STOPPED
