Profile/Photo Observation Report

Date:	03/28/2018	Weather:		Coding:	PACP 6.0
Pipe Length (ft):	330.5	Owner:	NA	Pre Clean:	Not Known
P.O.#:		Surveyor:	Selasie Honu	PSR:	P-303-022-021
Customer:		Clean Date:	01/01/1900	Shape:	C

Street:	KENWOOD ST	Flow Control:	Not Controlled
City:	Hobart, IN	Year Renewed:	
Location:	Other	Tape/Media #:	
Purpose:	Not Known	Dia/Height:	10"
Use:	Sanitary	Material:	VCP
Drain Area:	NA	Lining:	
Category:	NA		
Comment:

Location Details:		Direction of Survey:	Upstream
US MH:	M-303-021	DS MH:	M-303-022
		Total Length Surveyed (ft):	151.3

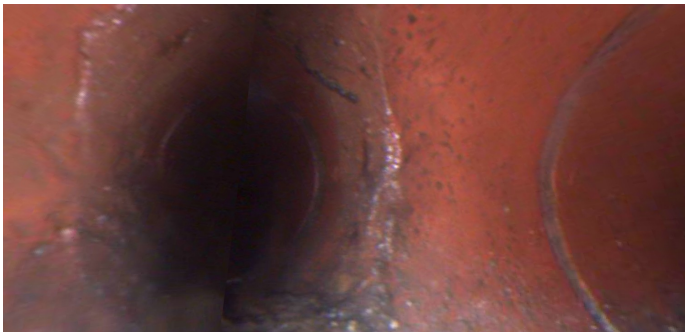
Code:	TF
Description:	Tap Factory

Distance (ft):	8.3
Structural Grade:	0
O&M Grade:	0
Clock Start/From:	3
Clock To:	
1st Value:	4.000
2nd Value:	
Value Percent:	
Continuous Index:	
Within 8" of Joint:	
Remarks:

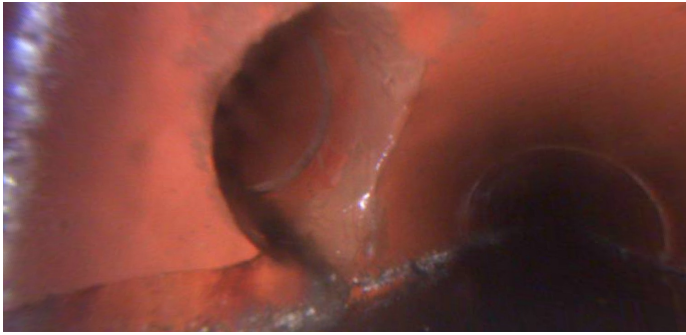
Code: **FL**
Description: **Fracture Longitudinal**

Distance (ft): **9.8**
Structural Grade: **3**
O&M Grade: **0**
Clock Start/From: **8**
Clock To:
1st Value:
2nd Value:
Value Percent:
Continuous Index:
Within 8" of Joint: **YES**
Remarks:

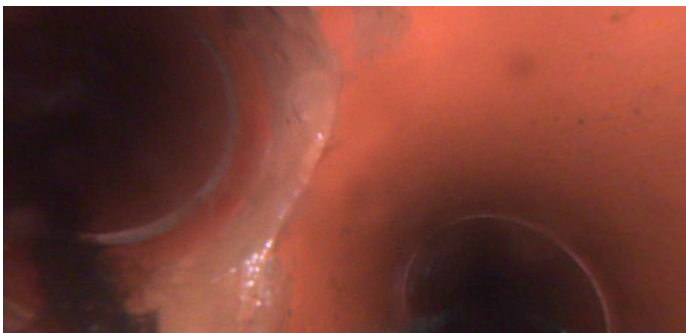
Code: **TFA**
Description: **Tap Factory Active**

Distance (ft): **10.0**
Structural Grade: **0**
O&M Grade: **0**
Clock Start/From: **9**
Clock To:
1st Value: **4.000**
2nd Value:
Value Percent:
Continuous Index:
Within 8" of Joint:
Remarks:

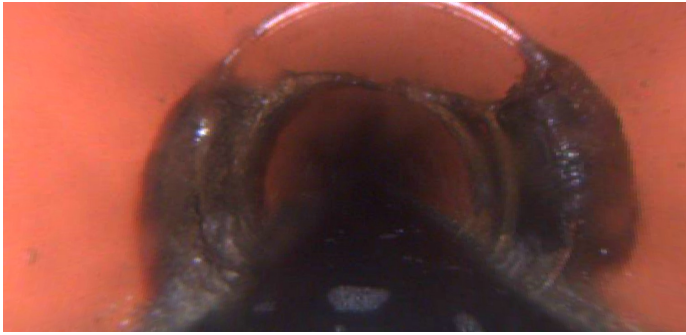
Code: **IW**
Description: **Infil Weeper**

Distance (ft): **41.2**
Structural Grade: **0**
O&M Grade: **2**
Clock Start/From: **7**
Clock To: **5**
1st Value:
2nd Value:
Value Percent:
Continuous Index:
Within 8" of Joint: **YES**
Remarks:

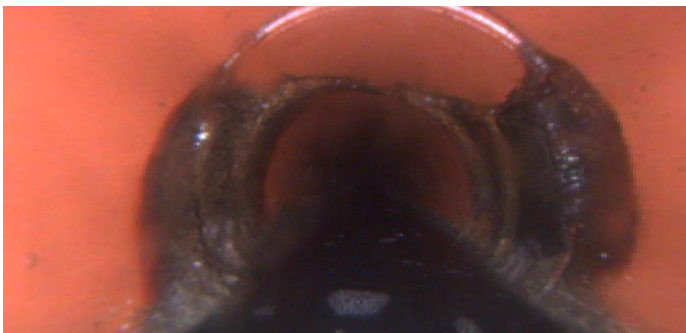
Code: **FC**
Description: **Fracture Circumferential**

Distance (ft): **41.2**
Structural Grade: **2**
O&M Grade: **0**
Clock Start/From: **7**
Clock To: **5**
1st Value:
2nd Value:
Value Percent:
Continuous Index:
Within 8" of Joint: **YES**
Remarks:

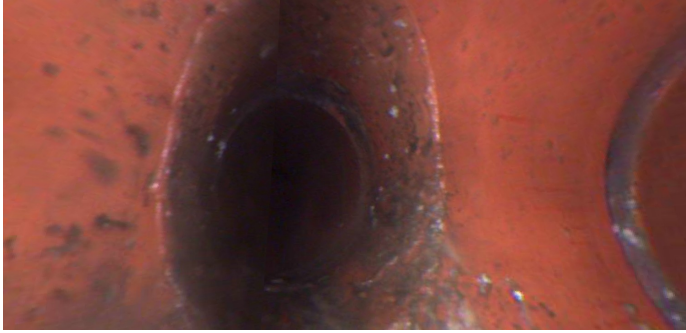
Code: **TF**
Description: **Tap Factory**

Distance (ft): **82.9**
Structural Grade: **0**
O&M Grade: **0**
Clock Start/From: **3**
Clock To:
1st Value: **4.000**
2nd Value:
Value Percent:
Continuous Index:
Within 8" of Joint:
Remarks:

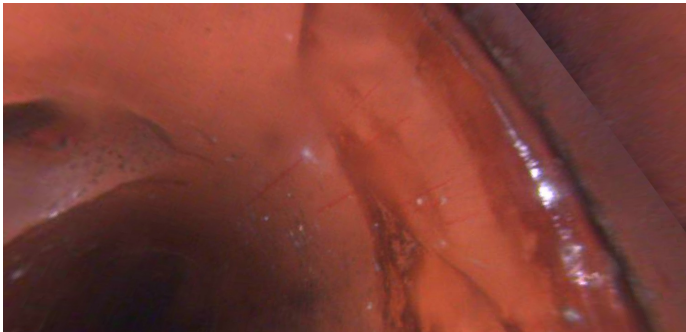
Code: **IW**
Description: **Infil Weeper**

Distance (ft): **84.1**
Structural Grade: **0**
O&M Grade: **2**
Clock Start/From: **1**
Clock To: **4**
1st Value:
2nd Value:
Value Percent:
Continuous Index:
Within 8" of Joint: **YES**
Remarks:

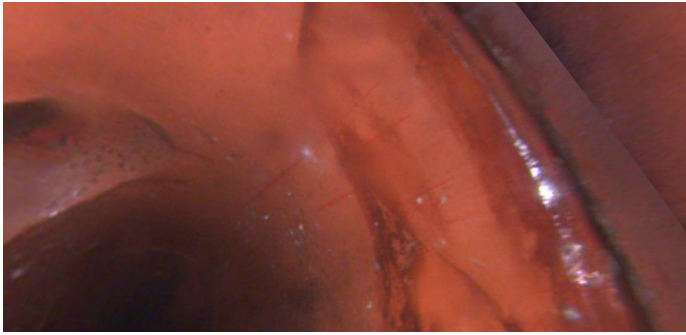
Code: **FM**
Description: **Fracture Multiple**

Distance (ft): **84.1**
Structural Grade: **4**
O&M Grade: **0**
Clock Start/From: **1**
Clock To: **4**
1st Value:
2nd Value:
Value Percent:
Continuous Index:
Within 8" of Joint: **YES**
Remarks:

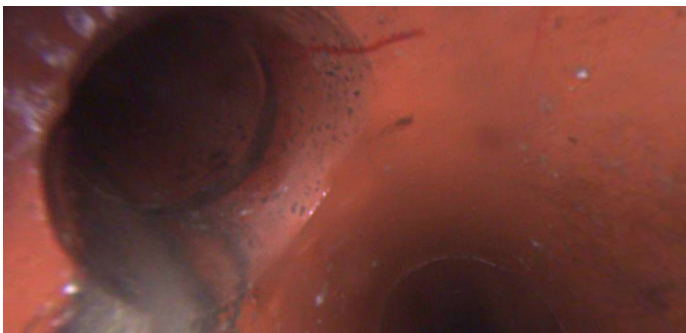
Code: **TF**
Description: **Tap Factory**

Distance (ft): **84.7**
Structural Grade: **0**
O&M Grade: **0**
Clock Start/From: **10**
Clock To:
1st Value: **4.000**
2nd Value:
Value Percent:
Continuous Index:
Within 8" of Joint:
Remarks:

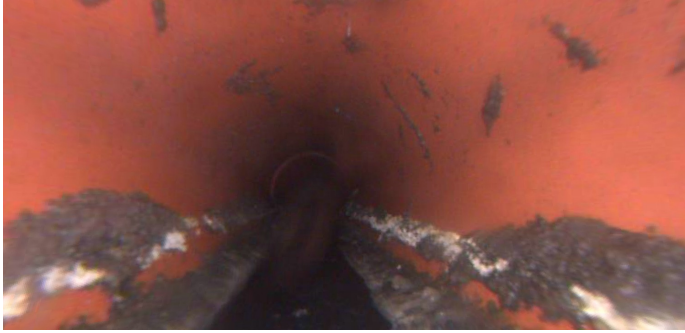
Code: **DAZ**
Description: **Deposits Attached Other**

Distance (ft): **143.5**
Structural Grade: **0**
O&M Grade: **2**
Clock Start/From: **8**
Clock To: **4**
1st Value:
2nd Value:
Value Percent: **5.000**
Continuous Index:
Within 8" of Joint: **NO**
Remarks:

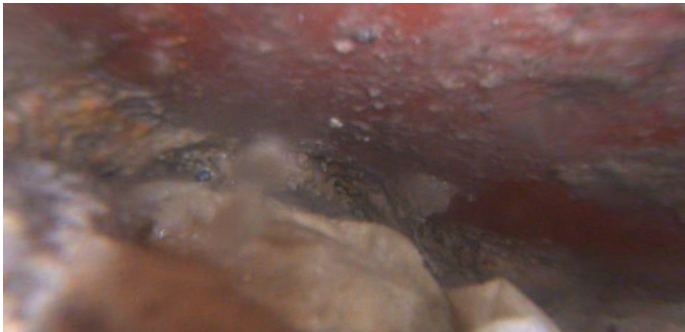
Code: **DAGS**
Description: **Deposits Attached Grease**

Distance (ft): **151.3**
Structural Grade: **0**
O&M Grade: **2**
Clock Start/From: **8**
Clock To: **4**
1st Value:
2nd Value:
Value Percent: **10.000**
Continuous Index:
Within 8" of Joint: **NO**
Remarks:

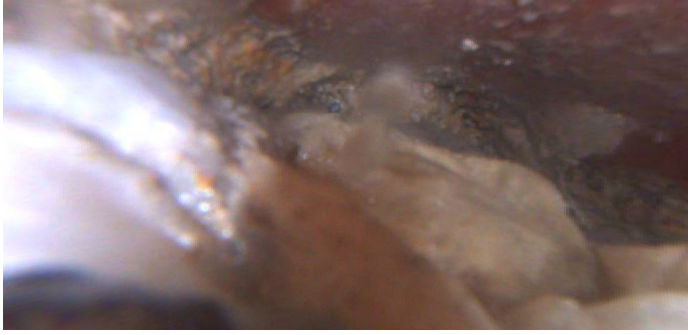
Code:	MSA
Description:	Abandoned Survey
Distance (ft):	151.3
Structural Grade:	0
O&M Grade:	0
Clock Start/From:	
Clock To:	
1st Value:	
2nd Value:	
Value Percent:	
Continuous Index:	
Within 8" of Joint:	NO
Remarks:	CAMERA STOPPED
