Profile/Photo Observation Report

Street:	Kenwood St	Flow Control:	Not Controlled
City:	Hobart, IN	Year Renewed:	
Location:	Light Highway	Tape/Media #:	
Purpose:	Routine Assessment	Dia/Height:	10"
Use:	Sanitary	Material:	VCP
Drain Area:	NA	Lining:	
Category:	NA		
Comment:

Location Details:		Direction of Survey:	Upstream
US MH:	M-303-021	DS MH:	M-303-022
		Total Length Surveyed (ft):	151.5

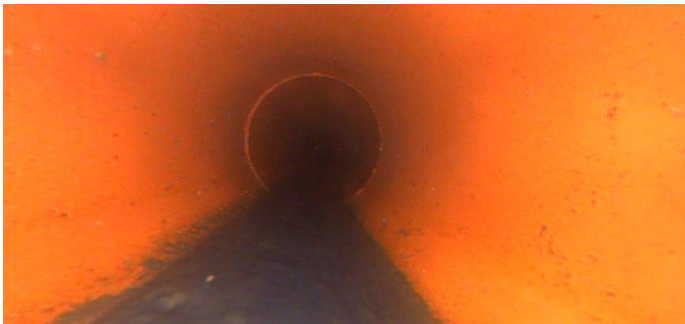
Code: **AMH**
Description: **Manhole**

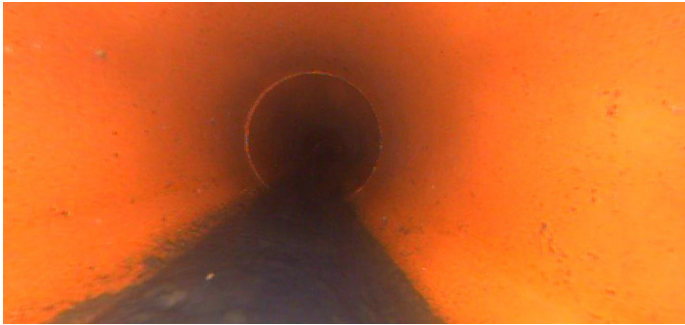
Code:	MWL
Description:	Water Level

Distance (ft):	.0
Structural Grade:	0
O&M Grade:	0
Clock Start/From:	
Clock To:	
1st Value:	
2nd Value:	
Value Percent:	5.000
Continuous Index:	
Within 8" of Joint:	NO
Remarks:

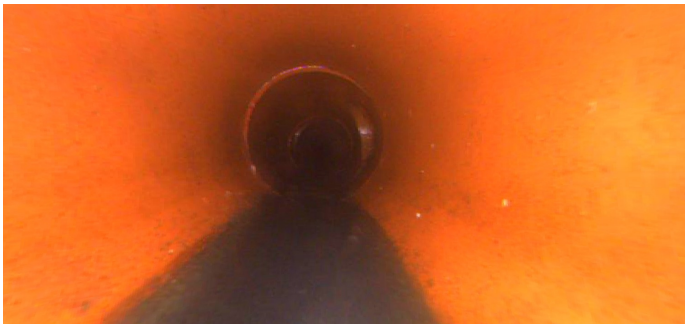
Code:	TF
Description:	Tap Factory

Distance (ft):	6.0
Structural Grade:	0
O&M Grade:	0
Clock Start/From:	3
Clock To:	
1st Value:	4.000
2nd Value:	
Value Percent:	
Continuous Index:	
Within 8" of Joint:	
Remarks:

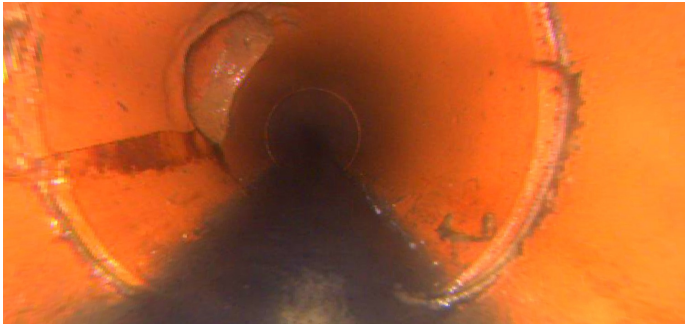
Code: **TF**
Description: **Tap Factory**

Distance (ft): **9.2**
Structural Grade: **0**
O&M Grade: **0**
Clock Start/From: **10**
Clock To:
1st Value: **4.000**
2nd Value:
Value Percent:
Continuous Index:
Within 8" of Joint:
Remarks:

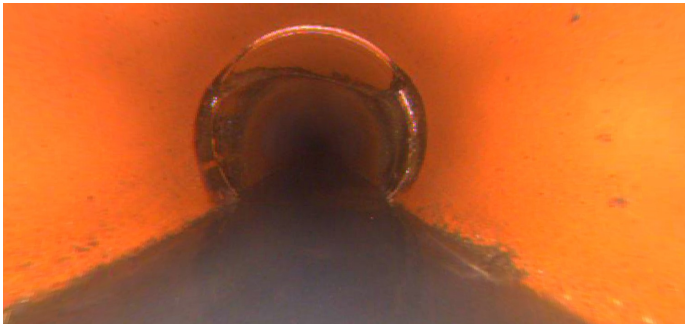
Code: **FS**
Description: **Fracture Spiral**

Distance (ft): **40.9**
Structural Grade: **3**
O&M Grade: **0**
Clock Start/From: **9**
Clock To: **2**
1st Value:
2nd Value:
Value Percent:
Continuous Index:
Within 8" of Joint: **YES**
Remarks:

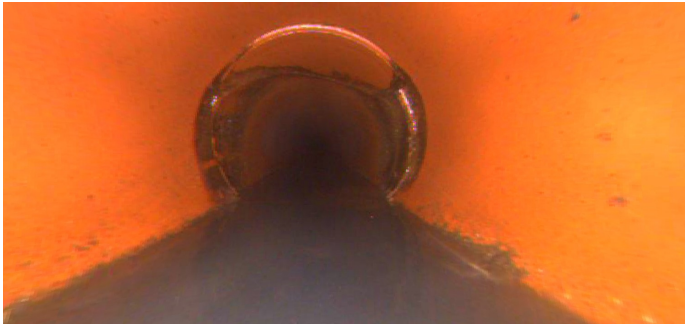
Code: **IS**
Description: **Infil Stain**

Distance (ft): **40.9**
Structural Grade: **0**
O&M Grade: **0**
Clock Start/From: **8**
Clock To: **4**
1st Value:
2nd Value:
Value Percent:
Continuous Index:
Within 8" of Joint: **YES**
Remarks:

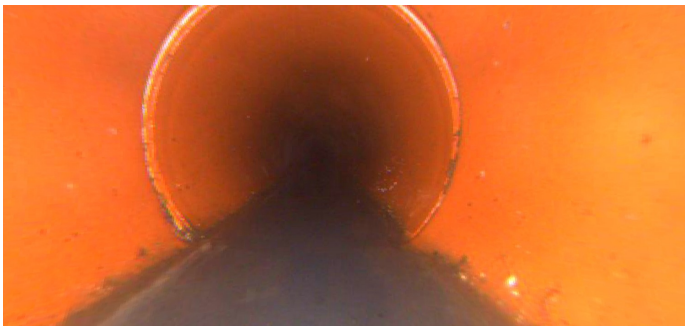
Code: **RFJ**
Description: **Roots Fine Joint**

Distance (ft): **66.5**
Structural Grade: **0**
O&M Grade: **1**
Clock Start/From: **7**
Clock To: **5**
1st Value:
2nd Value:
Value Percent:
Continuous Index:
Within 8" of Joint: **YES**
Remarks:

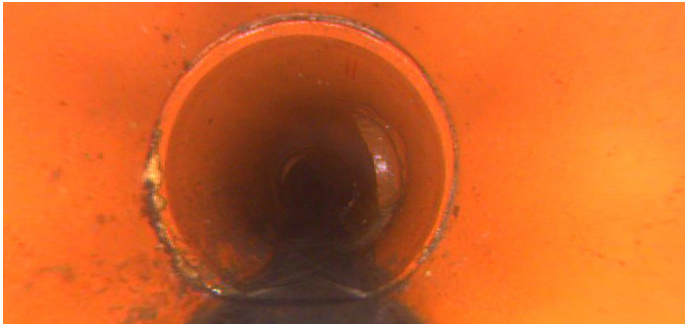
Code: **RFJ**
Description: **Roots Fine Joint**

Distance (ft): **81.6**
Structural Grade: **0**
O&M Grade: **1**
Clock Start/From: **7**
Clock To: **5**
1st Value:
2nd Value:
Value Percent:
Continuous Index:
Within 8" of Joint: **YES**
Remarks:

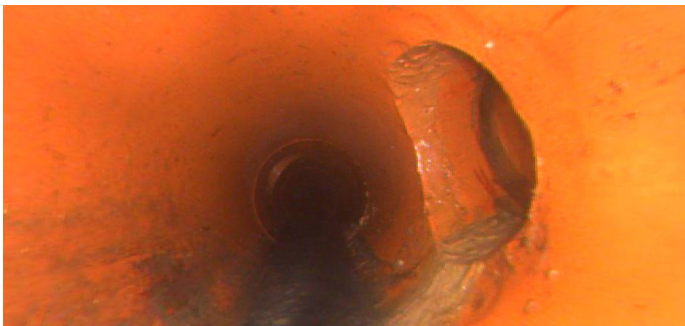
Code: **TF**
Description: **Tap Factory**

Distance (ft): **82.4**
Structural Grade: **0**
O&M Grade: **0**
Clock Start/From: **3**
Clock To:
1st Value: **4.000**
2nd Value:
Value Percent:
Continuous Index:
Within 8" of Joint:
Remarks:

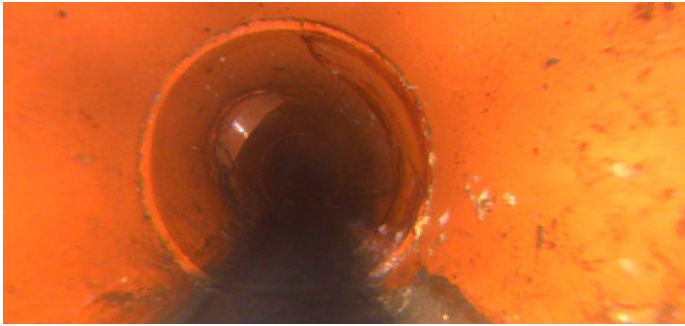
Code: **FL**
Description: **Fracture Longitudinal**

Distance (ft): **83.6**
Structural Grade: **3**
O&M Grade: **0**
Clock Start/From: **12**
Clock To:
1st Value:
2nd Value:
Value Percent:
Continuous Index:
Within 8" of Joint: **YES**
Remarks:

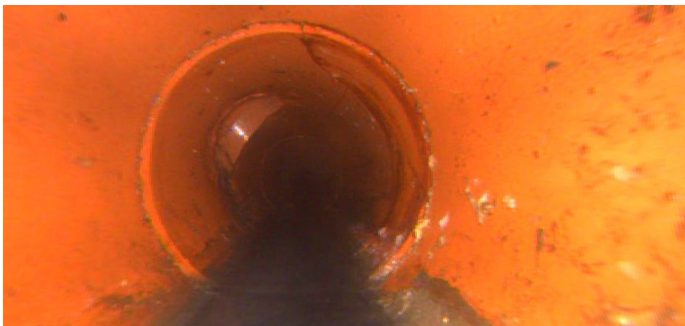
Code: **TF**
Description: **Tap Factory**

Distance (ft): **83.6**
Structural Grade: **0**
O&M Grade: **0**
Clock Start/From: **10**
Clock To:
1st Value: **4.000**
2nd Value:
Value Percent:
Continuous Index:
Within 8" of Joint:
Remarks:
