Profile/Photo Observation Report

Date:	04/07/2018	Weather:		Coding:	PACP 6.0
Pipe Length (ft):		Owner:	City of Hobart	Pre Clean:	No Pre-Cleaning
P.O.#:	1-1	Surveyor:	M. Pielacha	PSR:	M-303-021-M-303-027
Customer:	City of Hobart	Clean Date:		Shape:	C

Street:	Ridgelawn Drive	Flow Control:	Not Controlled
City:	Hobart, IN	Year Renewed:	
Location:	Light Highway	Tape/Media #:	DEP 1
Purpose:	Routine Assessment	Dia/Height:	18"
Use:	Sanitary	Material:	VCP
Drain Area:		Lining:

US MH: **M-303-021** DS MH: **M-303-027** Total Length Surveyed (ft): **312.4**

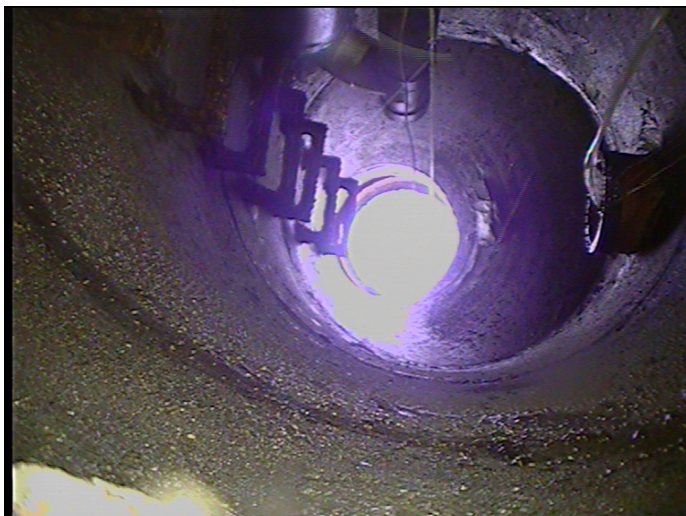
Code: **AMH**
Description: **Manhole**

Distance (ft): **.0**
Structural Grade: **0**
O&M Grade: **0**
Clock Start/From:
Clock To:
1st Value:
2nd Value:
Value Percent:
Continuous Index:
Within 8" of Joint: **NO**
Remarks: **M-303-027**

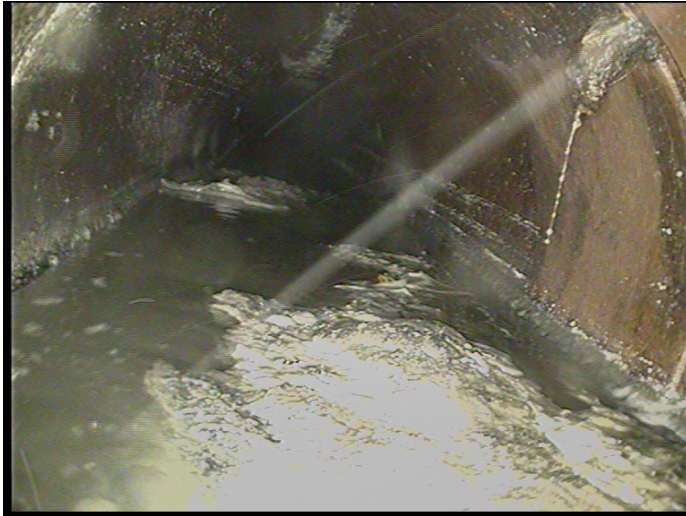
Code: **MWL**
Description: **Water Level**

Distance (ft): **.0**
Structural Grade: **0**
O&M Grade: **0**
Clock Start/From:
Clock To:
1st Value:
2nd Value:
Value Percent: **10.000**
Continuous Index:
Within 8" of Joint: **NO**
Remarks:

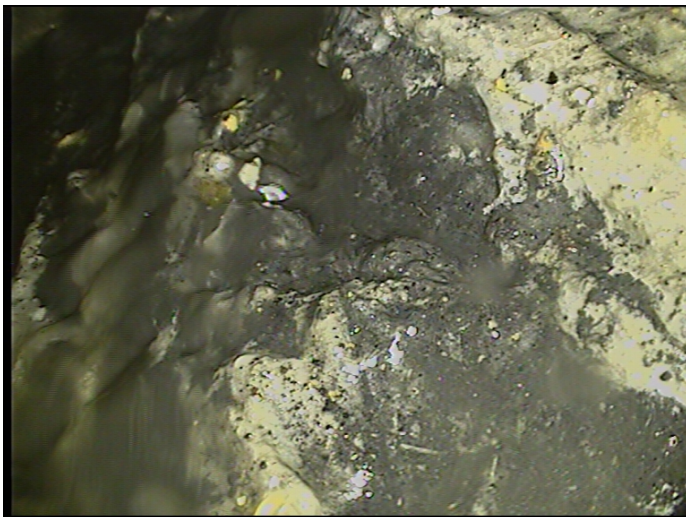
Code: **DSF**
Description: **Deposits Settled Fine**

Distance (ft): **6.4**
Structural Grade: **0**
O&M Grade: **3**
Clock Start/From: **5**
Clock To: **7**
1st Value:
2nd Value:
Value Percent: **15.000**
Continuous Index: **S01**
Within 8" of Joint: **YES**
Remarks:

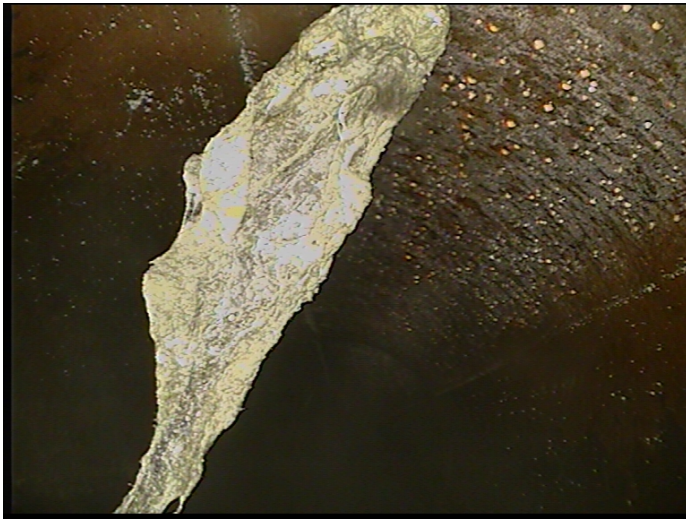
Code: **DAR**
Description: **Deposits Attached Ragging**

Distance (ft): **30.8**
Structural Grade: **0**
O&M Grade: **2**
Clock Start/From: **12**
Clock To:
1st Value:
2nd Value:
Value Percent: **10.000**
Continuous Index:
Within 8" of Joint: **YES**
Remarks:

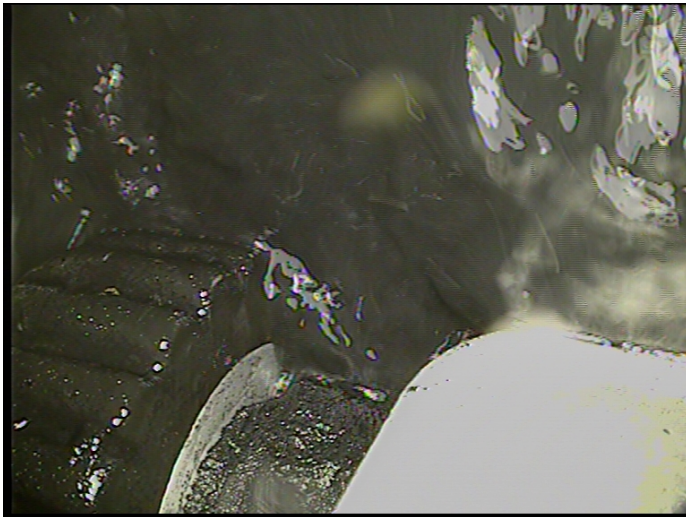
Code: **DSF**
Description: **Deposits Settled Fine**

Distance (ft): **36.5**
Structural Grade: **0**
O&M Grade: **3**
Clock Start/From: **5**
Clock To: **7**
1st Value:
2nd Value:
Value Percent: **15.000**
Continuous Index: **F01**
Within 8" of Joint: **NO**
Remarks:

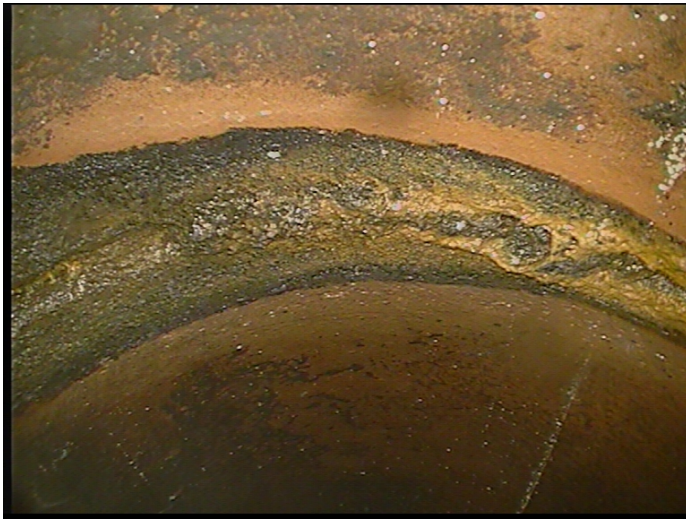
Code:	DAE
Description:	Deposits Attached Encrustation
Distance (ft):	44.8
Structural Grade:	0
O&M Grade:	2
Clock Start/From:	7
Clock To:	5
1st Value:	
2nd Value:	
Value Percent:	5.000
Continuous Index:	
Within 8" of Joint:	YES
Remarks:

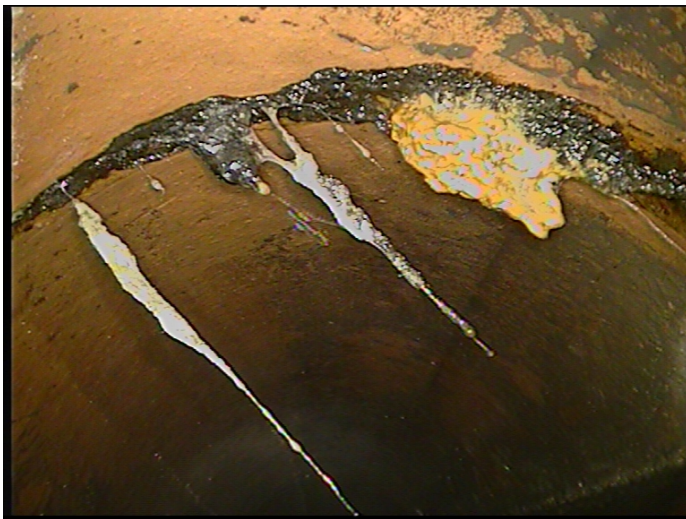
Code:	ID
Description:	Infil Dripper
Distance (ft):	175.1
Structural Grade:	0
O&M Grade:	3
Clock Start/From:	11
Clock To:	1
1st Value:	
2nd Value:	
Value Percent:	
Continuous Index:	
Within 8" of Joint:	YES
Remarks:

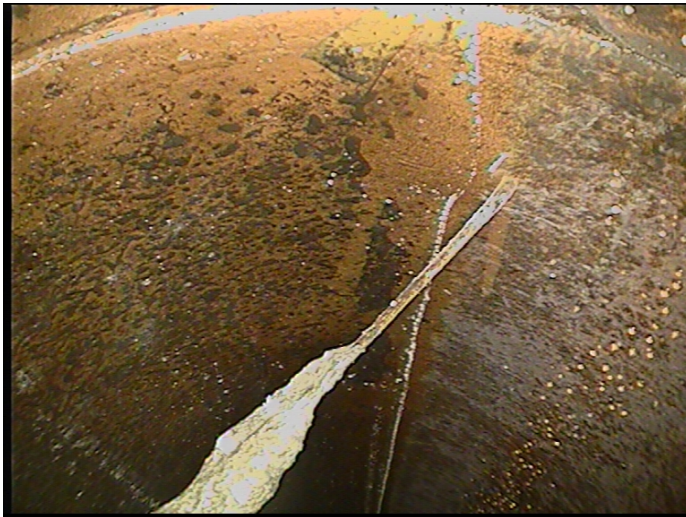
Code: **DAR**
Description: **Deposits Attached Ragging**

Distance (ft): **265.4**
Structural Grade: **0**
O&M Grade: **2**
Clock Start/From: **12**
Clock To:
1st Value:
2nd Value:
Value Percent: **10.000**
Continuous Index:
Within 8" of Joint: **YES**
Remarks:

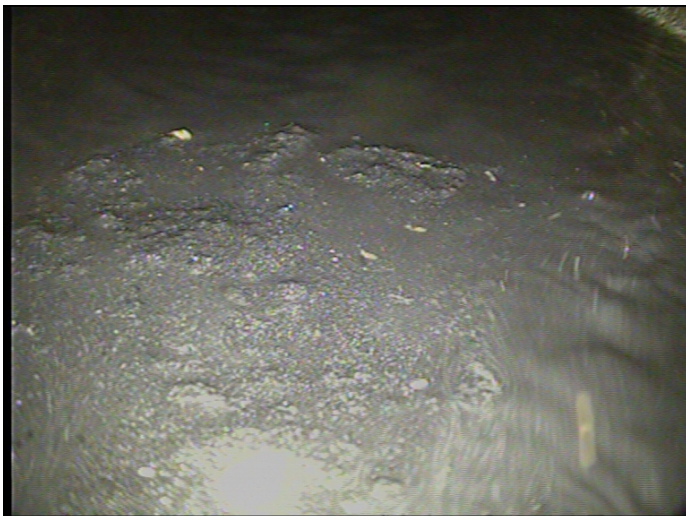
Code: **DSF**
Description: **Deposits Settled Fine**

Distance (ft): **305.1**
Structural Grade: **0**
O&M Grade: **3**
Clock Start/From: **4**
Clock To: **8**
1st Value:
2nd Value:
Value Percent: **20.000**
Continuous Index: **S02**
Within 8" of Joint: **YES**
Remarks:

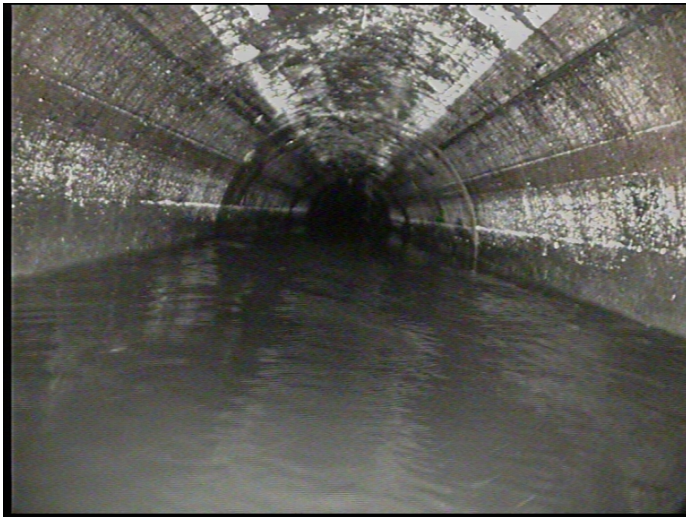
Code: **DSF**
 Description: **Deposits Settled Fine**

Distance (ft): **312.4**
 Structural Grade: **0**
 O&M Grade: **3**
 Clock Start/From: **4**
 Clock To: **8**
 1st Value:
 2nd Value:
 Value Percent: **20.000**
 Continuous Index: **F02**
 Within 8" of Joint: **YES**
 Remarks:

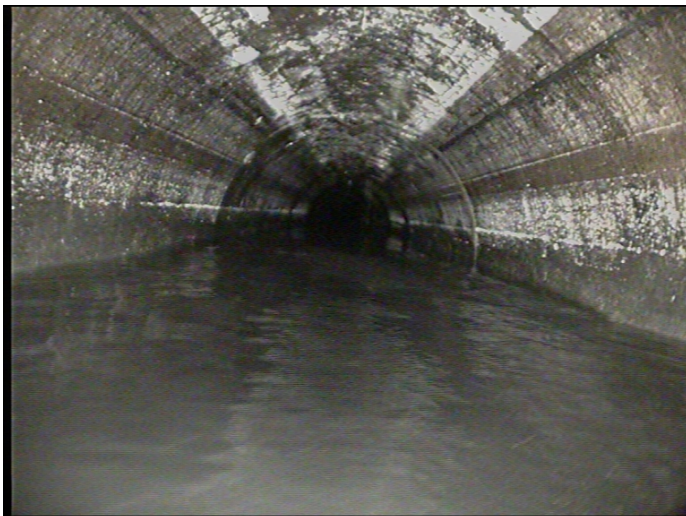
Code: **MSA**
 Description: **Abandoned Survey**

Distance (ft): **312.4**
 Structural Grade: **0**
 O&M Grade: **0**
 Clock Start/From:
 Clock To:
 1st Value:
 2nd Value:
 Value Percent:
 Continuous Index:
 Within 8" of Joint: **NO**
 Remarks: **deep sediment**
