Profile/Photo Observation Report

Street:	Ridgelawn Drive	Flow Control:	Not Controlled
City:	Hobart, IN	Year Renewed:	
Location:	Light Highway	Tape/Media #:	DEP 4
Purpose:	Reversal	Dia/Height:	18"
Use:	Sanitary	Material:	VCP
Drain Area:		Lining:

US MH: **M-303-021** DS MH: **M-303-027** Total Length Surveyed (ft): **4.8**

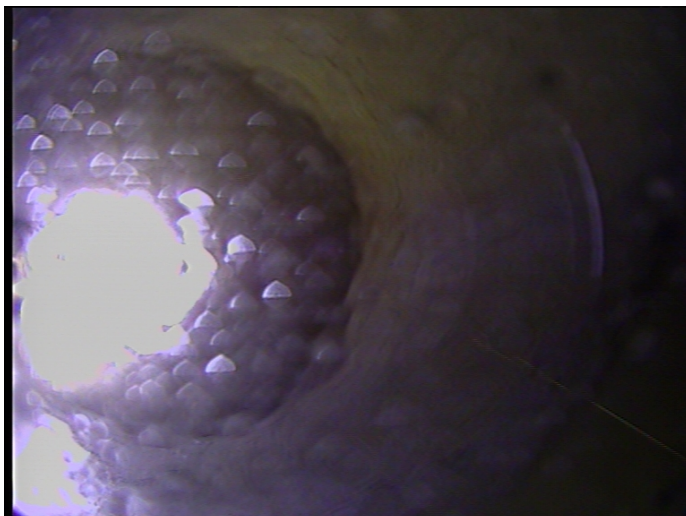
Code: **AMH**
Description: **Manhole**

Distance (ft): **.0**
Structural Grade: **0**
O&M Grade: **0**
Clock Start/From:
Clock To:
1st Value:
2nd Value:
Value Percent:
Continuous Index:
Within 8" of Joint: **NO**
Remarks: **M-303-021**

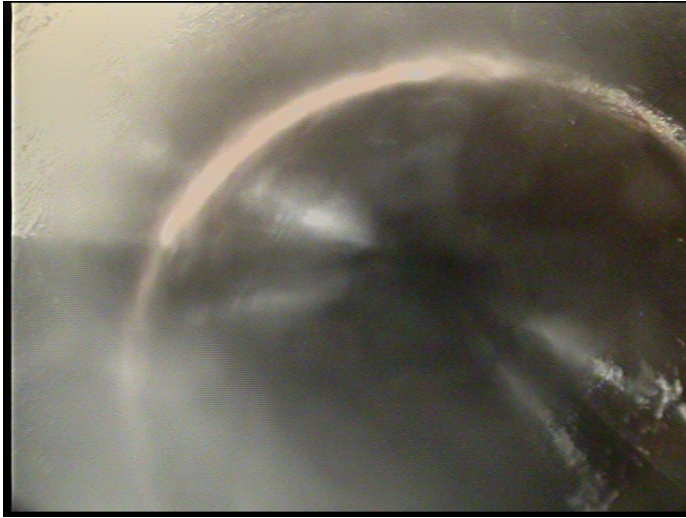
Code: **MWL**
Description: **Water Level**

Distance (ft): **.0**
Structural Grade: **0**
O&M Grade: **0**
Clock Start/From:
Clock To:
1st Value:
2nd Value:
Value Percent: **15.000**
Continuous Index:
Within 8" of Joint: **NO**
Remarks:

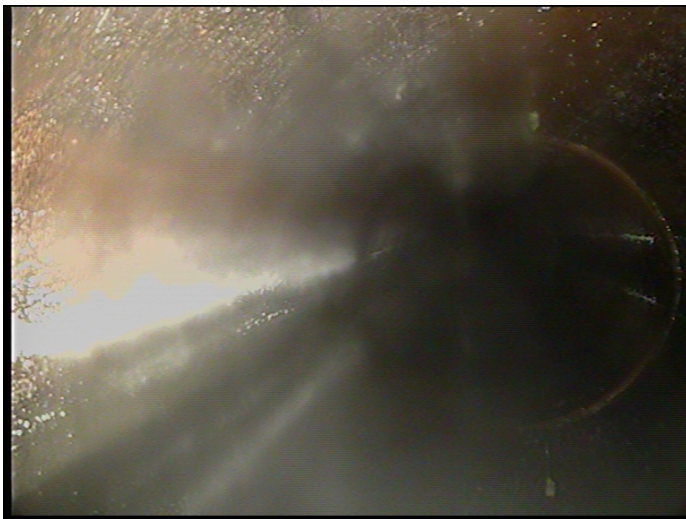
Code: **DSF**
Description: **Deposits Settled Fine**

Distance (ft): **4.4**
Structural Grade: **0**
O&M Grade: **3**
Clock Start/From: **4**
Clock To: **8**
1st Value:
2nd Value:
Value Percent: **15.000**
Continuous Index:
Within 8" of Joint: **YES**
Remarks:

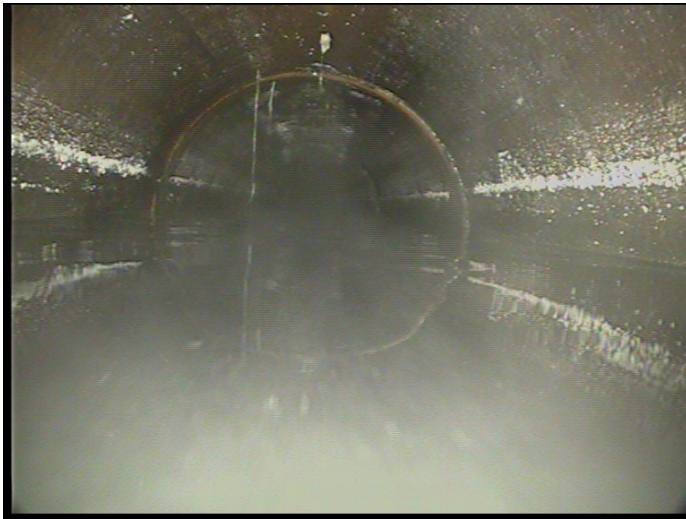
Code:	MSA
Description:	Abandoned Survey
Distance (ft):	4.8
Structural Grade:	0
O&M Grade:	0
Clock Start/From:	
Clock To:	
1st Value:	
2nd Value:	
Value Percent:	
Continuous Index:	
Within 8" of Joint:	NO
Remarks:	deep sediment
