## Profile/Photo Observation Report

Date:	<b>04/24/2018</b>	Weather:		Coding:	<b>PACP 6.0</b>
Pipe Length (ft):		Owner:	<b>City of Hobart</b>	Pre Clean:	<b>No Pre-Cleaning</b>
P.O.#:	<b>70</b>	Surveyor:	<b>M. Pielacha</b>	PSR:	<b>P-303-069-021</b>
Customer:	<b>City of Hobart</b>	Clean Date:		Shape:	<b>C</b>

Street:	<b>Ridgelawn Drive</b>	Flow Control:	<b>Not Controlled</b>
City:	<b>Hobart, IN</b>	Year Renewed:	
Location:	<b>Light Highway</b>	Tape/Media #:	<b>70</b>
Purpose:	<b>Routine Assessment</b>	Dia/Height:	<b>6"</b>
Use:	<b>Sanitary</b>	Material:	<b>PVC</b>
Drain Area:		Lining:	
Category:	<b>NA</b>		
Comment:	<b>YES501824 Submittal 2</b>		
Location Details:		Direction of Survey:	<b>Upstream</b>
US MH:	<b>M-303-069</b>	DS MH:	<b>M-303-021</b>
		Total Length Surveyed (ft):	<b>124.4</b>

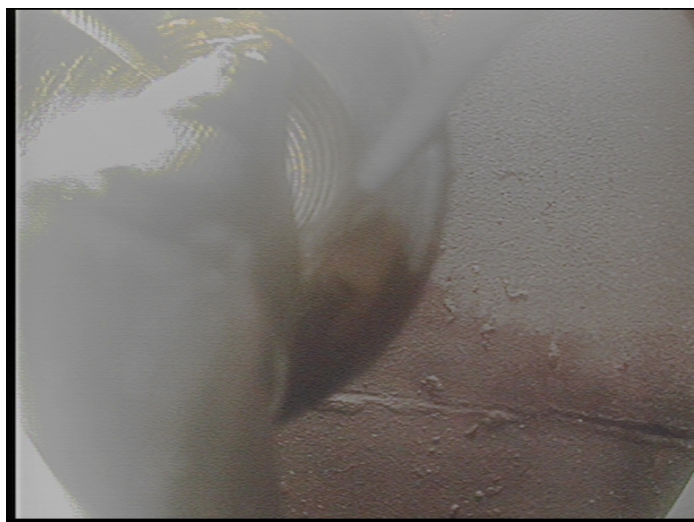
Code: **AMH**  
Description: **Manhole**

Distance (ft): **.0**  
Structural Grade: **0**  
O&M Grade: **0**  
Clock Start/From:  
Clock To:  
1st Value:  
2nd Value:  
Value Percent:  
Continuous Index:  
Within 8" of Joint: **NO**  
Remarks: **M-303-021**

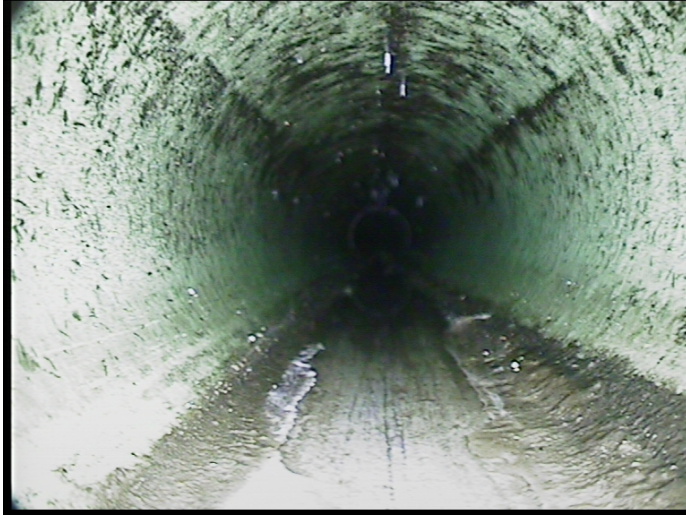
Code:	<b>MWL</b>
Description:	<b>Water Level</b>
Distance (ft):	<b>.0</b>
Structural Grade:	<b>0</b>
O&M Grade:	<b>0</b>
Clock Start/From:	
Clock To:	
1st Value:	
2nd Value:	
Value Percent:	<b>5.000</b>
Continuous Index:	
Within 8" of Joint:	<b>NO</b>
Remarks:

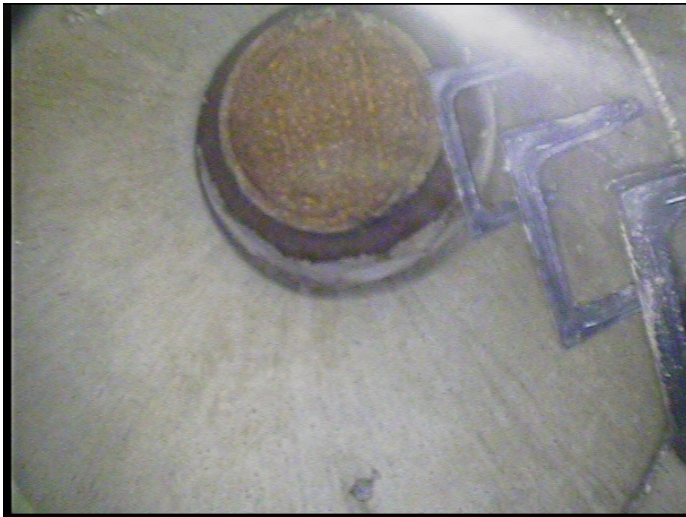
Code:	<b>AMH</b>
Description:	<b>Manhole</b>
Distance (ft):	<b>124.4</b>
Structural Grade:	<b>0</b>
O&M Grade:	<b>0</b>
Clock Start/From:	
Clock To:	
1st Value:	
2nd Value:	
Value Percent:	
Continuous Index:	
Within 8" of Joint:	<b>NO</b>
Remarks:	<b>M-303-069</b>
