Profile/Photo Observation Report

Street:	KENWOOD ST	Flow Control:	Not Controlled
City:	Hobart, IN	Year Renewed:	
Location:	Other	Tape/Media #:	
Purpose:	Not Known	Dia/Height:	10"
Use:	Sanitary	Material:	VCP
Drain Area:	NA	Lining:	
Category:	NA		
Comment:

Location Details:		Direction of Survey:	Upstream
US MH:	M-303-022	DS MH:	M-303-023
		Total Length Surveyed (ft):	29.8

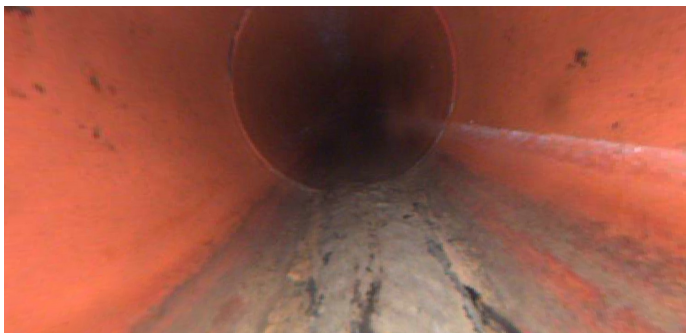
Code: **AMH**
Description: **Manhole**

Distance (ft): **.0**
Structural Grade: **0**
O&M Grade: **0**
Clock Start/From:
Clock To:
1st Value:
2nd Value:
Value Percent:
Continuous Index:
Within 8" of Joint: **NO**
Remarks: **M-303-023**

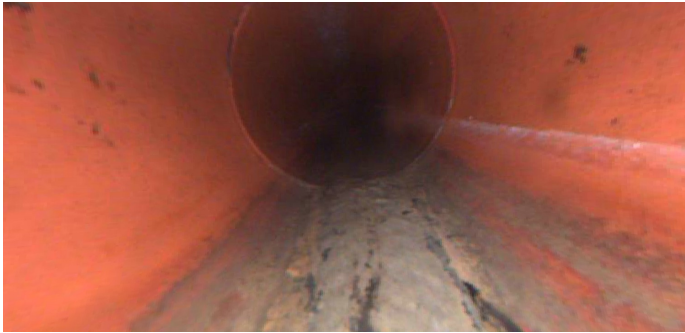
Code:	MWL
Description:	Water Level

Distance (ft):	.0
Structural Grade:	0
O&M Grade:	0
Clock Start/From:	
Clock To:	
1st Value:	
2nd Value:	
Value Percent:	5.000
Continuous Index:	
Within 8" of Joint:	NO
Remarks:

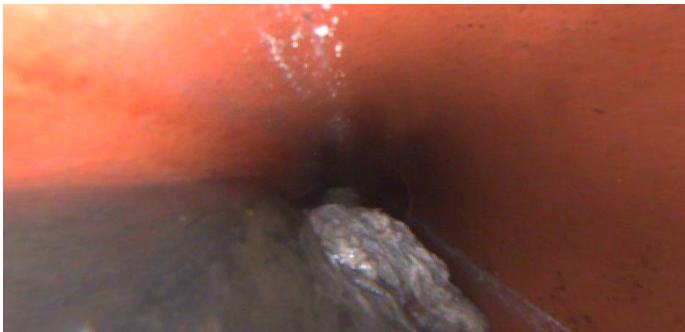
Code:	MSA
Description:	Abandoned Survey

Distance (ft):	29.8
Structural Grade:	0
O&M Grade:	0
Clock Start/From:	
Clock To:	
1st Value:	
2nd Value:	
Value Percent:	
Continuous Index:	
Within 8" of Joint:	NO
Remarks:	camera stopped

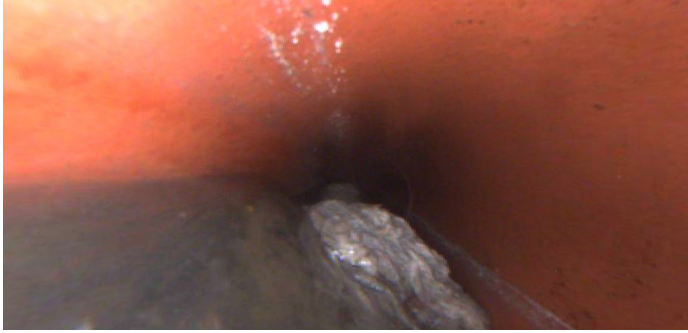
Code:	DSZ
Description:	Deposits Settled Other
Distance (ft):	29.8
Structural Grade:	0
O&M Grade:	2
Clock Start/From:	5
Clock To:	
1st Value:	
2nd Value:	
Value Percent:	5.000
Continuous Index:	
Within 8" of Joint:	NO
Remarks:	mixed material
