Profile/Photo Observation Report

Street:	KENWOOD ST	Flow Control:	Not Controlled
City:	Hobart, IN	Year Renewed:	
Location:	Other	Tape/Media #:	
Purpose:	Not Known	Dia/Height:	10"
Use:	Sanitary	Material:	VCP
Drain Area:	NA	Lining:	
Category:	NA		
Comment:

Location Details:		Direction of Survey:	Downstream
US MH:	M-303-022	DS MH:	M-303-023
		Total Length Surveyed (ft):	16.5

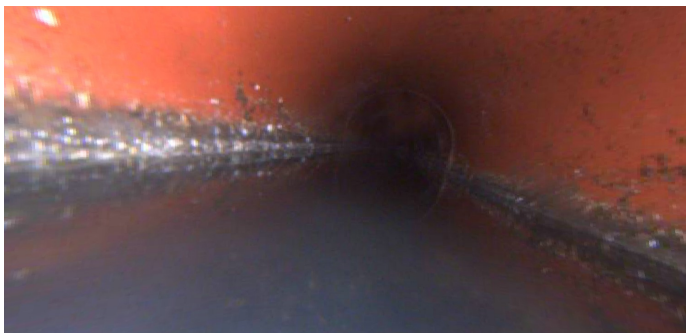
Code: **AMH**
Description: **Manhole**

Distance (ft): **.0**
Structural Grade: **0**
O&M Grade: **0**
Clock Start/From:
Clock To:
1st Value:
2nd Value:
Value Percent:
Continuous Index:
Within 8" of Joint: **NO**
Remarks: **M-303-022**

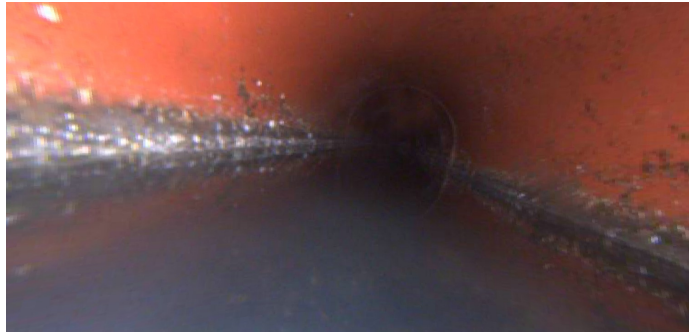
Code: **MWL**
Description: **Water Level**

Distance (ft): **.0**
Structural Grade: **0**
O&M Grade: **0**
Clock Start/From:
Clock To:
1st Value:
2nd Value:
Value Percent: **5.000**
Continuous Index:
Within 8" of Joint: **NO**
Remarks:

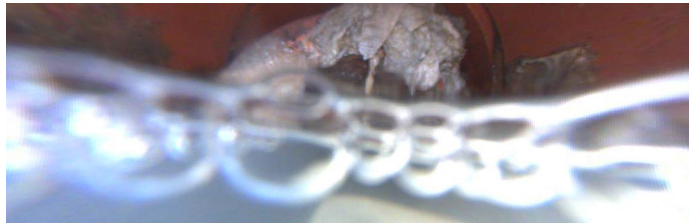
Code: **MWLS**
Description: **Water Level Sag**

Distance (ft): **12.7**
Structural Grade: **2**
O&M Grade: **3**
Clock Start/From:
Clock To:
1st Value:
2nd Value:
Value Percent: **10.000**
Continuous Index:
Within 8" of Joint: **NO**
Remarks:
