## Profile/Photo Observation Report

Street:	<b>KENWOOD ST</b>	Flow Control:	<b>Not Controlled</b>
City:	<b>Hobart, IN</b>	Year Renewed:	
Location:	<b>Other</b>	Tape/Media #:	
Purpose:	<b>Not Known</b>	Dia/Height:	<b>10"</b>
Use:	<b>Sanitary</b>	Material:	<b>VCP</b>
Drain Area:	<b>NA</b>	Lining:	
Category:	<b>NA</b>		
Comment:

Location Details:		Direction of Survey:	<b>Downstream</b>
US MH:	<b>M-303-023</b>	DS MH:	<b>M-303-024</b>
		Total Length Surveyed (ft):	<b>173.3</b>

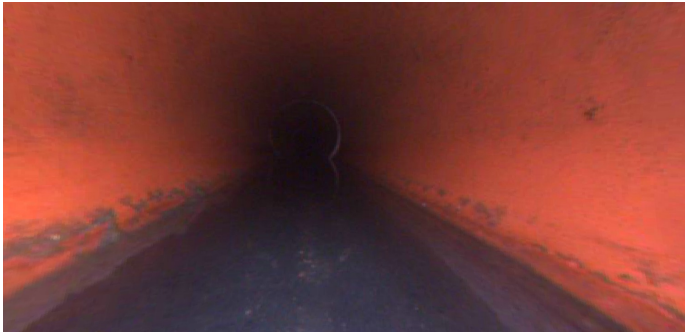
Code:	<b>MWL</b>
Description:	<b>Water Level</b>

Distance (ft):	<b>.0</b>
Structural Grade:	<b>0</b>
O&M Grade:	<b>0</b>
Clock Start/From:	
Clock To:	
1st Value:	
2nd Value:	
Value Percent:	<b>5.000</b>
Continuous Index:	
Within 8" of Joint:	<b>NO</b>
Remarks:

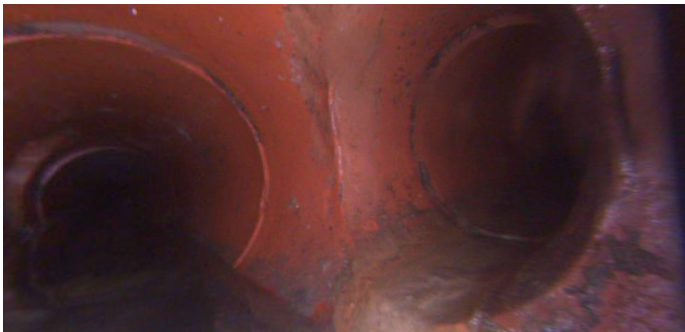
Code:	<b>TF</b>
Description:	<b>Tap Factory</b>

Distance (ft):	<b>53.8</b>
Structural Grade:	<b>0</b>
O&M Grade:	<b>0</b>
Clock Start/From:	<b>3</b>
Clock To:	
1st Value:	<b>4.000</b>
2nd Value:	
Value Percent:	
Continuous Index:	
Within 8" of Joint:	
Remarks:

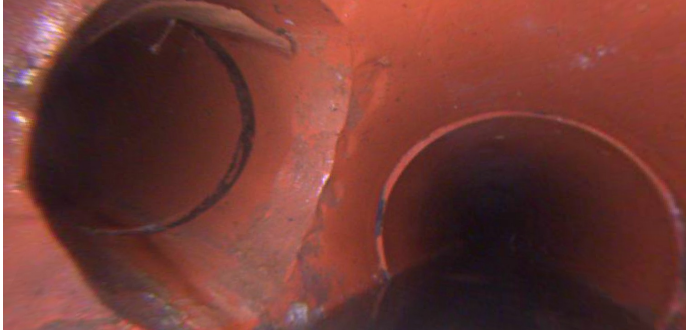
Code: **TF**  
Description: **Tap Factory**

Distance (ft): **55.8**  
Structural Grade: **0**  
O&M Grade: **0**  
Clock Start/From: **9**  
Clock To:  
1st Value: **4.000**  
2nd Value:  
Value Percent:  
Continuous Index:  
Within 8" of Joint:  
Remarks:

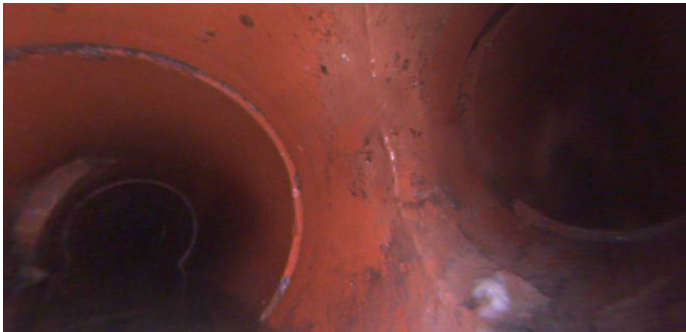
Code: **TF**  
Description: **Tap Factory**

Distance (ft): **104.1**  
Structural Grade: **0**  
O&M Grade: **0**  
Clock Start/From: **3**  
Clock To:  
1st Value: **4.000**  
2nd Value:  
Value Percent:  
Continuous Index:  
Within 8" of Joint:  
Remarks:

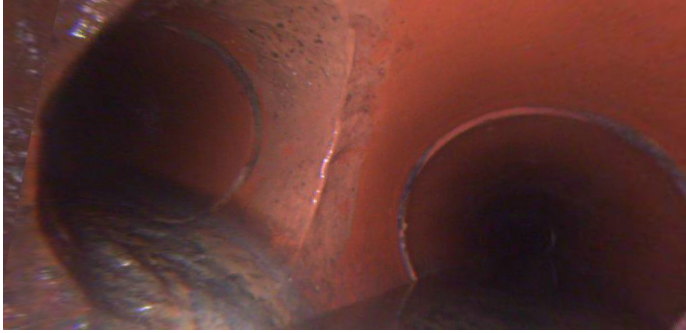
Code: **TFA**  
Description: **Tap Factory Active**

Distance (ft): **105.8**  
Structural Grade: **0**  
O&M Grade: **0**  
Clock Start/From: **9**  
Clock To:  
1st Value: **4.000**  
2nd Value:  
Value Percent:  
Continuous Index:  
Within 8" of Joint:  
Remarks:

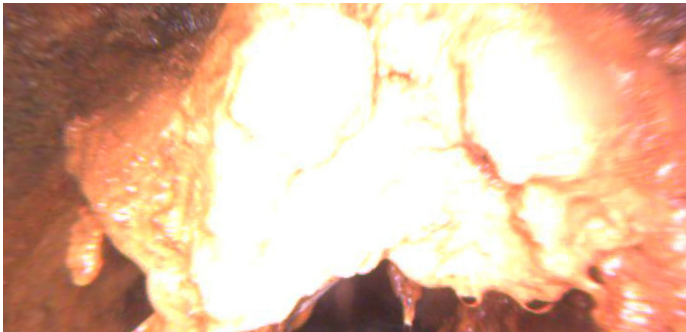
Code: **DAE**  
Description: **Deposits Attached Encrustation**

Distance (ft): **172.8**  
Structural Grade: **0**  
O&M Grade: **5**  
Clock Start/From: **8**  
Clock To: **4**  
1st Value:  
2nd Value:  
Value Percent: **80.000**  
Continuous Index:  
Within 8" of Joint: **NO**  
Remarks:

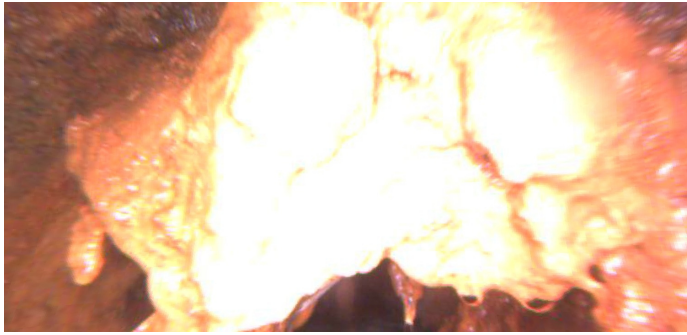
Code: ID  
Description: Infil Dripper

Distance (ft): 172.8  
Structural Grade: 0  
O&M Grade: 3  
Clock Start/From: 10  
Clock To: 2  
1st Value:  
2nd Value:  
Value Percent:  
Continuous Index:  
Within 8" of Joint:  
Remarks:
