Profile/Photo Observation Report

| Street: | KENWOOD ST | Flow Control: | Not Controlled |
| City: | Hobart, IN | Year Renewed: | |

| US MH: | M-303-023 | DS MH: | M-303-024 |

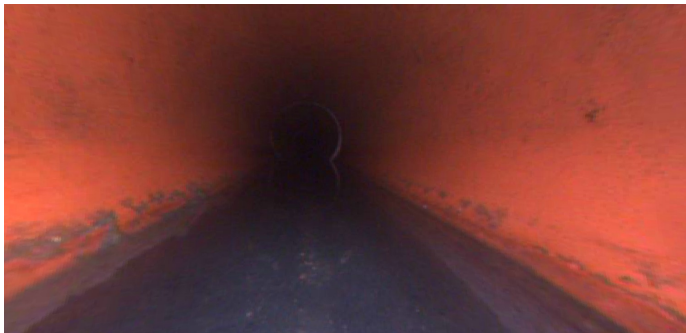
| Position | Code | Observation | Video (sec) | Grade |
|---|---|---|---|---|
| .0 | MWL | Water Level | 21 | NA |

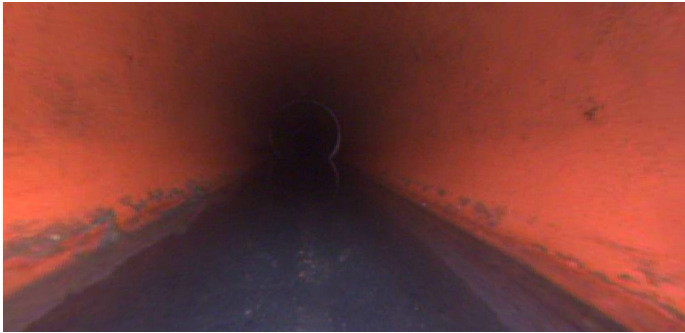
| Code: | MWL |
| Description: | Water Level |

| Distance (ft): | .0 |
| Value Percent: | 5.000 |

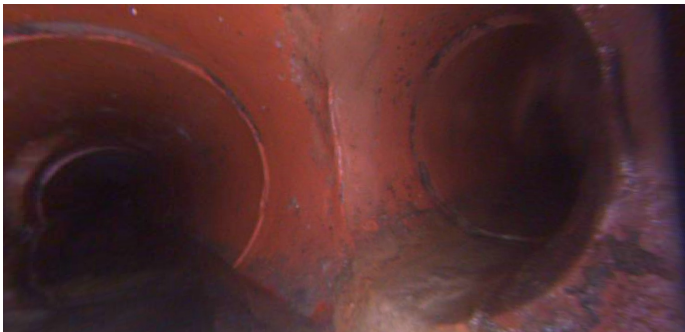
| Code: | TF |
| Description: | Tap Factory |

| Distance (ft): | 53.8 |
| Clock Start/From: | 3 |
| 1st Value: | 4.000 |

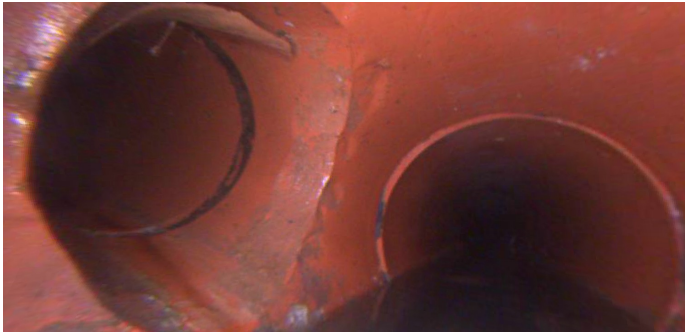
Code: **TF**
Description: **Tap Factory**

Distance (ft): **55.8**
Structural Grade: **0**
O&M Grade: **0**
Clock Start/From: **9**
Clock To:
1st Value: **4.000**
2nd Value:
Value Percent:
Continuous Index:
Within 8" of Joint:
Remarks:

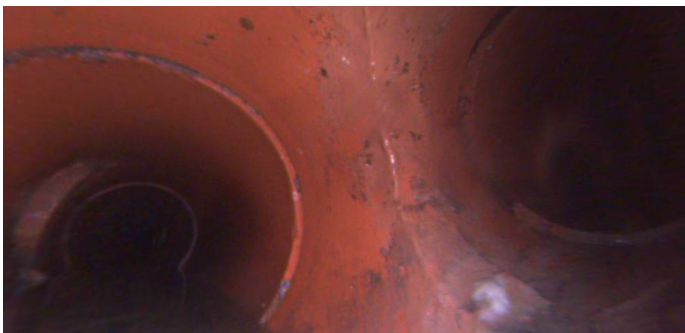
Code: **TF**
Description: **Tap Factory**

Distance (ft): **104.1**
Structural Grade: **0**
O&M Grade: **0**
Clock Start/From: **3**
Clock To:
1st Value: **4.000**
2nd Value:
Value Percent:
Continuous Index:
Within 8" of Joint:
Remarks:

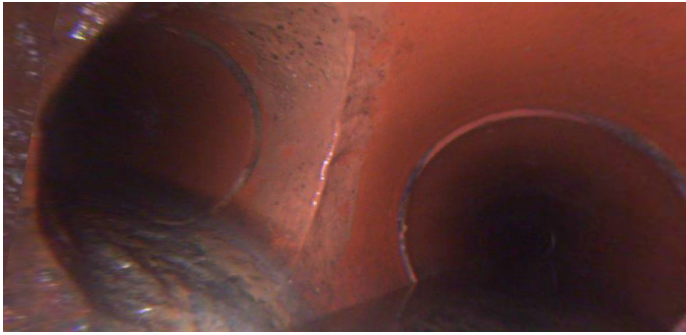
Code: **TFA**
Description: **Tap Factory Active**

Distance (ft): **105.8**
Structural Grade: **0**
O&M Grade: **0**
Clock Start/From: **9**
Clock To:
1st Value: **4.000**
2nd Value:
Value Percent:
Continuous Index:
Within 8" of Joint:
Remarks:

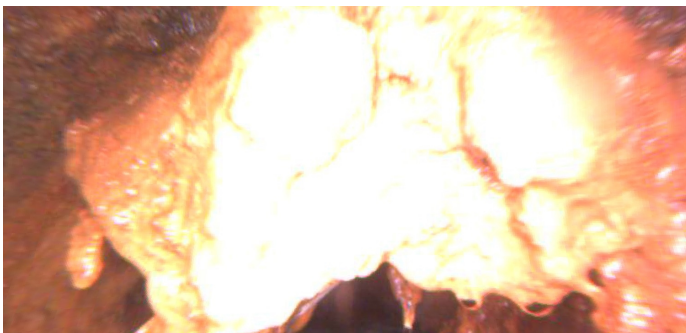
Code: **DAE**
Description: **Deposits Attached Encrustation**

Distance (ft): **172.8**
Structural Grade: **0**
O&M Grade: **5**
Clock Start/From: **8**
Clock To: **4**
1st Value:
2nd Value:
Value Percent: **80.000**
Continuous Index:
Within 8" of Joint: **NO**
Remarks:

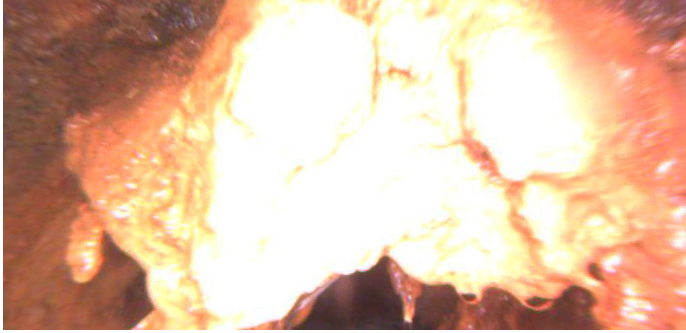
Code: ID
Description: Infil Dripper

Distance (ft): 172.8
Structural Grade: 0
O&M Grade: 3
Clock Start/From: 10
Clock To: 2
1st Value:
2nd Value:
Value Percent:
Continuous Index:
Within 8" of Joint:
Remarks:
